2012 ANNUAL FISHWAY STATUS REPORT  
THE DALLES DAM

Date: Jan, 2013

From: Bob Cordie, Paul Keller, Erin Kovalchuk and Jeff Randall

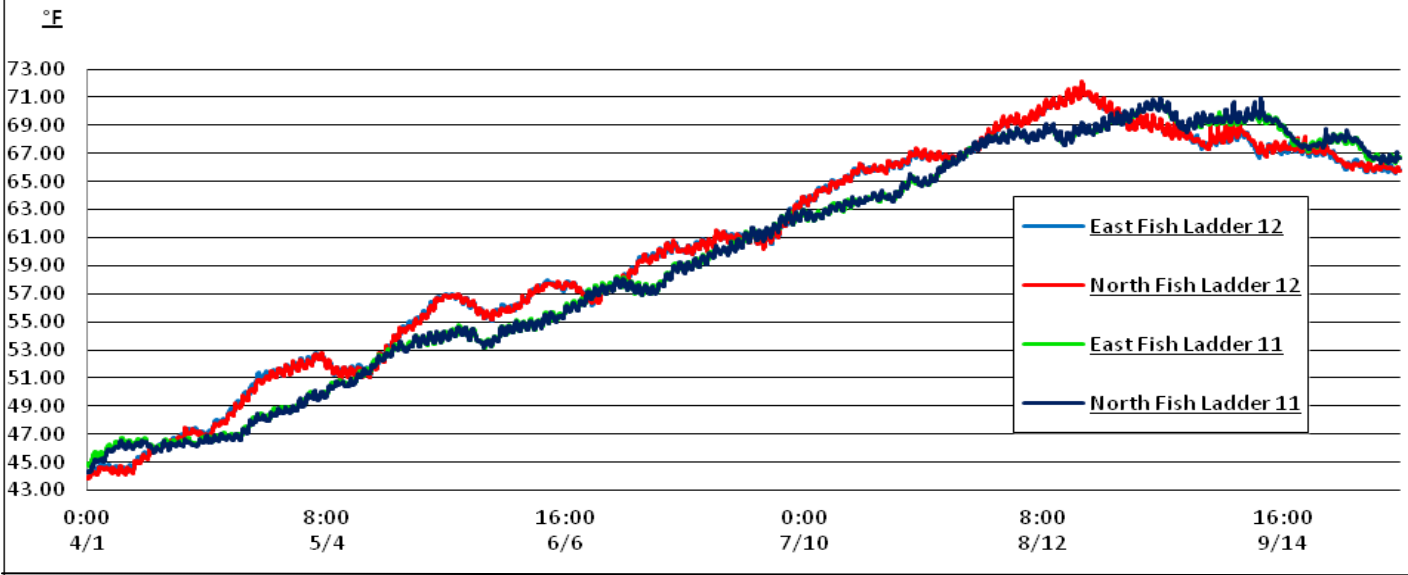
**The Dalles Adult Fish Ladder River/Water Temperatures (2012 vs 2011)**

Temperatures for 2012 generally were several degrees F warmer than 2011 through most of the season and reached a maximum of over 71F.

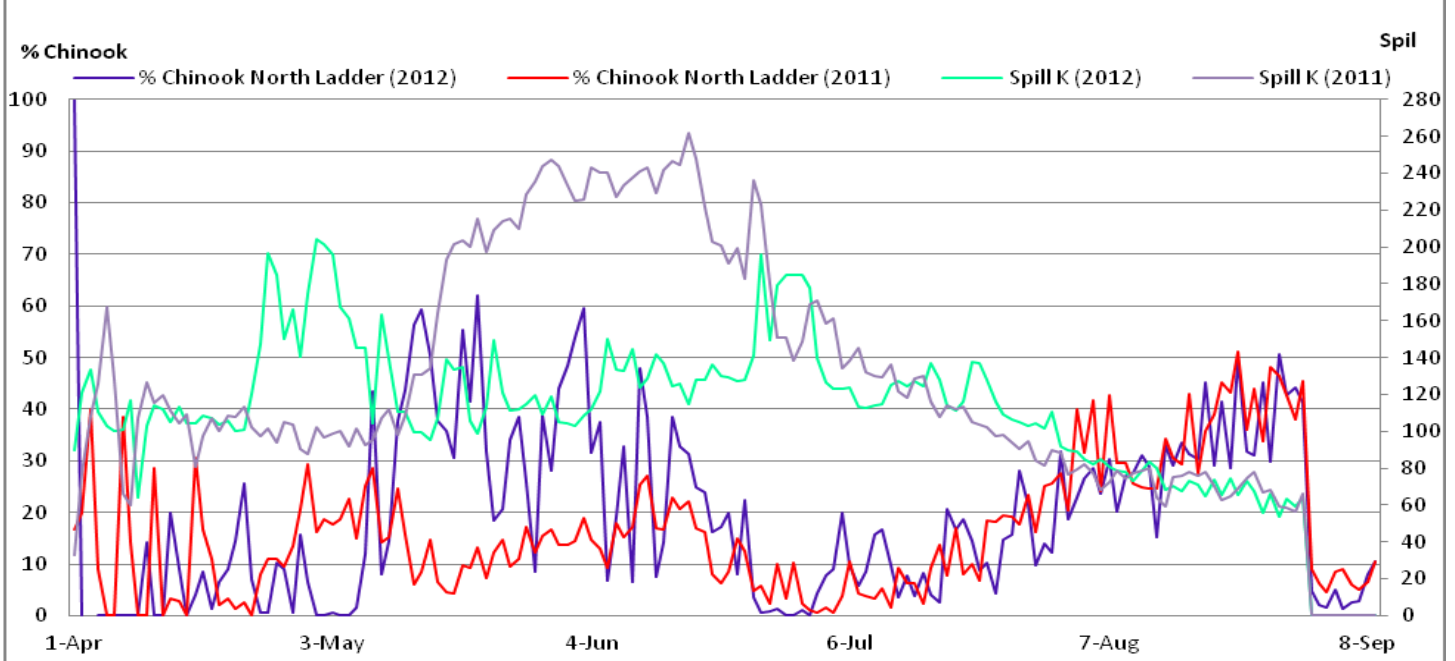
**The Dalles North Adult Fish Ladder: (%) Chinook vs Spill (K)**

Spill operation has been documented to affect north fishladder passage in the past several years. Spill >110KCFS tended to block salmonids from entering the north ladder. This was very apparent early May to early June 2012 when spill volume dropped below the 110KCFS and passage increased. In 2012, spill reached approached 200KCFS twice and passage remained low. It did not reach the 230KCFS mark as it did in 2011, so we did not see the return of passage after the ~220KCFS mark as we did in 2011. This was not evident for Chinook jacks or other salmonids. The theory remains that spill from ~110KCFS to ~220KCFS impedes north passage for adult Chinook. It was again clearly demonstrated that with no spill, salmonids are not attracted to the north entrance area either; hence the drop in north passage immediately after spill stops. Monitoring to north passage trends will continue.
