# 2015 ANNUAL FISHWAYS STATUS REPORT

## JOHN DAY DAM

**Date:** Jan, 2016

**From:** Mirosław Zyndol, Jim Dillon, Pete Rankin, Eric Grosvenor & Michael Lotspeich

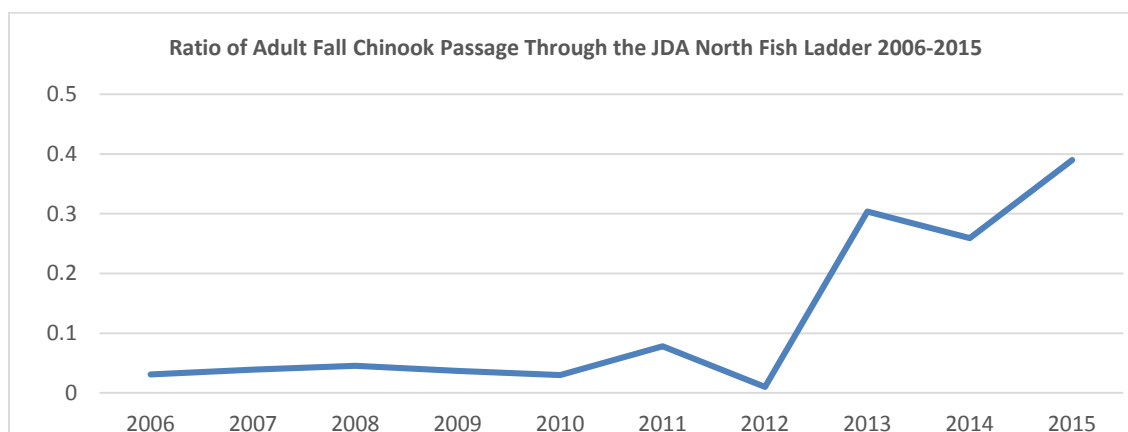
Visual fish counting was conducted April 1<sup>st</sup> – October 31<sup>st</sup> during the 2015 adult fish passage season. These counts were conducted through a contract with Normandeau Associates Inc., and all fish count data was sent electronically to an online database. Prior to the 2013 adult fish passage season, the vast majority of fish passage occurred through the South Fishway (> 95 %). Since completion of the North Fishway Entrance modifications (2010-2012), adult fish passage has become significantly more balanced (nearly 40 % in 2015) (See figure 2).

**Figure 2:** Ratio of adult fall Chinook salmon that migrated through the JDA North Fishway (versus South Fishway) 2006-2015 (September 1<sup>st</sup> through November 1<sup>st</sup>).

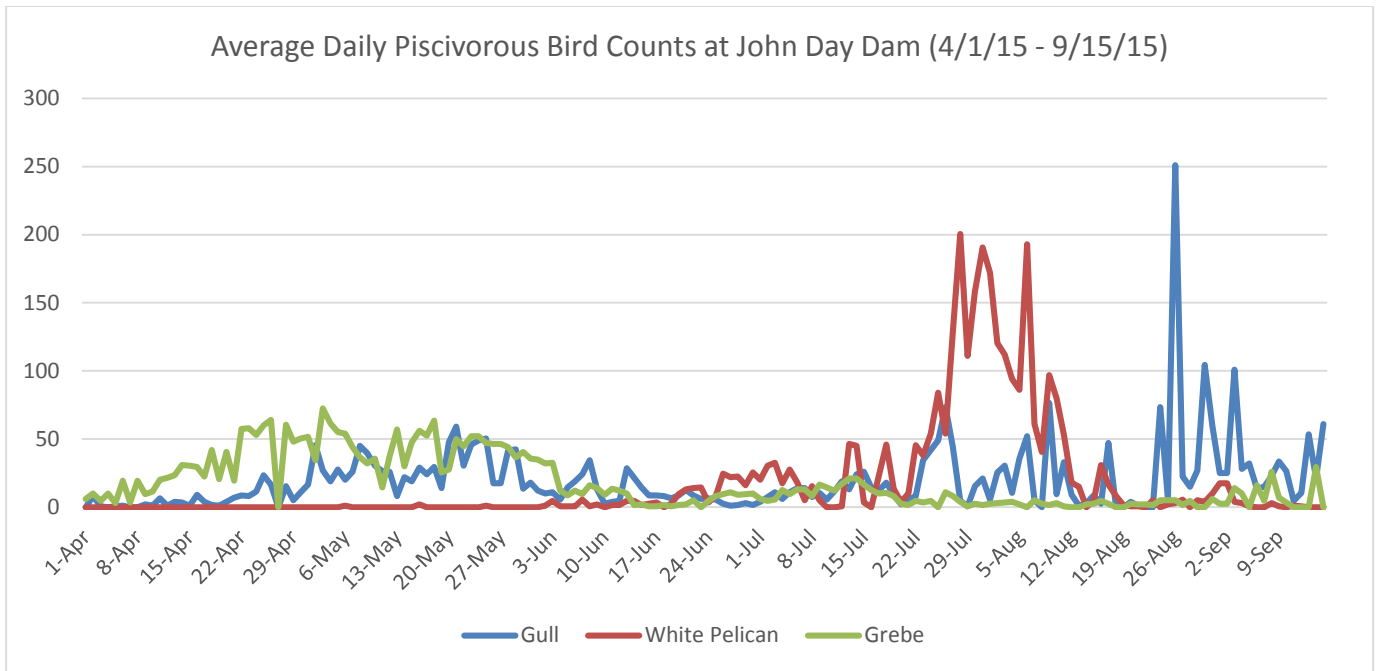
However, the white pelican presence increased from 1,443 in 2014 to 5,050 in 2015 and we are monitoring for any possible breeding colonies near JD. Despite their high numbers, the white pelicans' presence/ feeding peaked primarily after the peak smolt migration in July (see figure 4), and at the downstream edge of SWT3 & PHT3, where it is unlikely to affect smolts to any high degree (they could be consuming other fish species including the smolt predators?)

**Figure 4:** Average Daily Piscivorous Bird Counts at John Day Dam in 2015

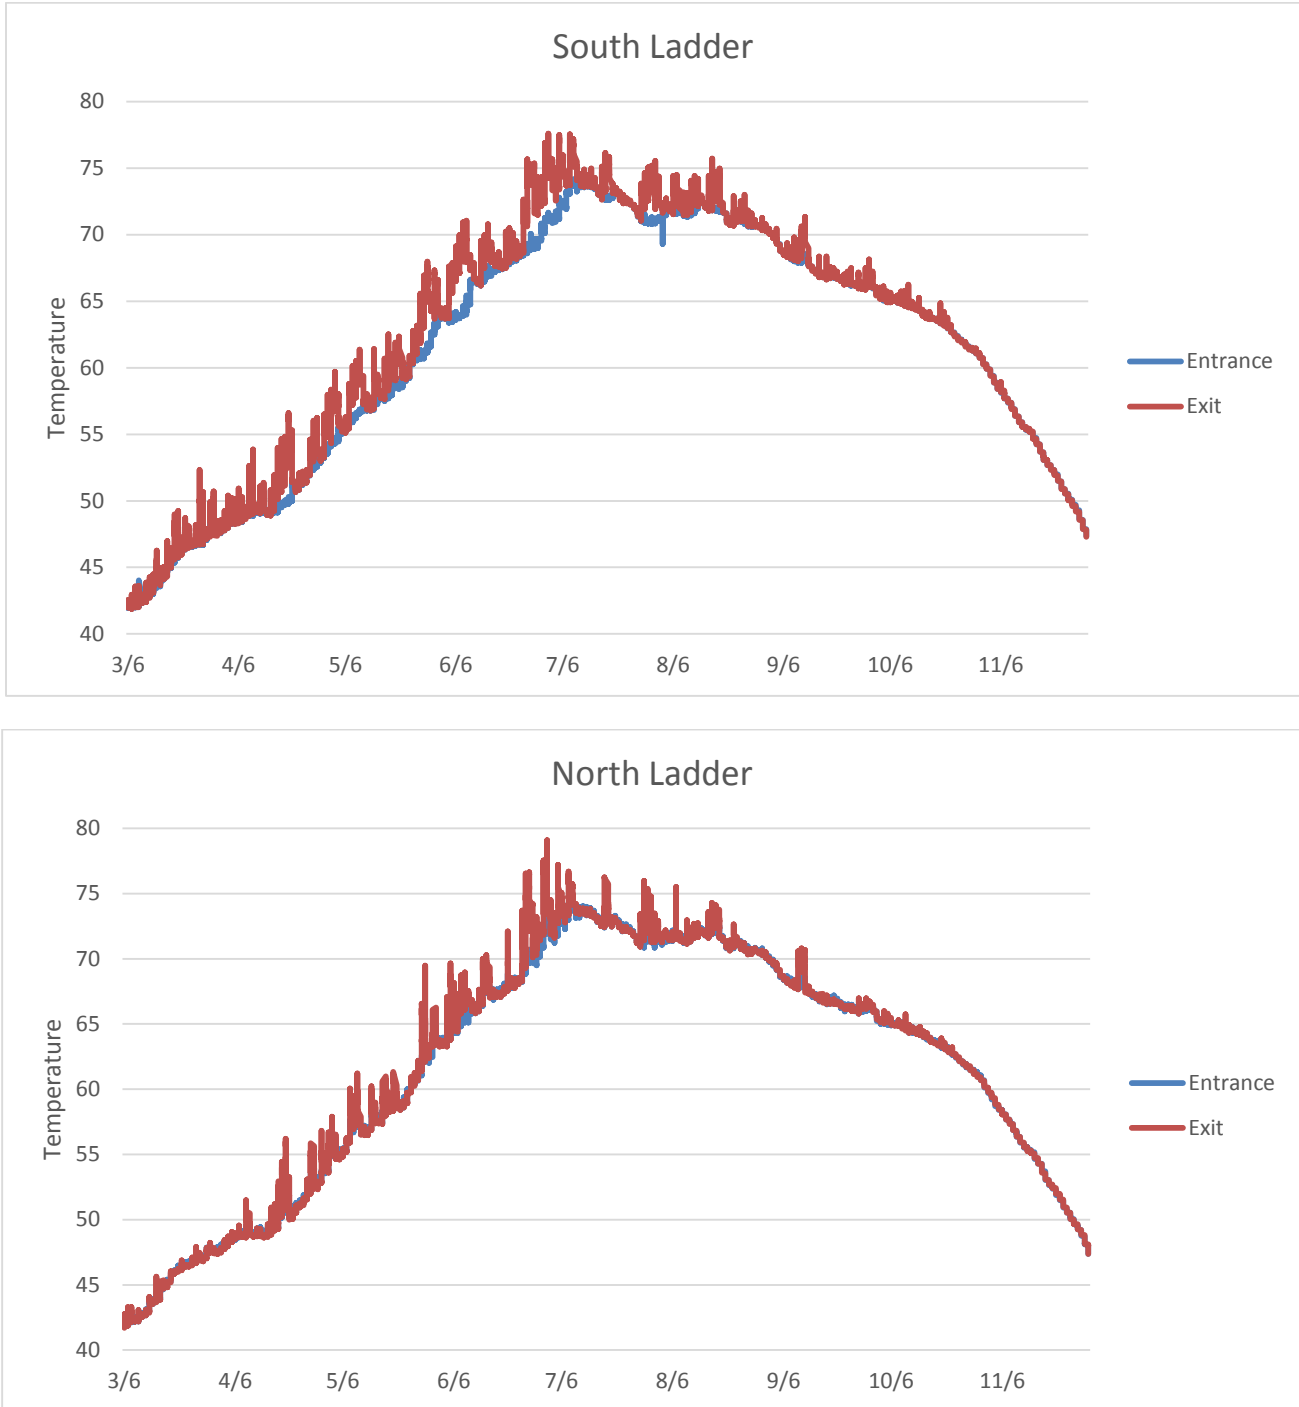
JD daily river temperatures were obtained from the USGS sensor located in the Forebay, at the tip of upstream navigation lock's guide wall. Additionally, the Water Temperatures were collected in both fish ladders at the entrance and exits with HOBO data loggers by JDA Fisheries, 1 April – Nov. 30 (see Figure 6). Water Clarity was read by Secchi disc at the North Fishladder counting station during daily fishway inspections.

**Figure 6:** John Day Dam Fishway Water Temperatures 2015

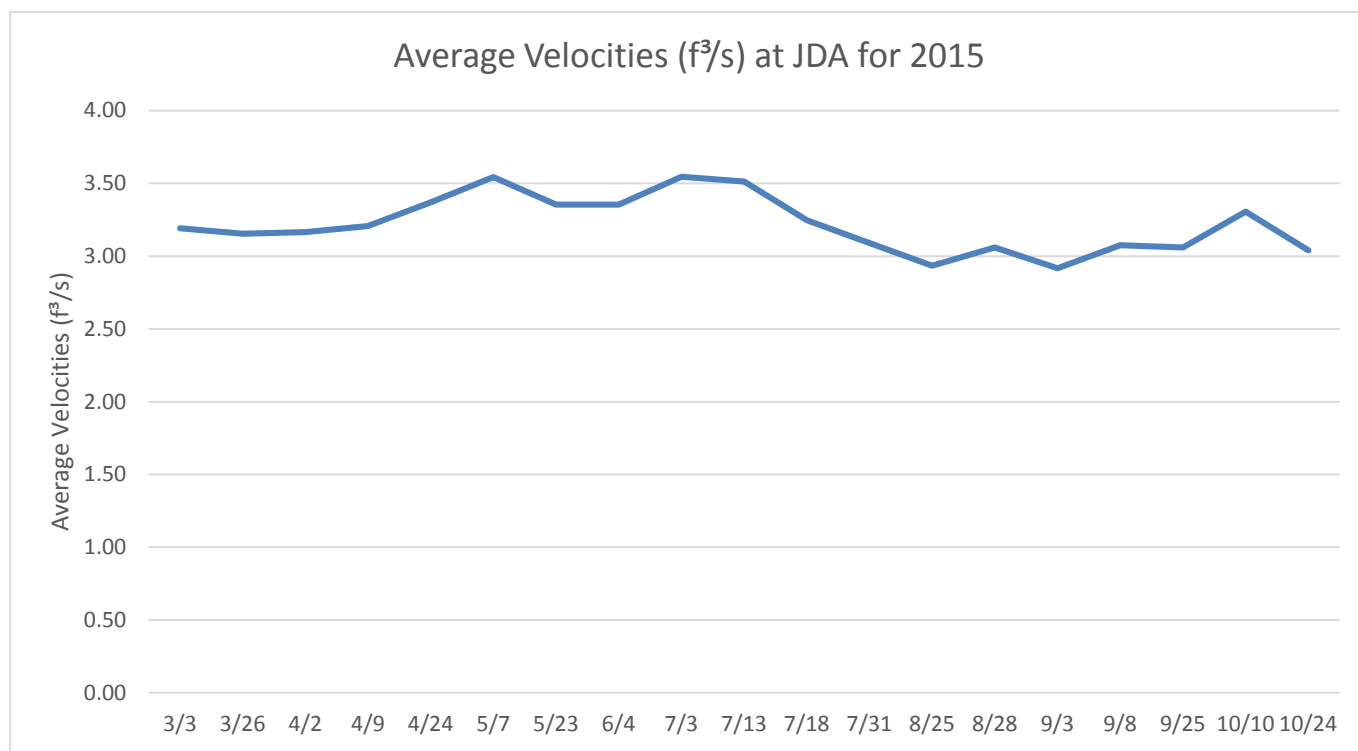
During the 2015 Adult Fish Passage Season (March 1<sup>st</sup> - November 1<sup>st</sup>), the South Fishway, adult collection channel, velocities were estimated on a near weekly basis. Wooden floats were dropped at the head of the collection channel, channel travel times were recorded, and used to calculate velocities. These results were posted in JDA status reports throughout the year. The 2015 JDA South Fishway collection channel velocities were well within the Fish Passage Plan (FPP) criteria of 1.5 to 4.0 f<sup>3</sup>/s (See Figure 7).

**Figure 7:** JDA South Fishway collection channel velocities during the 2015 Adult Fish Passage Season (Mar. 1<sup>st</sup> – Nov. 1<sup>st</sup>).
