2015 ANNUAL FISHWAY STATUS REPORT

THE DALLES DAM

Date: Jan, 2016

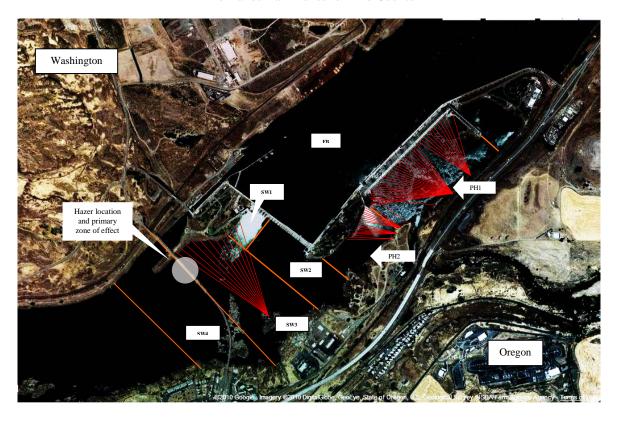
The Dalles Dam Zones for Bird Counts

The United States Department of Agriculture (USDA) was contracted to provide avian hazing abatement via pyrotechnics from mid Apr – July 31. Hazing commenced when there were a minumum of 12 birds present. Counts were tallied to see how many birds left after hazing, again for how many stayed in the zone, and a third time after a 10 minute time period to determine the effectiveness of the hazing. Graph shows that gulls were most prevelant in May and that the vast majority returned after 10 minutes. USDA concentrated specifically on zones upstream of the US-197 bridge (SWT3) and dowstream of the bridge (SWT4).
