# 2017 ANNUAL FISHWAYS STATUS REPORT

## JOHN DAY DAM

**Date:** January, 2018

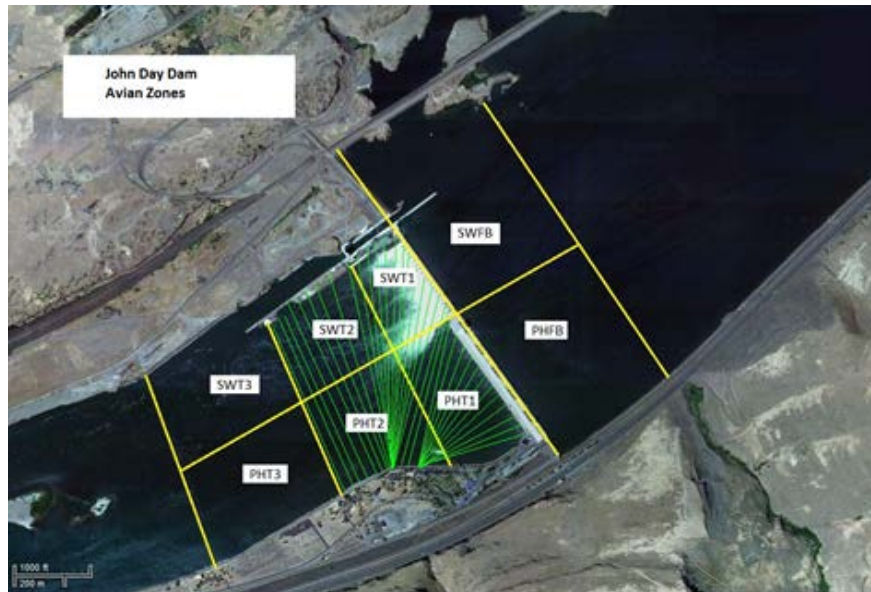
Prior to the 2017 juvenile passage season, 21 avian lines were replaced, and 8 broken lines were not. Additionally, 12 older lines broke during the passage season. Despite missing lines, the remaining Avian Lines combined with the USDA boat hazing were effective in deterring gull predation on smolts at JD (Figure 5.) It appears that the high river flows in 2017 naturally protected smolts from the avian predators. It needs to be emphasized that only gulls are a significant and proven avian predator impacting the JD smolt passage.

**Figure 3:** Avian array at JDA Tailrace BRZ installed in 2010 and re-tensioned for 2017 (Powerhouse Forebay-PHFB, Spillway Forebay-SWFB, Spillway Tailrace zones 1-3 [SWT1-SWT3], Powerhouse Tailrace zones 1-3 [PHT1-PHT3]).

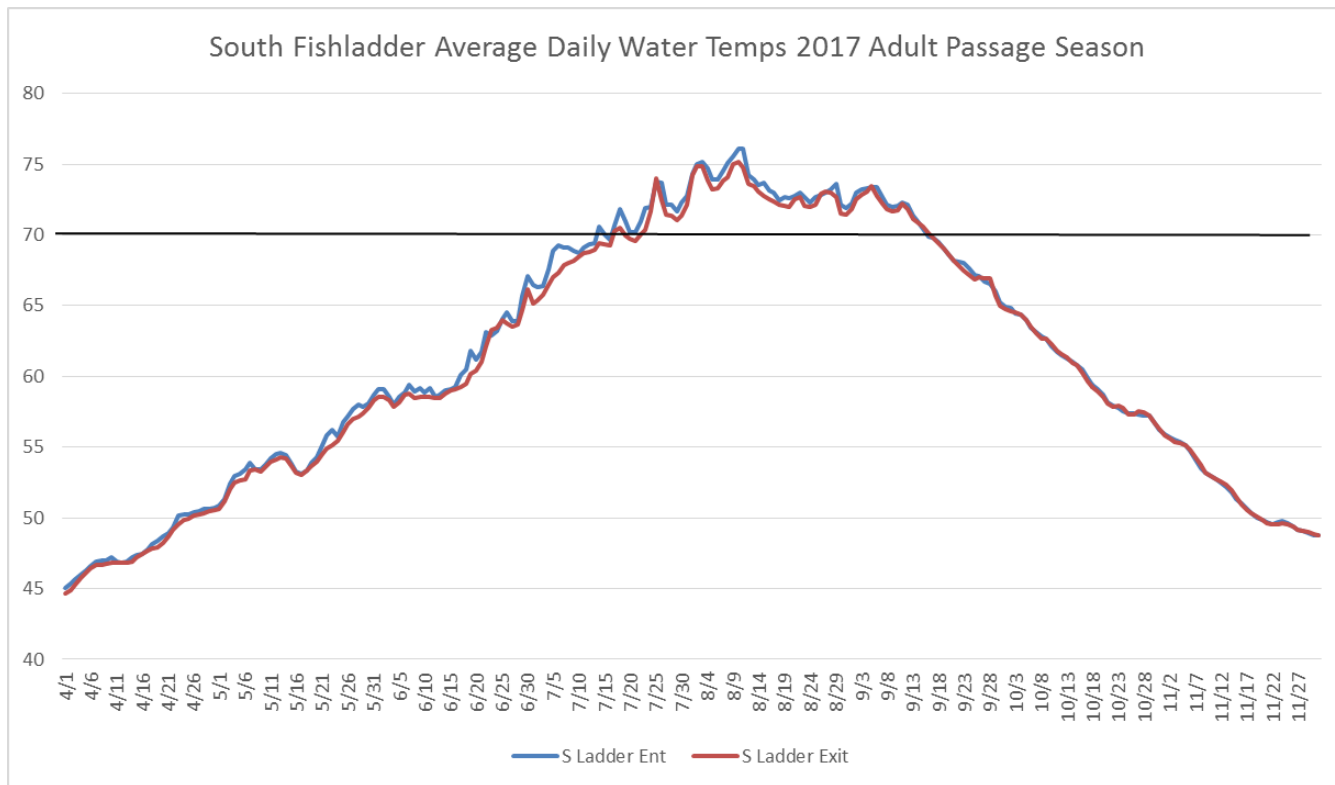
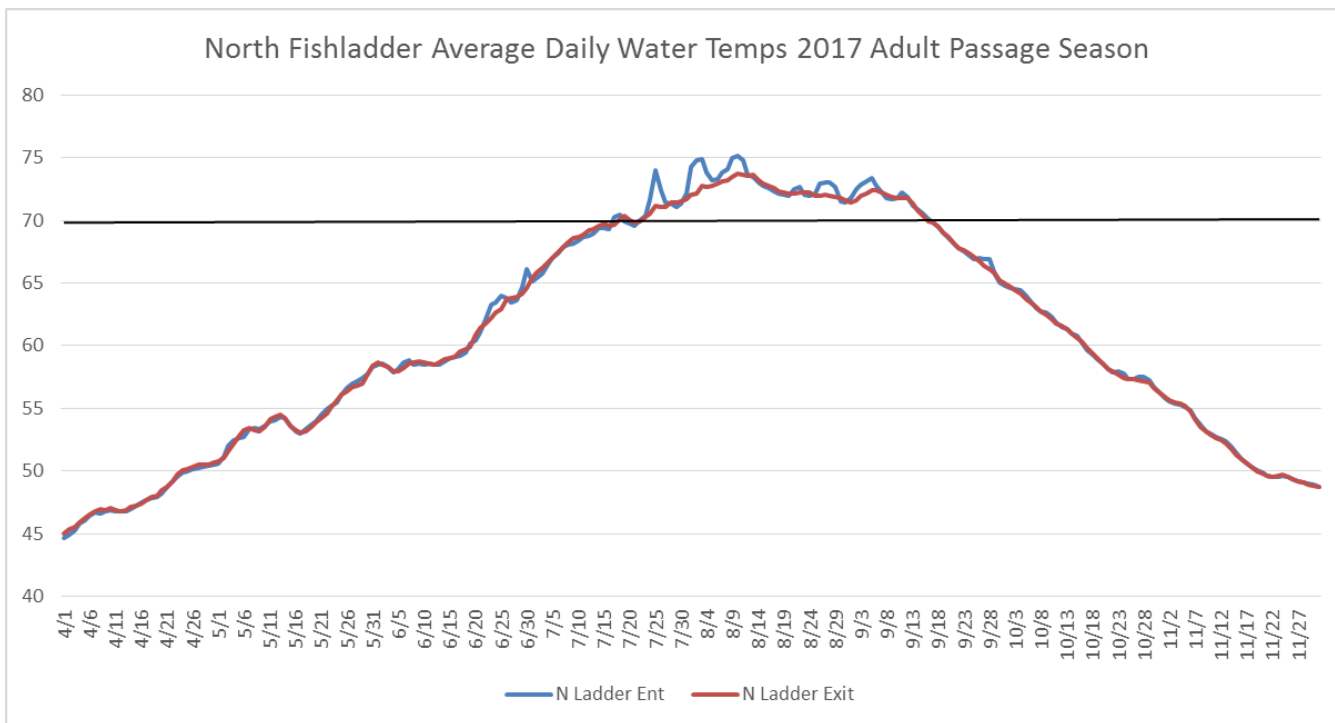
JDA river temperatures were obtained from the United States Geological Survey's (USGS) sensor, located in the Forebay at the tip of the upstream navigation lock's guide wall. Additionally, water temperatures were collected by JDA Fisheries at the entrances and exits of both fish ladders using HOBO data loggers (April 1<sup>st</sup> – Nov. 30<sup>th</sup>) (see Figure 6). Water clarities were measured by Secchi disc at the North Fish Ladder counting station daily, throughout the 2017 passage season.

**Figure 6:** John Day Dam average daily fishladder water temperatures for 2017.

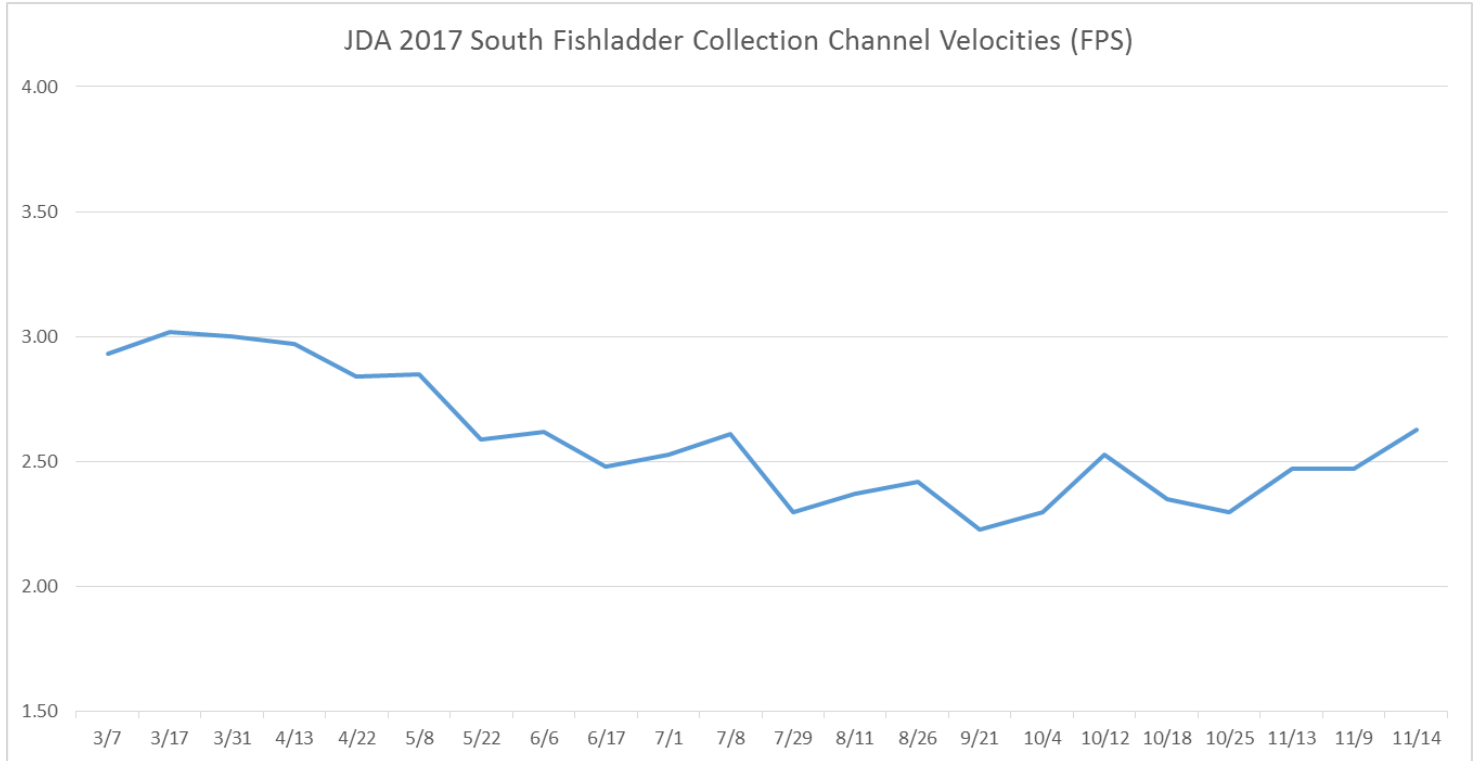
Similar to the previous years, the 2017 JDA SFL Collection Channel velocities were all within the Fish Passage Plan (FPP) criteria (1.5 - 4.0 feet per second) (See Figure 7). The velocities have been excellent in spite of the two AWS turbines operations and this suggests that the third turbine should become a regular backup to be used only when another pumps fails.

**Figure 7:** JDA South Fishway collection channel velocities during the 2017 Adult Fish Passage Season (Mar. 1<sup>st</sup> – Dec. 1<sup>st</sup>).
