# **2020 Annual Fishways Status Report**

## **John Day Dam Project**

Date: January 2021

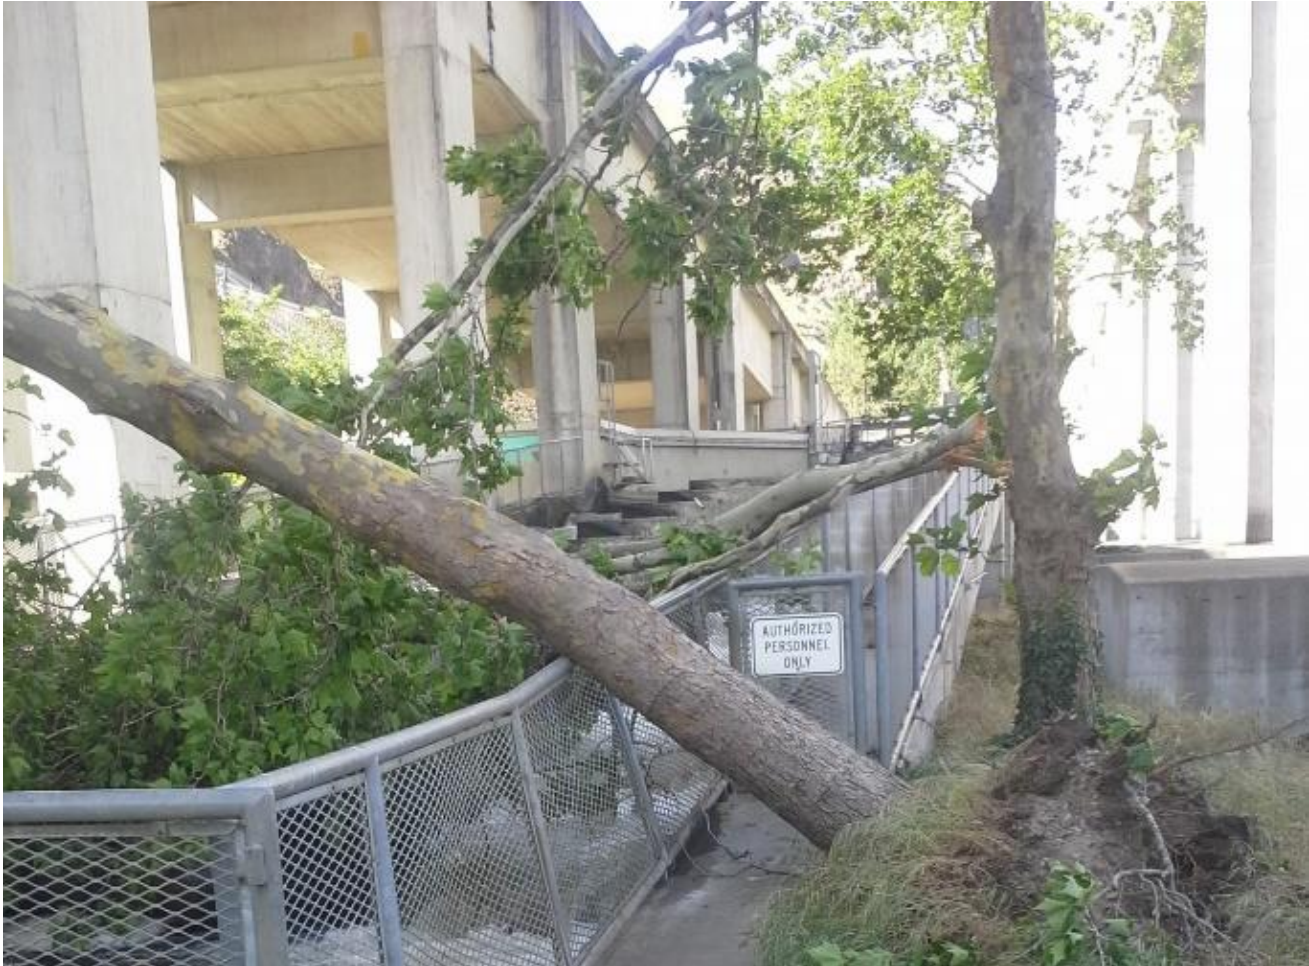
One of many trees toppled by a windstorm at the John Day project on May 30, 2020. This tree fell across the south fish ladder. No structural damage to the ladder occurred and the tree was promptly removed.

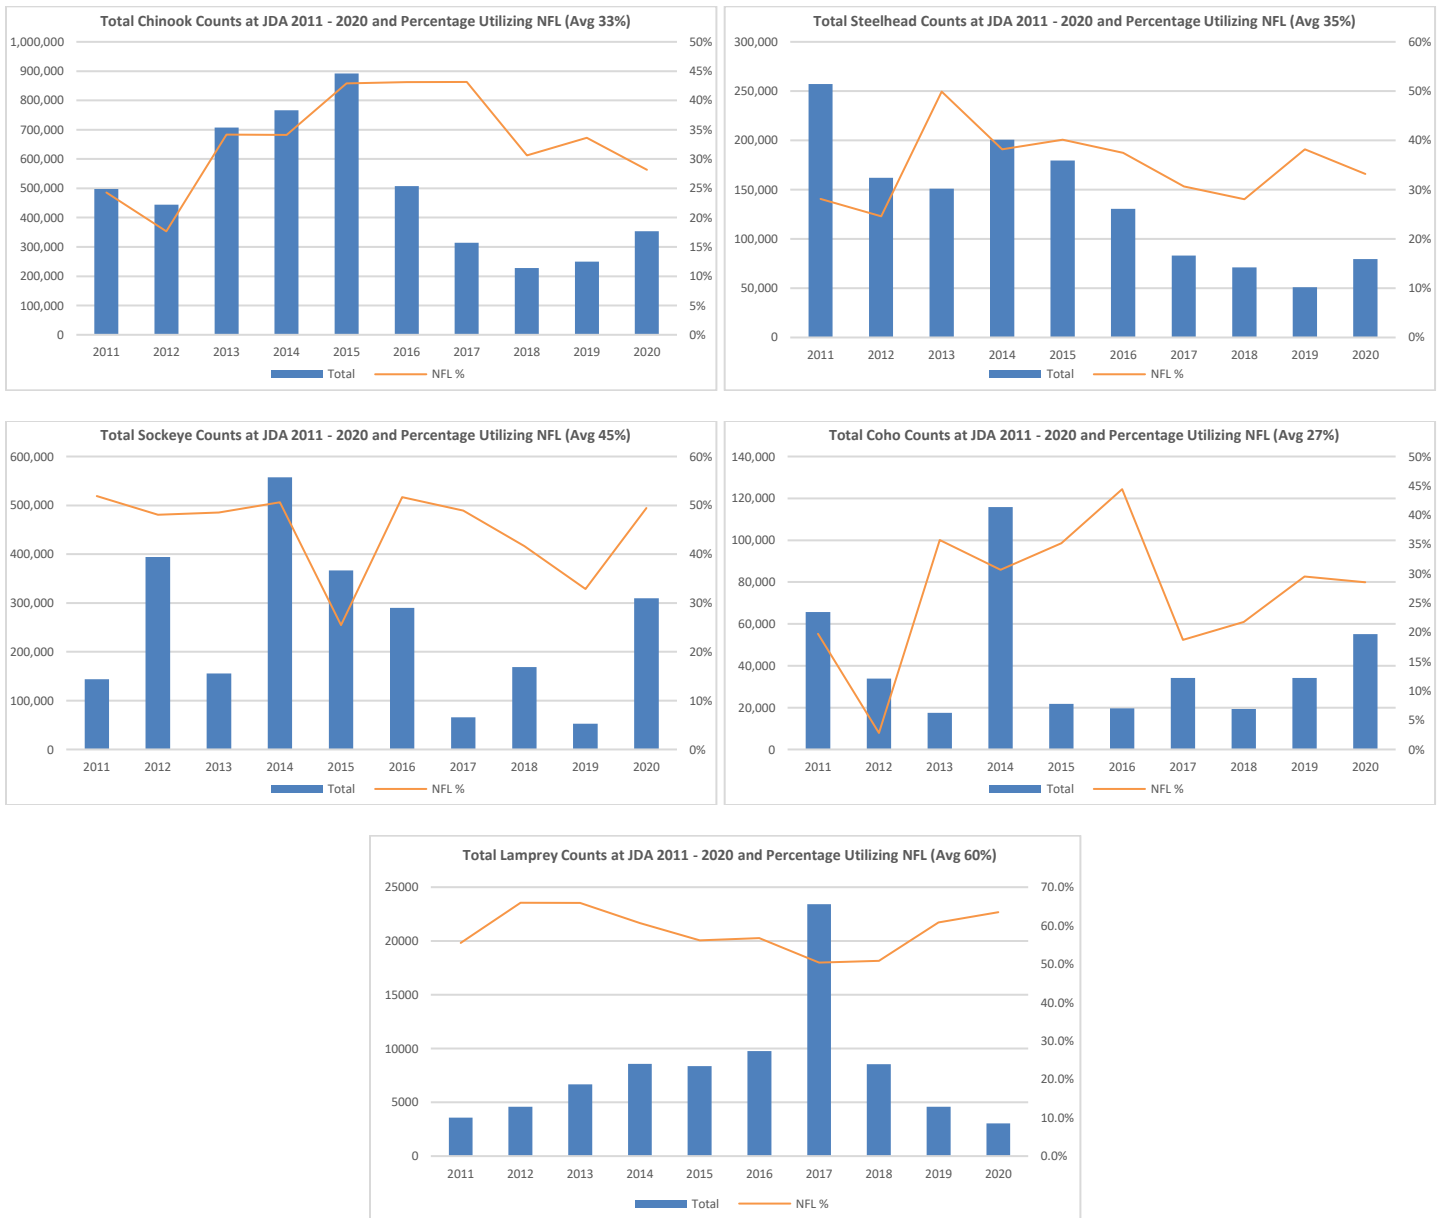
Figure 3: Total fish ladder counts (north and south combined) over a 10-year span (2011-2020) for 5-different fish species (Chinook, steelhead, sockeye, coho, and lamprey), and the percentage that use the north fish ladder at John Day Dam.

Present and historical count-data suggests adult salmonids are more attracted to the SFL, at JDA. In 2020 counts ranged from 29-49% at the NFL (see figure 2) and the 10-year averages (see figure 3) ranged from 27-45%. Sockeye appear to be the exception. Most years sockeye preferred the SFL, however there were years with slightly higher counts at the NFL (2011, 2014, and 2016). Lamprey, however, appear to consistently prefer the NFL over the SFL. Improvements were made to the NFL entrance between 2010 and 2012 to help improve fish ladder passage for salmonids and lamprey.

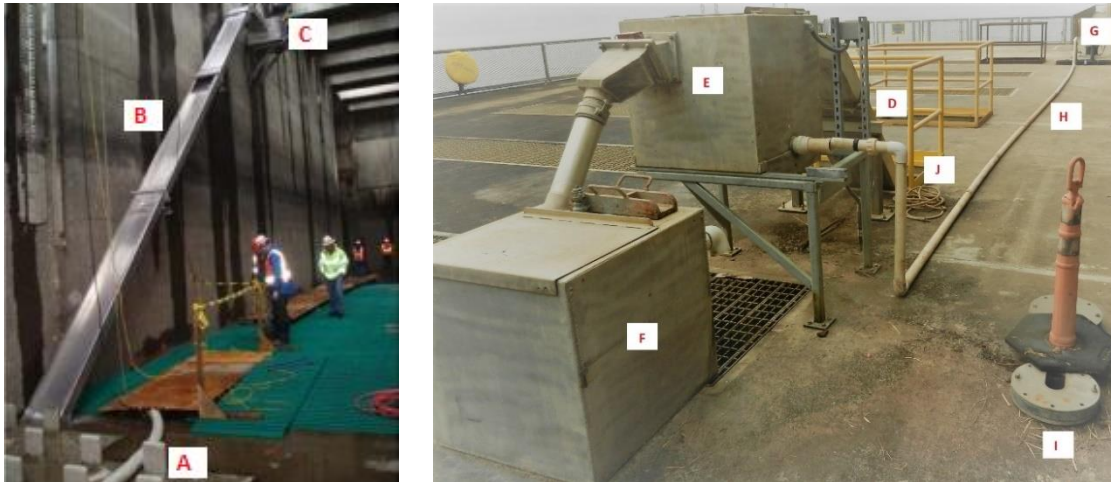
The NFL LPS is located at the NFL entrance. When lamprey enter the ladder, they navigate a bollard field. This field is used to break up velocity and makes ladder entrance easier. On the north side of the NFL entrance is a ramp fed by pumped water. Lampreys must climb this ramp to reach the holding tank. A rest box is located halfway up the ramp (the box can be flushed pneumatically as needed) to give lampreys a chance to recover during their journey. Once lampreys climb the ramp, they enter an upwelling box. This is where pumped water enters the system. The water percolates through porosity plating, and either down the

ramp (for attraction) or into the holding tank (to circulate water in the holding tank). The lampreys travel through the upwelling box, however, porosity plating only allows access the upper portion of the box. Once lampreys navigate the upwelling box, they drop into the holding tank via irrigation piping. This is where personnel recover the lampreys (see figure 4)

Figure 4: Images of the north fish ladder (NFL) lamprey passage system (LPS) (\*Note\* the first picture is facing east, and the second picture is facing west): (A) bollard field (B) access ramp (C) resting box (D) ramp entering the upwelling box (E) upwelling box (F) holding tank (G) lamprey pumps (H) water supply line (I) pump location from the 2019 modification (J) pneumatic airlines to flush the rest box.

The pump deployment location is a concern for this system. Lamprey pumps were originally deployed in the ‘queen pump’ access area. This means mechanical crews must remove the LPS pumps, by crane, when dewatering the NFL. Therefore, a new pumping system was designed and implemented for the 2019 season.

Unfortunately, the new system failed before the 2019 season started (pump housing broke off in the auxiliary water supply). John Day personnel worked quickly to reinstall the old pumps (in the original location), but lamprey collection was almost nonexistent in 2019 (3-total at the NFL LPS). Several in-season modifications were attempted to improve passage efficiency, with little success. There was one modification that could not be implemented in 2019. Reinstalling a PVC water supply line from the lamprey pumps to the LPS. With limited time to get the system online in 2019, rubber hosing (same diameter as the PVC) was used in its place.

For the 2020 season JDF personnel installed a new PVC water supply line from the pumps to the LPS. It was, and still is, unknown if the supply line modification is the reason efficiency improved. However, there were significantly more lampreys collected in 2020 (162) than in 2019 (3). Without more research, any number of factors could have attributed to this improvement (run size, improved ladder conditions, attraction water flow, etc.).

A more permanent system is still needed for the NFL LPS. The LPS pumps were returned to their original location, so they will need to be removed before installing a queen pump. Also, the LPS pumps get connected to the NFL dewatering pump (pump #7) power supply. The previous LPS power supply was removed during the 2019 modifications and has not been replaced. Fortunately, pump 7, and the LPS pumps are unlikely to run at the same time, and the repair of pump #7 reduces the need for the queen pump (used as a backup).

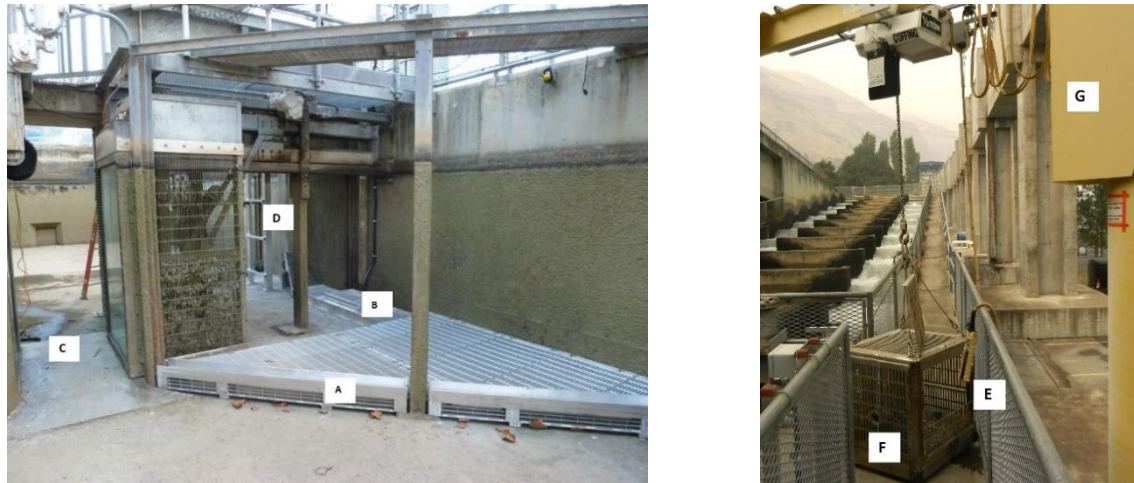
The SFL LTS is located near the SFL count station. Lampreys approach this area and enter the system below a grating structure on the deck. Once inside, they travel into a conduit which leads them up a small ramp, and into a trap box. This trap box can then be lifted, by a fixed jib crane, allowing personnel to collect the lampreys (see figure 5). This system generally operates flawlessly, however success is variable. One issue with this area is that lampreys tend to mill in the conduit/ramp area. The flows appear to be ideal in this area, and they may reside there for long periods of time (actual residing times unknown). Every year, during winter maintenance, several lampreys are observed exiting the conduit/ramp area [(2015: 75), (2016: 101), (2017: 180), (2018: 26), (2019: 12)].

Figure 5: Images of the south fish ladder (SFL) lamprey trap system (LTS): (A) entrance (B) diversion conduit (C) count station window/crowder (D) trap box guide (E) trap box (with access hatch removed) (F) lamprey entrance port (G) trap hoisting jib crane. \*Note\* when in operation picketed leads rest atop the LTS entrance (A), and upriver from the trap box guide (D). These picketed leads guide fish to the count station window (D).

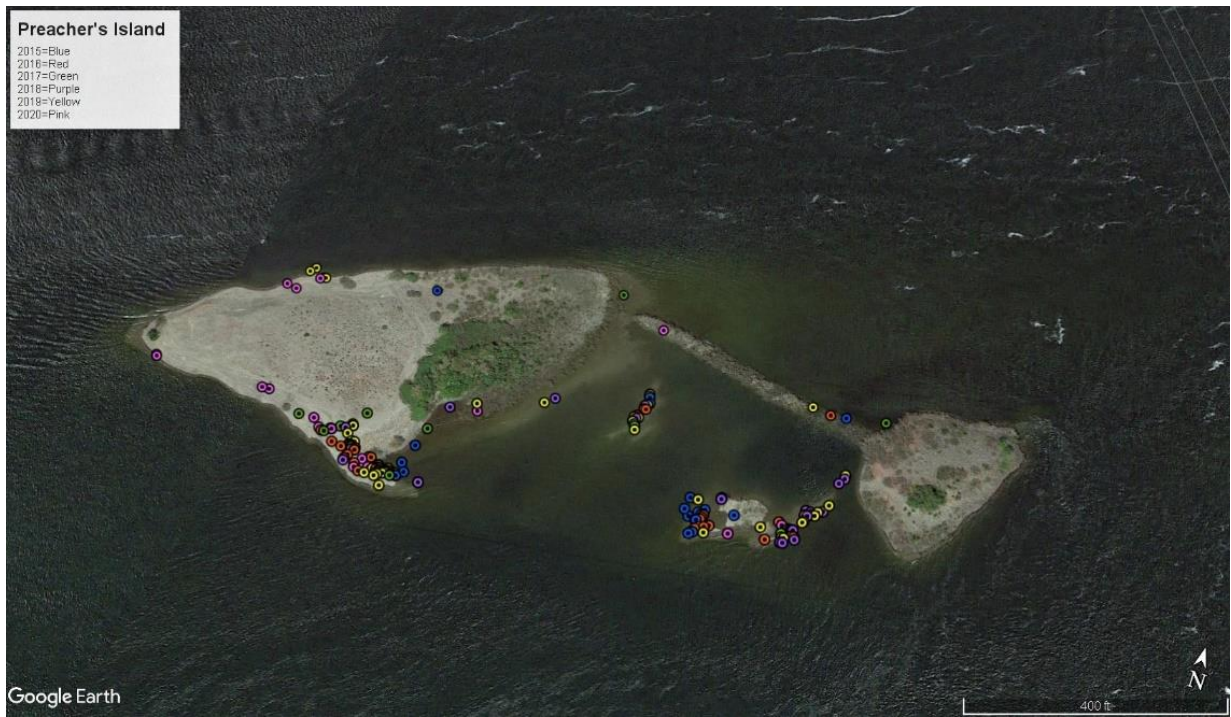
Figure 11: An image of Preacher's Island with 6-years (2015-2020) of recovered PIT tag coordinates.  
 \*Note\* this is a satellite image from 2015 (best picture quality), and there is more vegetation on the island now.

On September 22, 2020 the JDF crew scanned Preacher’s Island for PIT tags using Biomark HPR Plus readers. This was the second annual island scan. In 2019 Real Time Research scanned a small section of Preacher’s Island and found 136 unique PIT tags. In 2020 the JDF crew scanned a much larger area of the island, focusing on areas where birds are known to congregate, and recovered 545 unique PIT tags (see figure 11). Of the 545 unique PIT tags recovered: 320 were Chinook, 174 were Steelhead, 35 were Coho, and 13 were Sockeye (see figure 12). The PIT tag origin dates ranged widely. The earliest tag was from 1998, and the most recent was from 2020. The most observed origin year was 2019 (53-tags), and 1998 had the fewest (1-tag) (see figure 13).

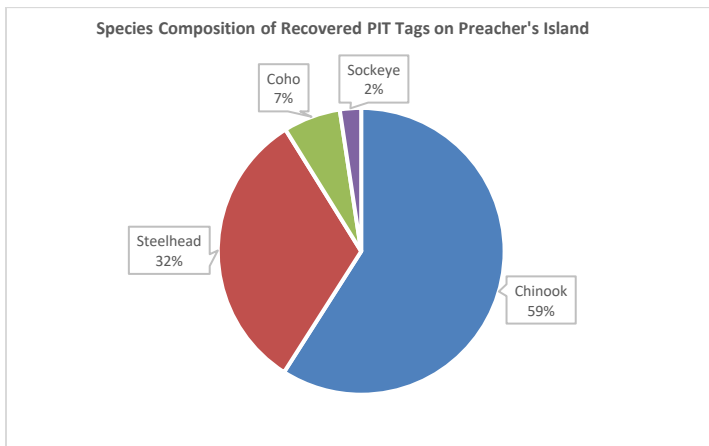
Figure 12: Species composition of recovered PIT tags on Preacher's Island from the 2020 tag scan survey

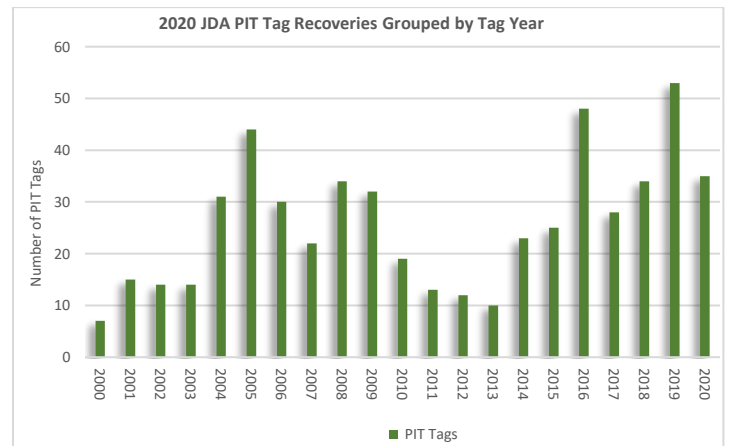
Figure 13: Number of PIT tags recovered on Preacher's Island by tag year (1998 had 1-tag present)
