2021 Annual Fishways Status Report

John Day Dam Project

U.S Army Corps of Engineers
John Day Lock & Dam
Rufus, OR 97050
(541) 506-7861

Date: January 2022

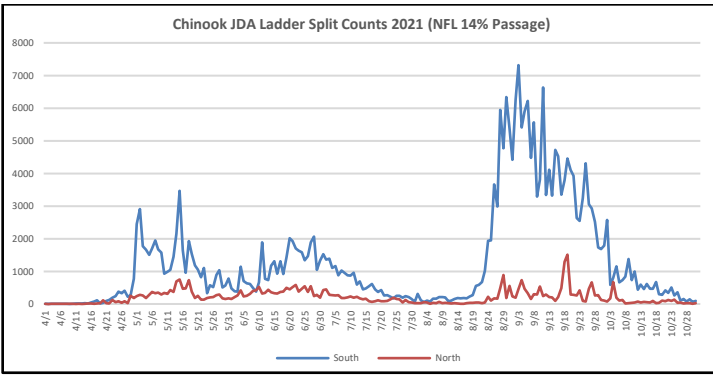
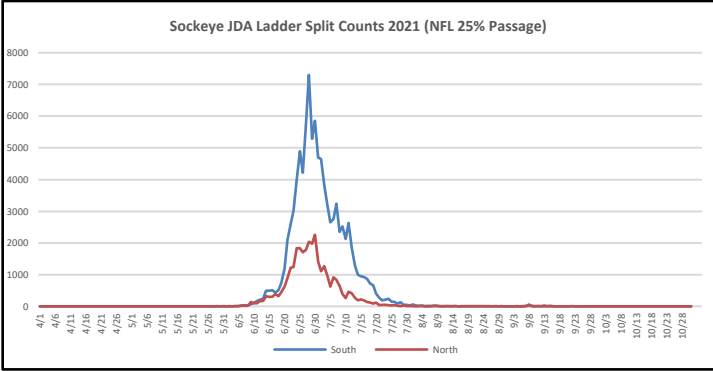
Figure 2: Graphs comparing adult fish counts between fish ladders (north and south), for 6-different fish species (Chinook, steelhead, sockeye, coho, pink, and lamprey), at the John Day project during the 2021 adult fish count season.

Improvements were made to the NFL entrance between 2010 and 2012 to help improve fish ladder passage for salmonids and lamprey. In 2021 the total salmonid counts ranged from 11-25% at the NFL vs. 75-89% at the SFL (see figure 2) and the 10-year averages (see figure 3) at the NFL ranged from 22-44% vs. 56-78% for the SFL. Salmonids are consistently counted more at the SFL vs the NFL. Sockeyes appear to be the exception. Most years sockeye preferred the SFL, however there were years with slightly higher counts at the NFL (2014 and 2016). Conversely lampreys appear to prefer the NFL over the SFL. However, in 2021 only 46% of the lamprey counts occurred at the NFL. This is the only occurrence over the past 10-years where more lamprey counts were observed at the SFL.

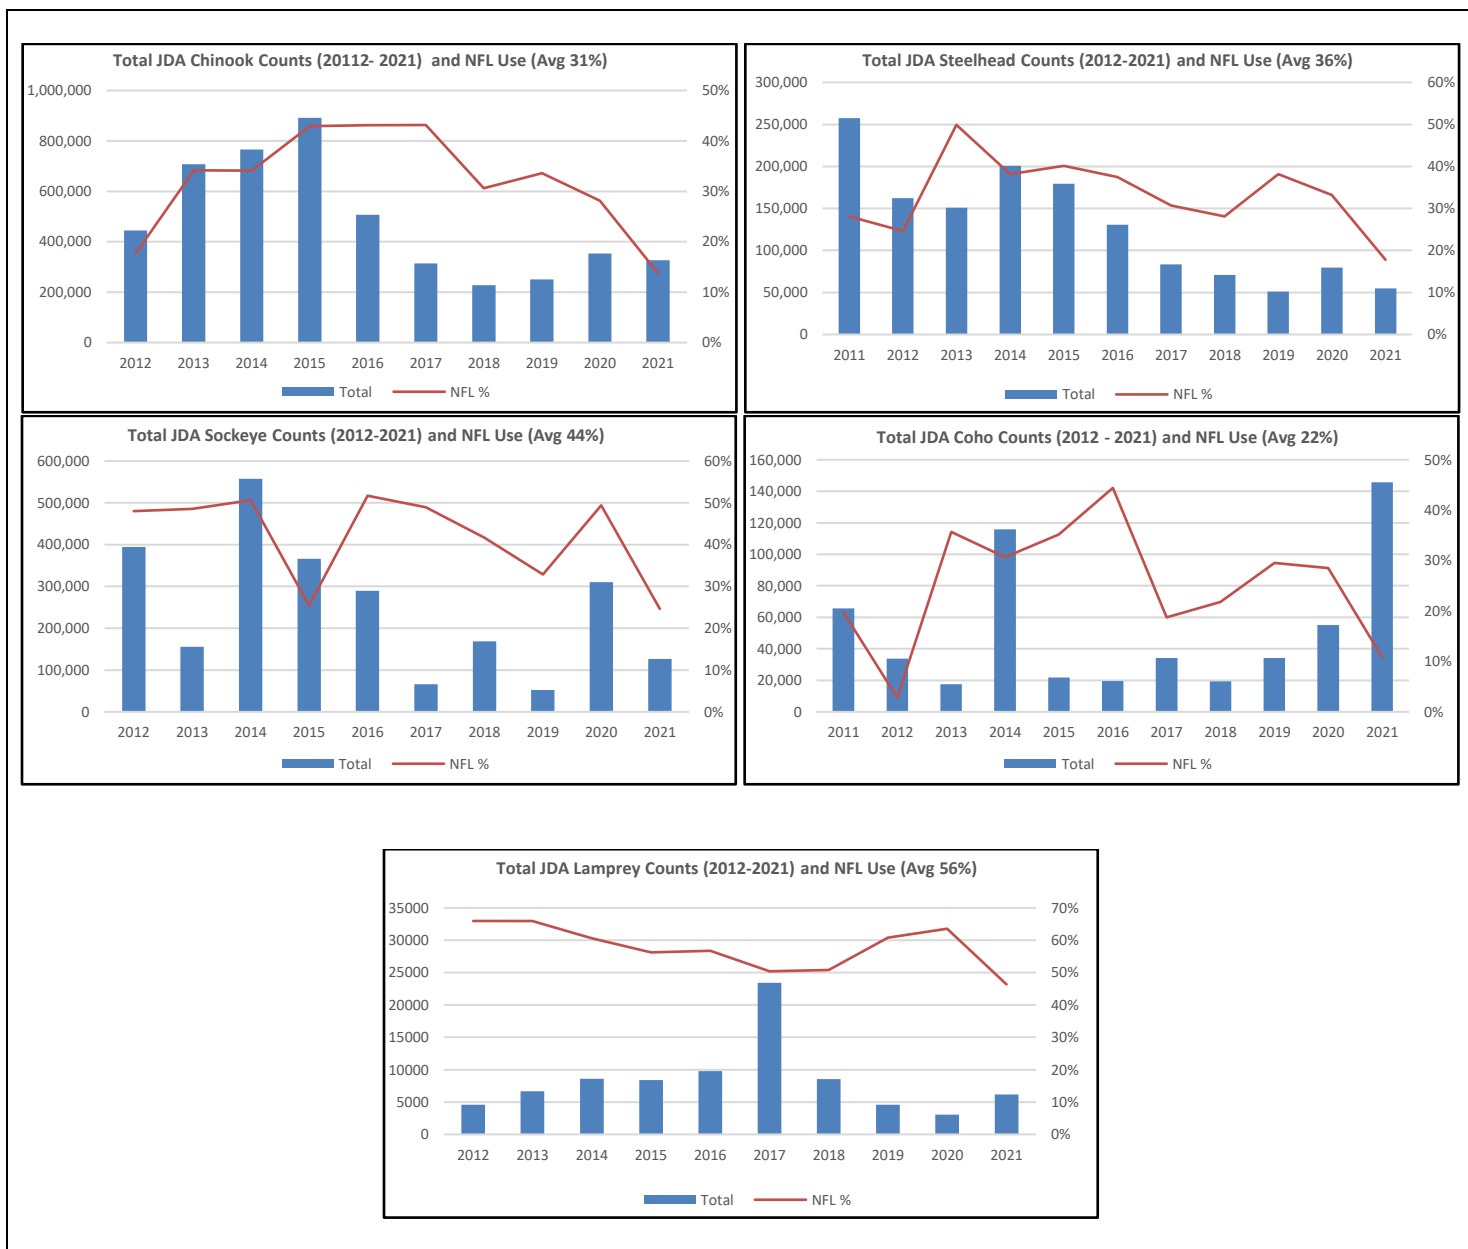
Figure 3: Total fish ladder counts (north and south combined) over a 10-year span (2012-2021) for 5-different fish species (Chinook, steelhead, sockeye, coho, and lamprey), and the percentage that use the north fish ladder at John Day Dam.

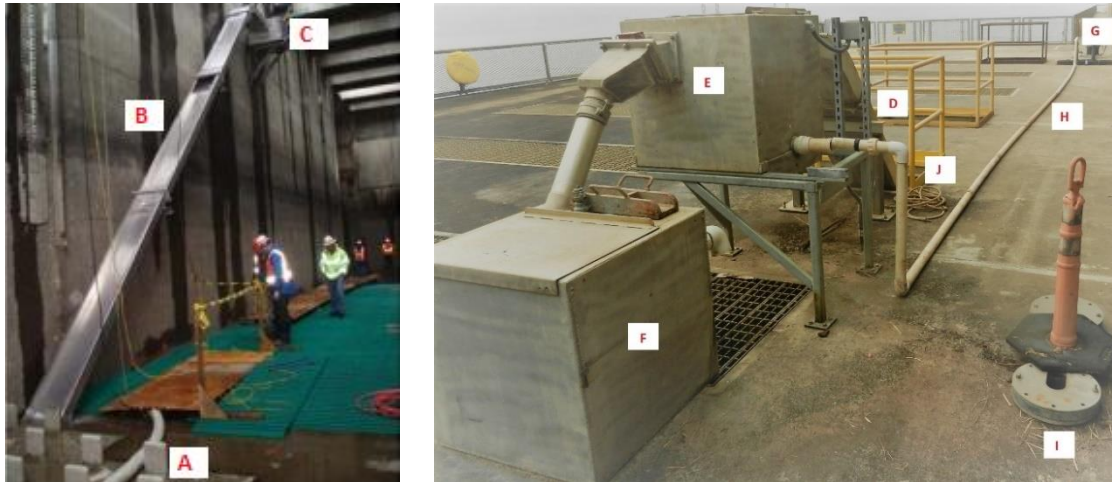
Figure 4: Images of the north fish ladder (NFL) lamprey passage system (LPS) (*Note* the first picture is facing east, and the second picture is facing west): (A) bollard field (B) access ramp (C) resting box (D) ramp entering the upwelling box (E) upwelling box (F) holding tank (G) lamprey pumps (H) water supply line (I) pump location from the 2019 modification (J) pneumatic airlines to flush the rest box.

The NFL LPS is located at the NFL entrance. When lamprey enter the ladder, they navigate a bollard field. This field is used to break up velocity and makes ladder entrance easier. On the north side of the NFL entrance is a ramp fed by pumped water. Lampreys must climb this ramp to reach the holding tank. A rest box is located halfway up the ramp (the box can be flushed pneumatically as needed) to give lampreys a chance to recover during their journey. Once lampreys climb the ramp, they enter an upwelling box. This is where pumped water enters the system. The water percolates through porosity plating, and either down the

ramp (for attraction) or into the holding tank (to circulate water in the holding tank). The lampreys travel through the upwelling box, however, porosity plating only allows access the upper portion of the box. Once lampreys navigate the upwelling box, they drop into the holding tank via irrigation piping. This is where personnel recover the lampreys (see figure 4)

Note The only methods to transport collected lampreys are by stairs, elevator, or winch. It is 100-foot climb to the intake deck (access area). It is difficult on personnel, and fish to transport them by stairs. The elevator is outdated, and unreliable. A winch system was created for backup, but it has not been tested. Access is the most limiting factor for this system.

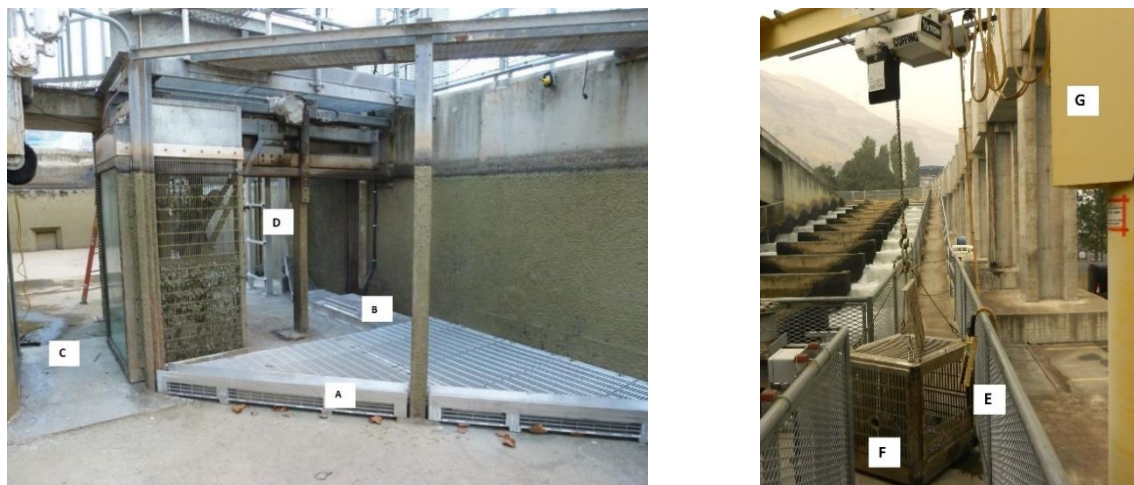
Figure 5: Images of the south fish ladder (SFL) lamprey trap system (LTS): (A) entrance (B) diversion conduit (C) count station window/crowder (D) trap box guide (E) trap box (with access hatch removed) (F) lamprey entrance port (G) trap hoisting jib crane. *Note* when in operation picketed leads rest atop the LTS entrance (A), and upriver from the trap box guide (D). These picketed leads guide fish to the count station window (D).

The SFL LTS is located near the SFL count station. Lampreys approach this area and enter the system below a grating structure on the deck. Once inside, they travel into a conduit which leads them up a small ramp, and into a trap box. This trap box can then be lifted, by a fixed jib crane, allowing personnel to collect the lampreys (see figure 5). This system generally operates flawlessly, however success is variable. One issue with this area is that lampreys tend to mill in the conduit/ramp area. The flows appear to be ideal in this area, and they may reside there for long periods of time (actual residing times unknown). Every year, during winter maintenance, several lampreys are observed exiting the conduit/ramp area [(2015: 75), (2016: 101), (2017: 180), (2018: 26), (2019: 12)].

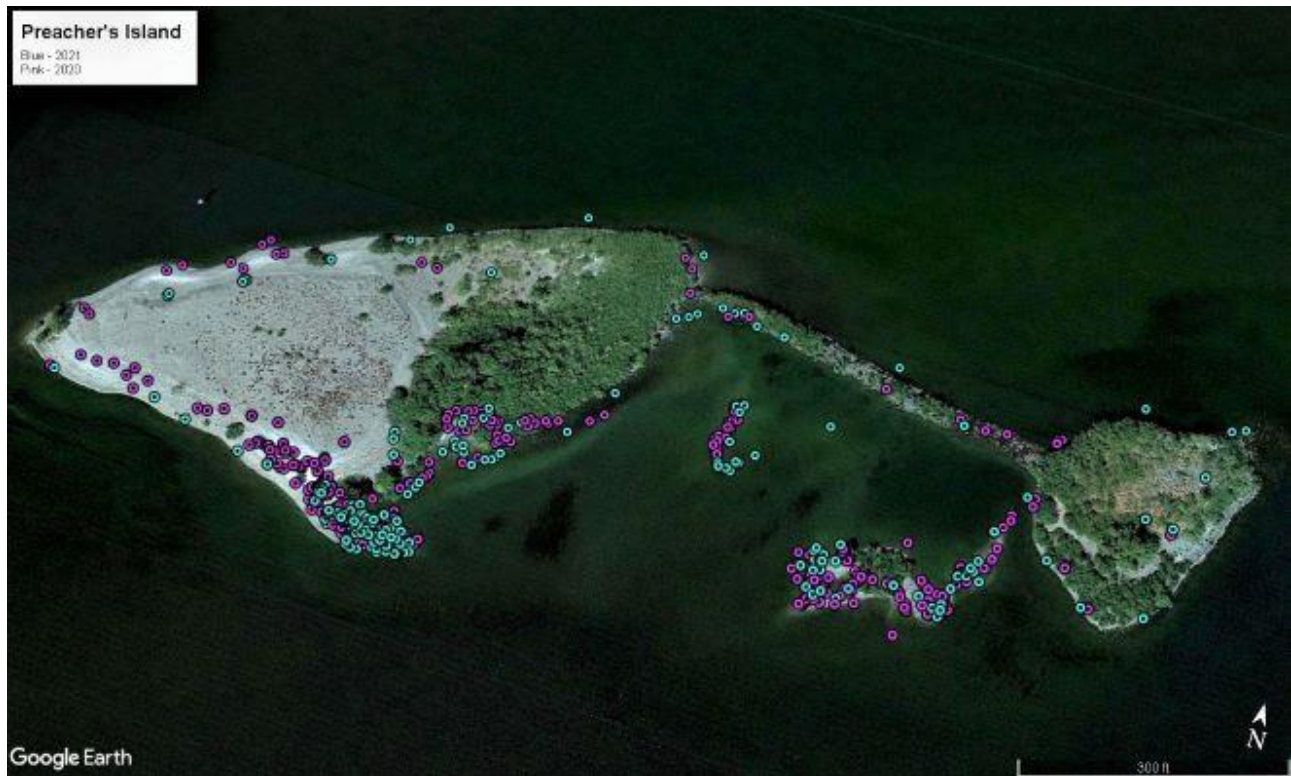
Figure 12: An image of Preacher's Island with recovered PIT tag coordinate locations from the 2020 and 2021 surveys. Blue - 2021 locations, Pink - 2020 locations

The third annual island scan was conducted on September 13, 2021 using Biomark HPR Plus readers. The JDF crew scanned the whole island, focusing on areas where birds are known to congregate, and recovered 287 unique PIT tags (see figure 12). Of the 287 unique PIT tags recovered, 168 were Chinook, 99 were Steelhead, 11 were Coho, 6 were Sockeye, 2 were Smallmouth Bass, and 1 was American Shad. The predominate species of all the PIT tags that have been recovered on JDPI is Chinook (58%) followed by Steelhead (33%) (see figure 13).

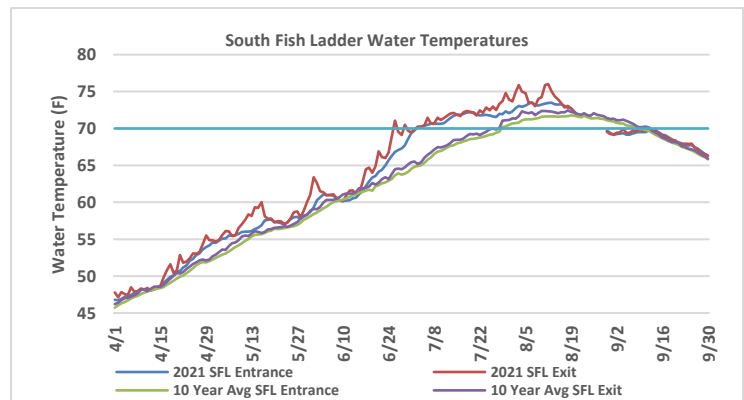
Figure 16: JDA 2021 average daily water temperatures and 10-year averages (2011-2020) for both entrance and exit at each ladder. No ladder temps from 8/22/21-8/30/21 due to shuttle malfunction. No NFL entrance data from 8/30/21-9/4/21 because probe was set to record every second instead of every hour.

John Day fisheries personnel (JDF) records ladder temperatures at the entrance and exit of both fish ladders (north and south). The exit temperatures are recorded upstream of the diffusers, and just downstream of the control sections (modulating weirs). These temperatures are measured using Hobo® (P/N: U22-001) temperature loggers (see figure 15). The temperatures are offloaded weekly (or as time permits) and sent to the Fish Passage Center (FPC). These temperatures are also graphed and displayed in the weekly status reports (see figure 16).
