2023 Annual Fishways Status Report

John Day Dam Project

Date: January 2024

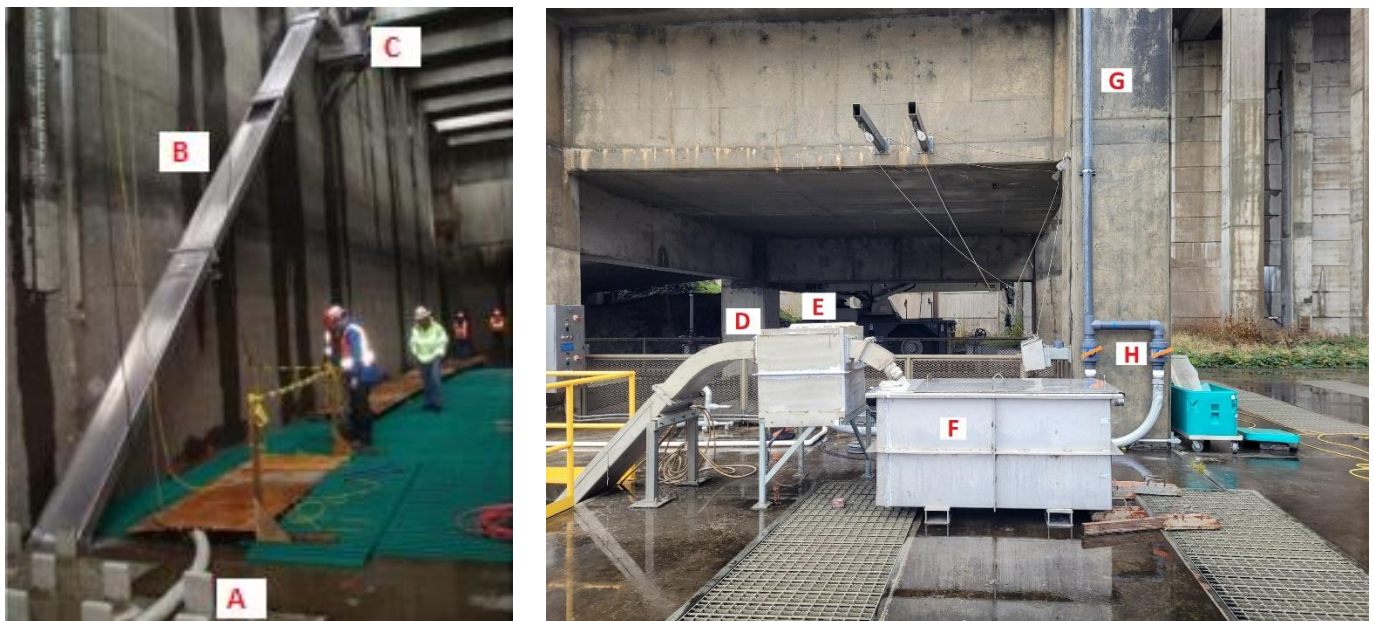
Figure 4: Images of the NFL LPS

(*Note* the first picture is facing east, and the second picture is facing north): (A) bollard field (B) access ramp (C) resting box (D) ramp entering the upwelling box (E) upwelling box (F) holding tank (G) water supply line (H) valve for tank and upwelling box.

The NFL has a lamprey passage system (LPS). When lamprey enter the NFL, they navigate a bollard field. This field breaks up velocities and guides lamprey to the LPS entrance. Lamprey must climb a ramp to reach the holding tank. A rest box is located halfway up the ramp so lamprey can recover during their journey. Once lamprey climb the ramp, they enter an upwelling box. This is where gravity-fed water enters the system. The water percolates through porosity plating, and either down the ramp (for attraction) or into the holding tank (to circulate water in the holding tank). The lamprey travel through the upwelling box then drop into the holding tank for retrieval (Figure 4).

Prior to the 2023 lamprey collection season, improvements were made to the NFL LPS system. The previous design relied on pumped water to feed the system. There were no indicators for a failed pump and failure would result in lamprey fatalities as air temperatures can reach well over 100°F. Without a constant flow of cooler water, temperatures within the tank would quickly rise to lethal levels.

New improvements consisted of a gravity fed water supply coming from the NFL drain. This drain is located near the count station (deemed fish-free water). This line then travels ~200-feet along the fish ladder to the upwelling box and holding tank. Additionally, the holding tank was replaced with a larger (~50-ft³) version that has a built-in auxiliary water supply line to help keep water temperatures cooler.

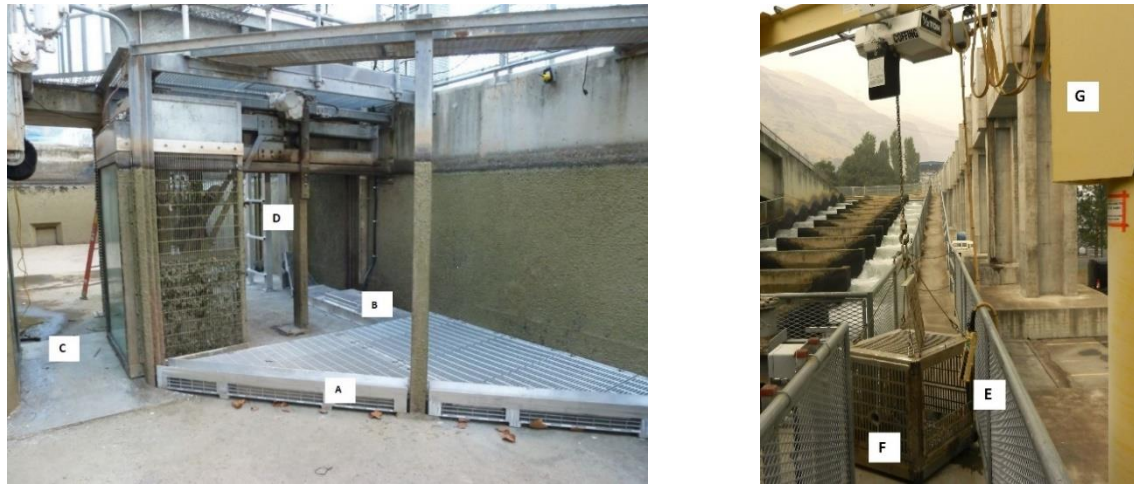
Figure 5: Images of the SFL LTS

(A) entrance (B) diversion conduit (C) count station window/crowder (D) trap box guide (E) trap box (with access hatch removed) (F) lamprey entrance port (G) trap hoisting jib crane. *Note* when in operation picketed leads rest atop the LTS entrance (A), and upriver from the trap box guide (D). These picketed leads guide non-trapped fish to the count station window (C) for counting.

The SFL lamprey trapping system (LTS) is located near the SFL count station, lamprey approach this area and enter the system below a grating structure on the deck. Once inside, they travel into a conduit which leads them up a small ramp, and into a trap box. This trap box can then be lifted, by a fixed jib crane, allowing personnel to collect the lamprey (Figure 5). This system generally operates flawlessly; however, success is variable. One issue with the LTS is that lamprey tend to mill in the conduit/ramp area. The flows are ideal in this area, and they may reside there for long periods of time (actual residing times unknown). Every year, during winter maintenance, several lamprey are collected/released that exit the conduit/ramp area.

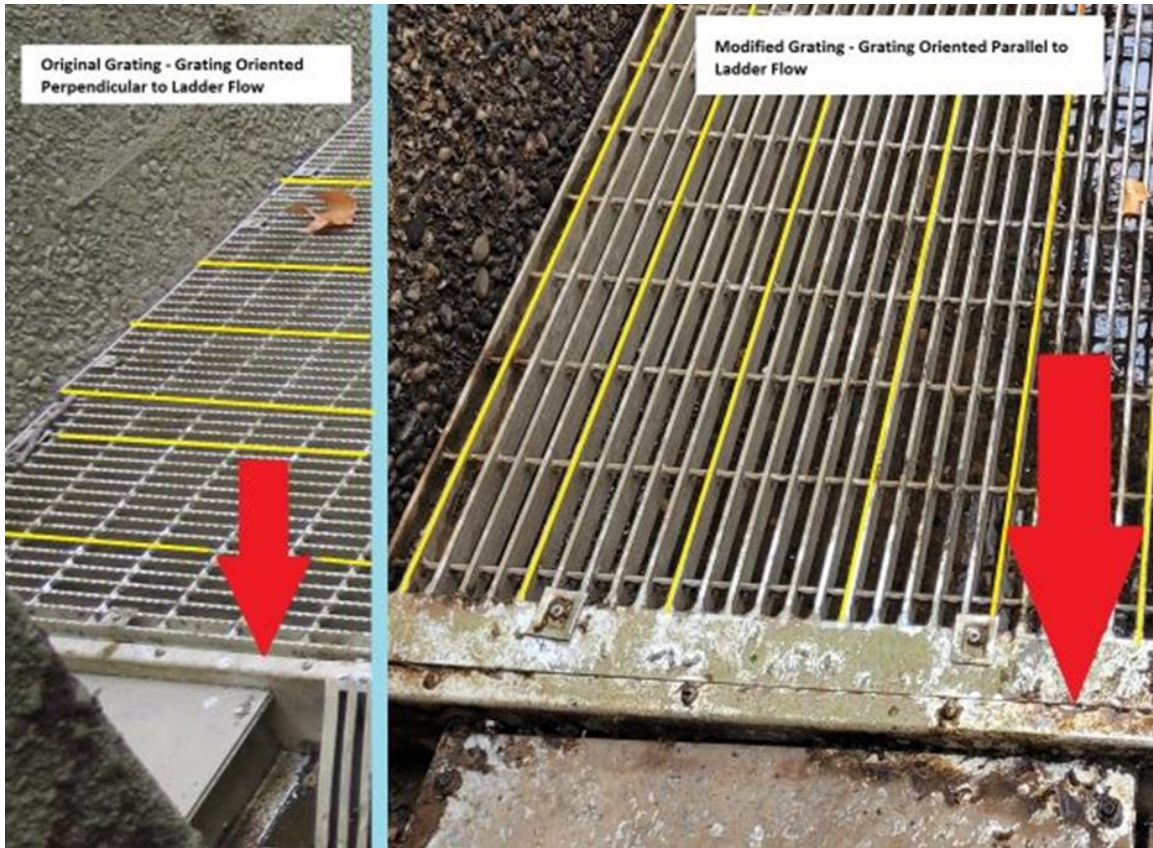
Figure 6: SFL LTS grating
The red arrow indicates the entrance to the lamprey trap, and the yellow line indicates the grating orientation.

Prior to the 2022 lamprey passage season, the grating at the SFL trap entrance was modified in an attempt to improve trapping efficiency. Previously, the grating to the entrance was oriented perpendicular to the flow of the ladder. During dewaterings high sediment volumes accumulated at the entrance. There were concerns that the sediment deterred lamprey from the system, so project personnel replaced the grating and oriented it parallel to the ladder flow (Figure 6). It is unknown whether altering the grating's orientation improved the trapping efficiency; however, the project will continue to monitor trapping efficiency. It should be noted that in addition to the 1,679-lamprey collected from the SFL trap in 2023, there were an additional 100 lamprey salvaged from the trap area during the winter dewatering (Table 4).

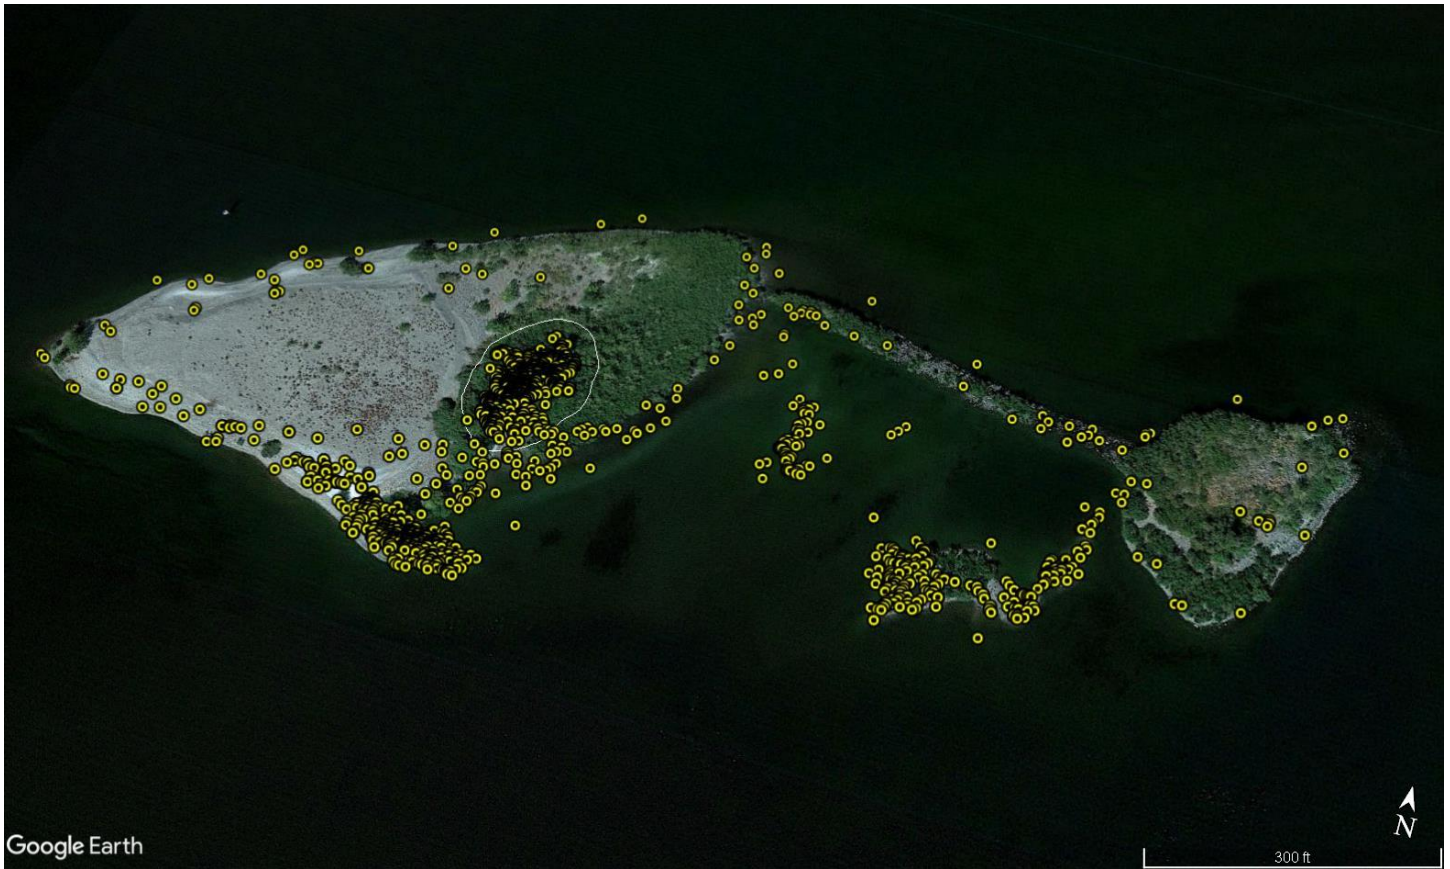
Figure 14: Preacher's Island with recovered PIT tag coordinate locations
 The white circled location is the heron colony on the island.

The fifth annual island scan was conducted on October 17, 2023, using Biomark HPR Plus readers. The JDF crew scanned the whole island focusing on areas where birds are known to congregate and recovered 713 unique PIT tags (Figure 15). This was the first year an attempt was made to get detection efficiencies for the island. On April 5, 2023, 50 tags were sown under the heron nests on the island, and 50 tags were sown on the peninsula of the island which is a main loafing site for pelicans. Then on October 17, 2023, 50 additional tags were sown under the heron nests and 50 on the peninsula right before the island was scanned that day. The detection efficiency under the heron nests was 56% pre-season and 82% post-season, and for the peninsula loafing site was 42% pre-season, and 70% post-season.

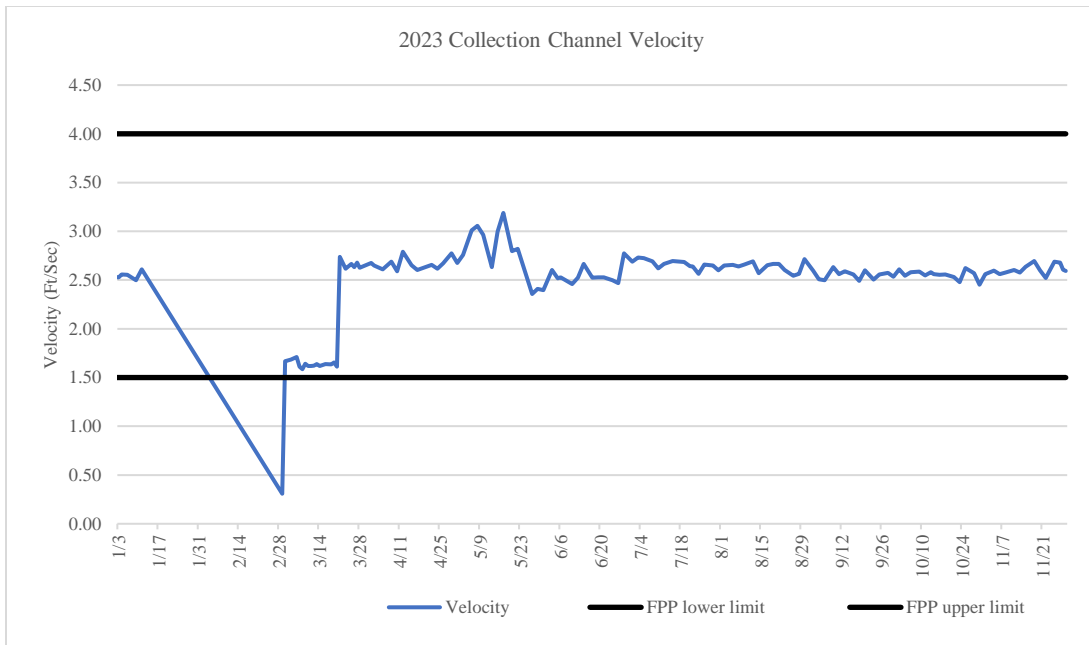
Figure 28: SFL collection channel velocities
 Dark black lines represent the FPP criteria range of 1.5 - 4.0 feet per second (Ft/Sec)

JDF monitors water velocities from the SFL collection channel. Historically velocities were calculated by recording the travel time of floats down the length of the collection channel. The times were recorded at every 2nd monolith, and this revealed velocities along the entire channel. In 2020 JDF began using a General Oceanics (model: 2030) velocity meter to obtain more accurate readings, (Figure 28) and continued using this velocity meter for 2023. Velocities are measured at 2-different locations, for at least 5-minutes, along the collection channel (Bays 4 & 12) (Figure 29). There were no time guidelines included with the meter, the times were established onsite. From March 1, 2023, through March 20, 2023, the SFL was on a 1 turbine operation due to gear box repairs on fish turbine #3 and vibration issues on fish turbine #2. During the 1 turbine operation NE-1 was closed and FOGs were removed. On March 1st when turbine #2 was forced out of service due to the vibration issues, a velocity was taken and was found to be out of criteria. NE-2 and SE-1 were adjusted to maintain velocity per FPP.
