# 2023 ANNUAL FISHWAY STATUS REPORT

## THE DALLES DAM

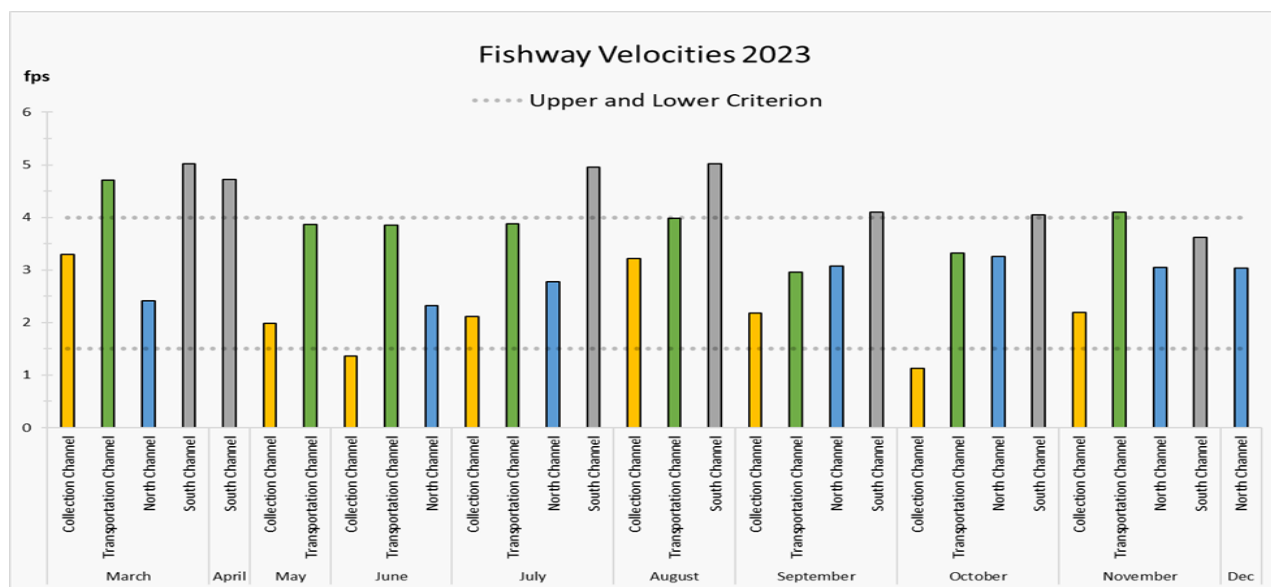
The following visual shows averaged monthly velocities for our several fishway channels. Most fall within the flow criteria of 1.5 fps – 4 fps (feet per second).

The South Channel was generally above or right at 4 fps and the Collection Channel was mostly within criteria except for the months of June and October, when it was just short of the lower criterion.

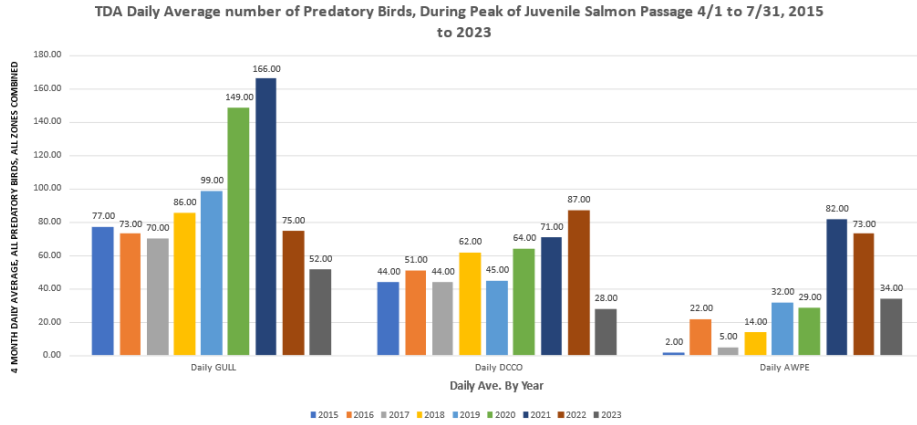
Comparing Previous Year Daily Ave. # of Total Avian Predators at The Dalles, Gulls, Cormorants and Pelicans.

Table above compares average number of three main piscivorous birds counted daily. Deterrent efforts seem to result in a decline in cormorants, gulls and pelicans.

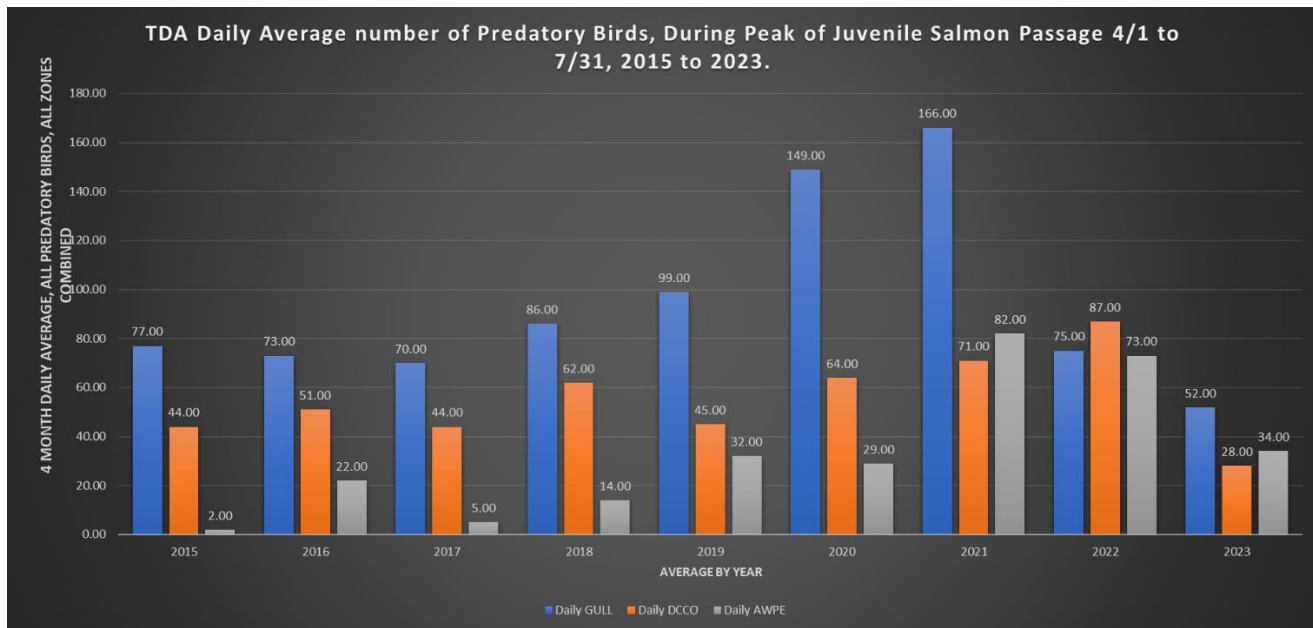
Table reveals a decline in all species.

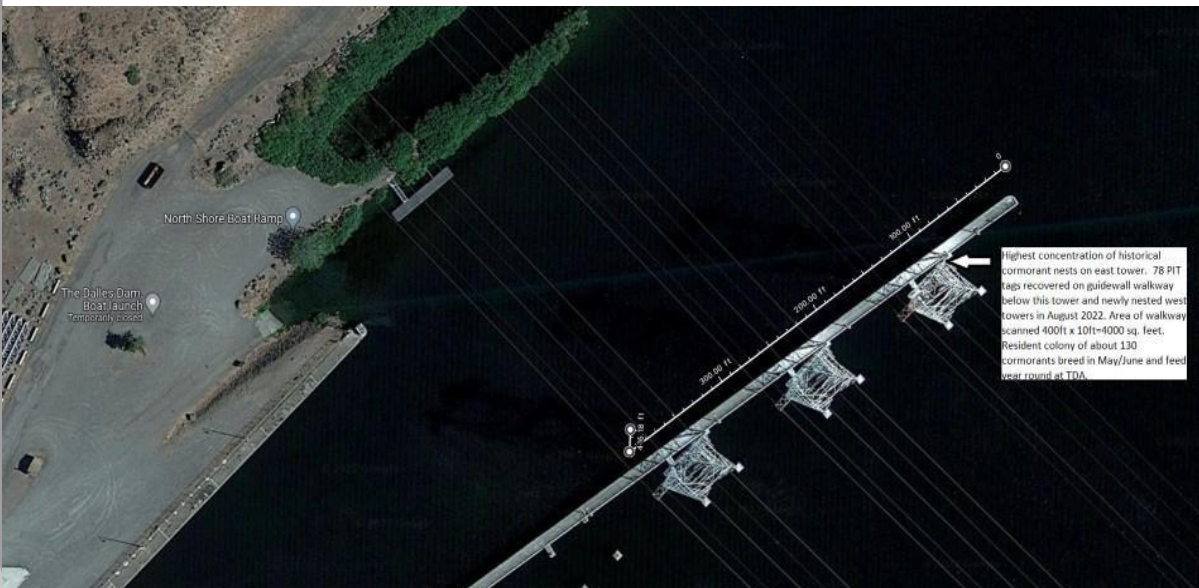
**TDBPAT PIT tag site and DCCO colony.**

The walkway is only 8' wide and is bounded by a curb on the south side. A small percentage of the PIT tags migrate out of the nests on the walkway and then are carried by wind and water into the river bottom. The vast majority of area under the towers is over water and not scannable.
