The Dalles Dam Fishway Status Report

Inspection Period: 11/15 - 11/21

THE DALLES DAM

US Army Corps
of Engineers
Portland District

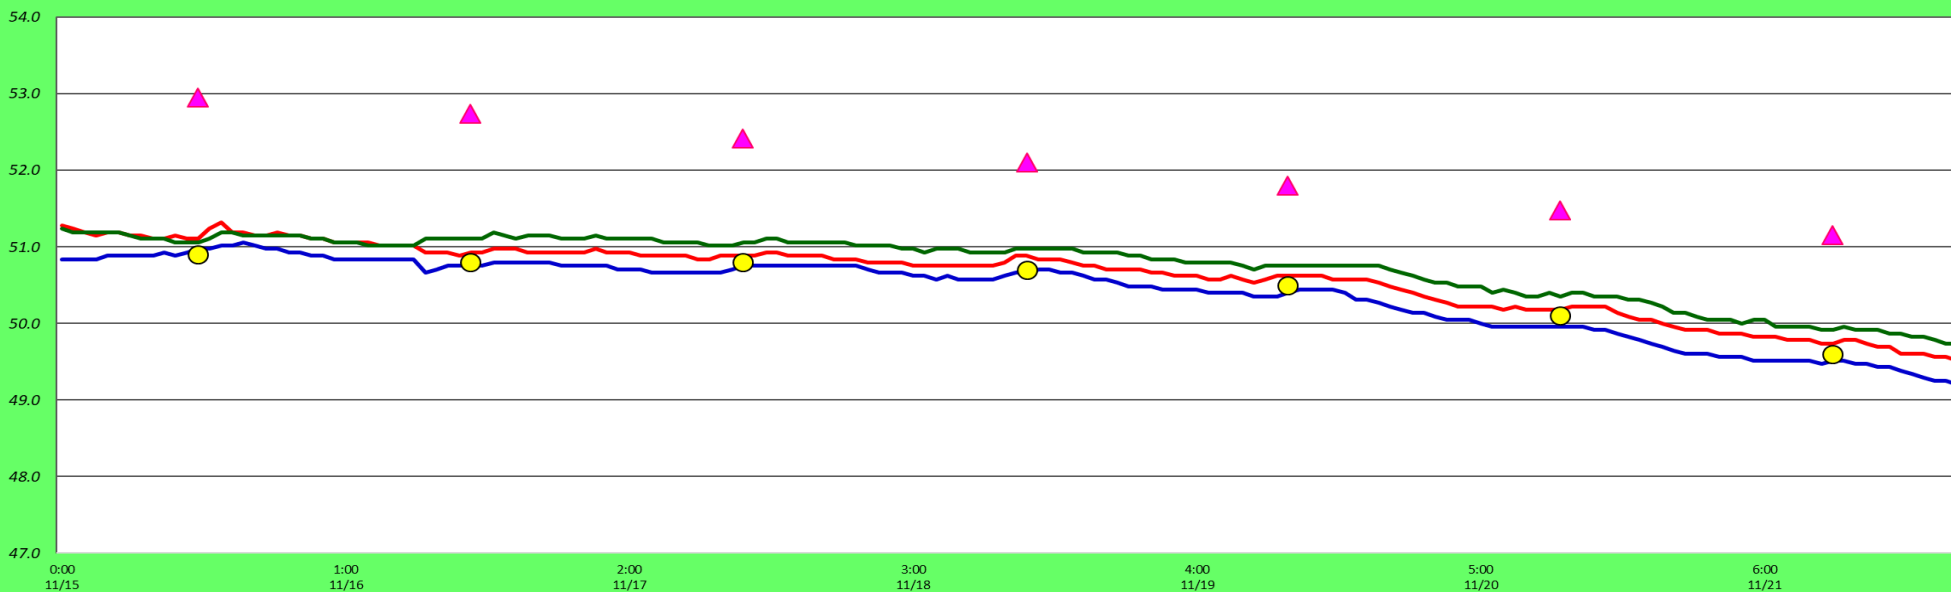
Adult Fish Ladders-River Temperatures

— East Count Station — North Count Station — North Entrance ● Current USGS daily tailwater average ▲ USGS daily tailwater average (2007-2019)

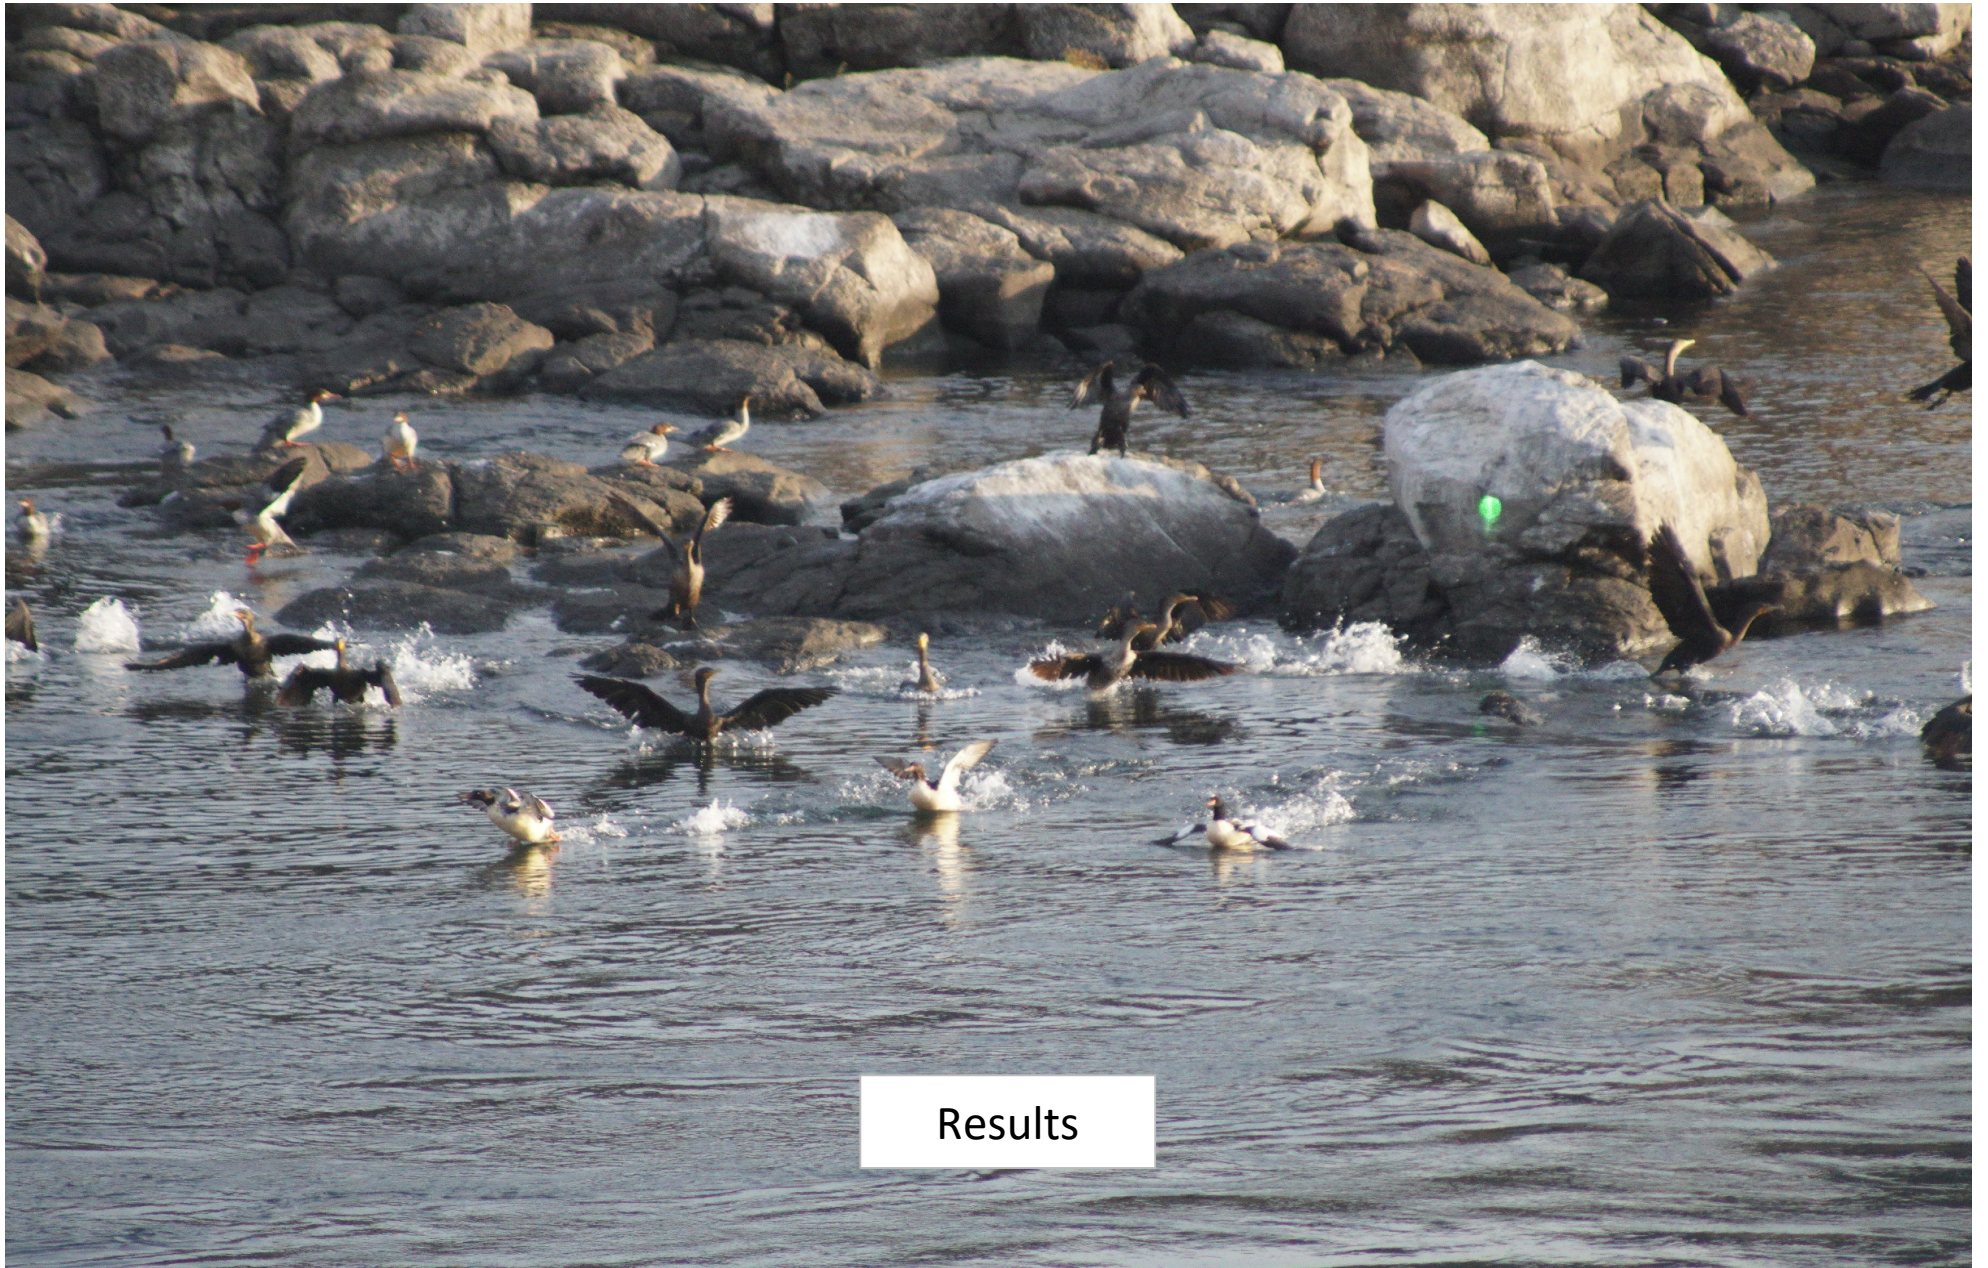
Green spot laser deterrent in dim morning light. Cormorants and common mergansers leave resting rock in PH1 11/12/2020
