The	Dalles Dan	THE DALLES DAM									
		The Dalles Project-Fisheries									
			E.U. DUX 304	0 07050 0000							
	Inspection Pe	of Eng Portland	ineers The Dalles, Of								
	inspection re	Portiand		0-3000							
The Dalles Dam	Inspections	Criteria	Total Number of Inspections:	6		88.7 °F					
	000	Limit	Comments: nominal		Weekly Ave. Se	cchi: 5+					
NORTH FISHWAY											
Exit differential	0	≤ 0.5'	Large amounts of floating milfoil kept out by	boom and	raking gratings.						
Count station differential	0	≤ 0.3'	Video counting is ongoi								
Weir crest depth	0		North ladder is rock solid automation.								
Entrance weir N1	0		Avg. for week 10.0								
Entrance Differential	0		Avg. for week 1.3								
N2 PUD Intake differential	0	Closed			f						
	0		PUD and hand raking keeping up with floating								
EAS	ST FISH	WAY -L		MAIN	<b>FAINENCE</b>						
JUVENILE BYPASS											
Sluicegate operation	0	closed	Endgate closed 12/16/22. Intakes 1-8-16-18	8 open.

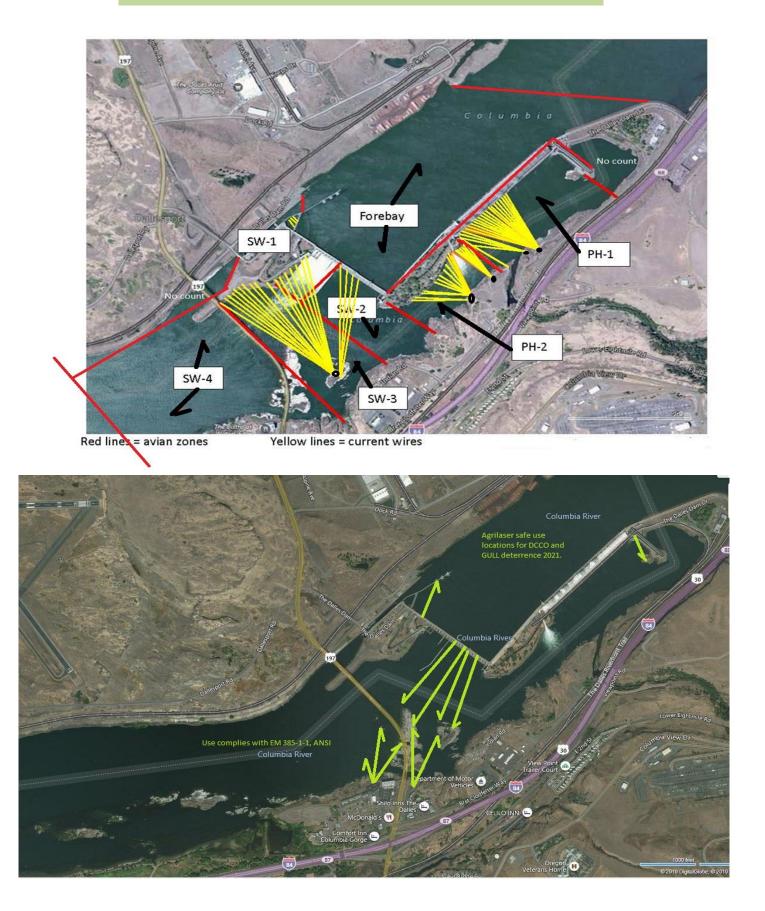
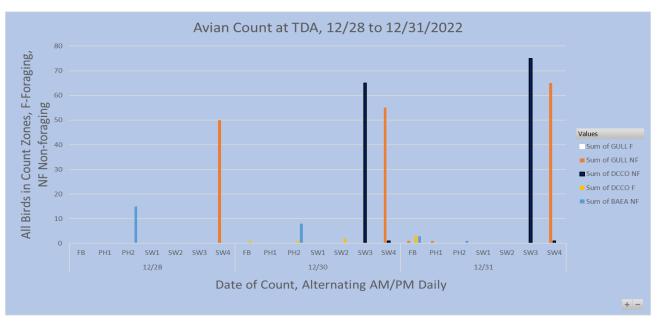
## Bird Count Zones, Avian Lines and Laser Deterrent Sites

Eagle numbers fluctuate daily but are trending upward to roughly peak of 15 around midday. Non foraging gulls distancing from eagles in SW4.

Using green laser to move gulls and cormorants from common resting areas. Making comments to EA drafted by Paul Schmidt.

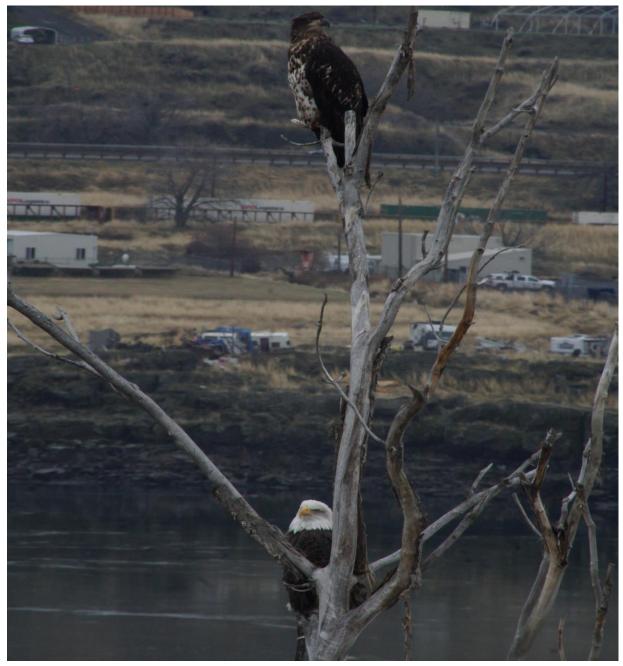
Bald eagles have taken over the bird count zones at The Dalles. Lone Pine village in the background.

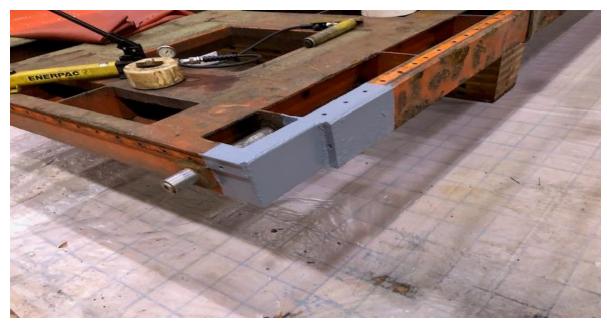
Lamprey orifices cut into each side of 154 and 155 weirs. Dimensions 1.5" x 12"  $\,$

EFL exit weir 155 repair in progress. Weirs 154 and 155 cutting lamprey orifices per PDT recommendation.
