The Dalles Dam Fishway Status Report

Inspection Period 07/02-07/08, 2023

THE DALLES DAM

US Army Corps
of Engineers
Portland District

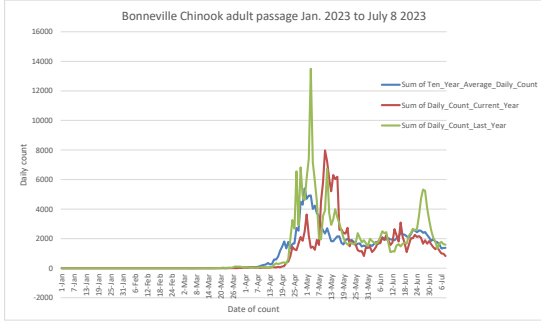
Tori line deployed at east entrance 6/26 at east entrance, then moved to south July 5th

Cursor look at counts to assure no obvious detriment from tori line deployment.

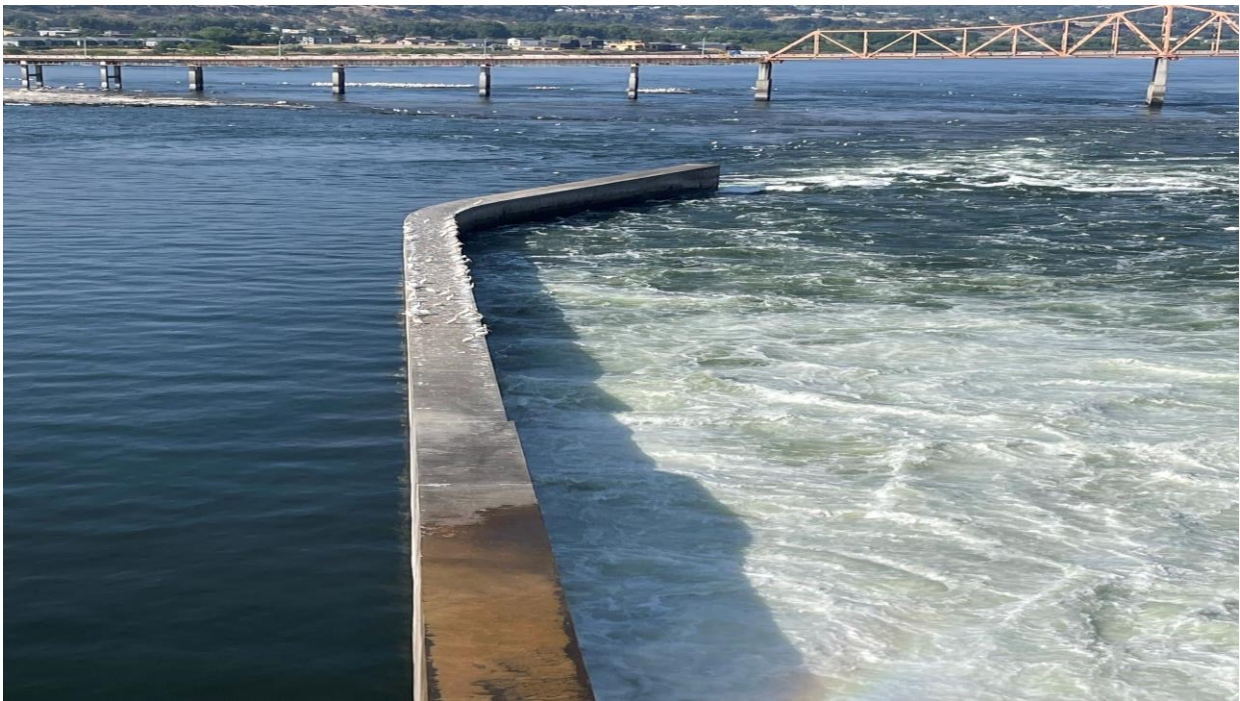
Typical pelican foraging this week

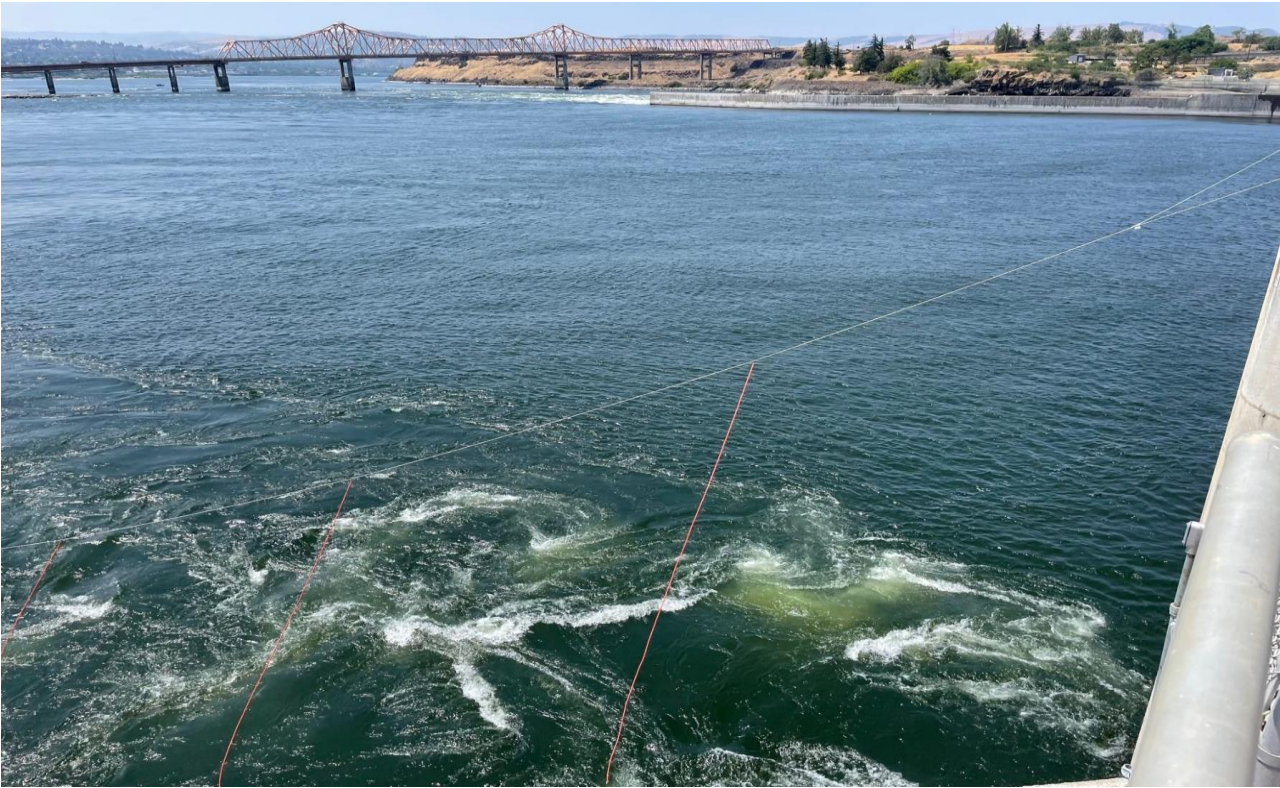
New tori line moved to south July 6th

relocated tori line from NOAA seagrant at south entrance to deter predator birds. Initial response promising.
Northern Pikeminnow Management Program (NPM) ≥ 230 231 for the week, 1335 YTD
USGS temperature link- °F
4 Peaks conduction fish counts, night video commenced
Supporting lamprey improvements PDT. Two of 4 exit weir modified with lamprey orifice, other 2 next winter.
ODFW conducting monthly fishway inspections.
PTAGIS fishladder data collection at count stations continues
No zebra mussel samples taken yet.
