The Dalles Dam Fishway Status Report

Inspection Period 3/24-3/30, 2024

THE DALLES DAM

US Army Corps
of Engineers
Portland District

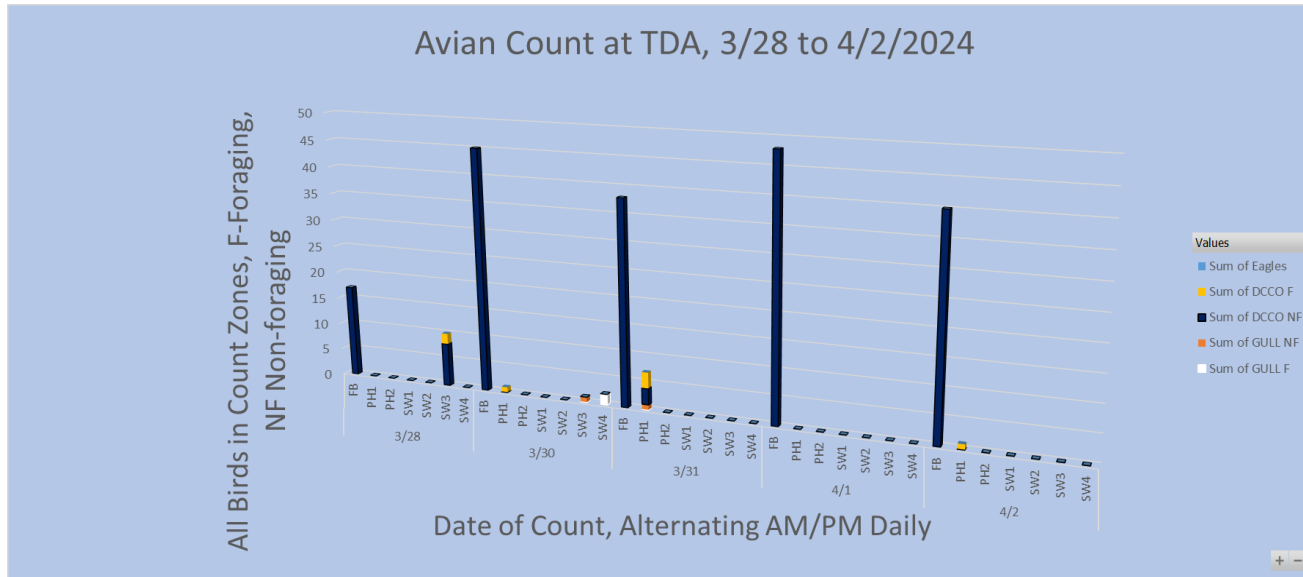
Cormorants have begun to feed and congregate around the project structures in anticipation of breeding.

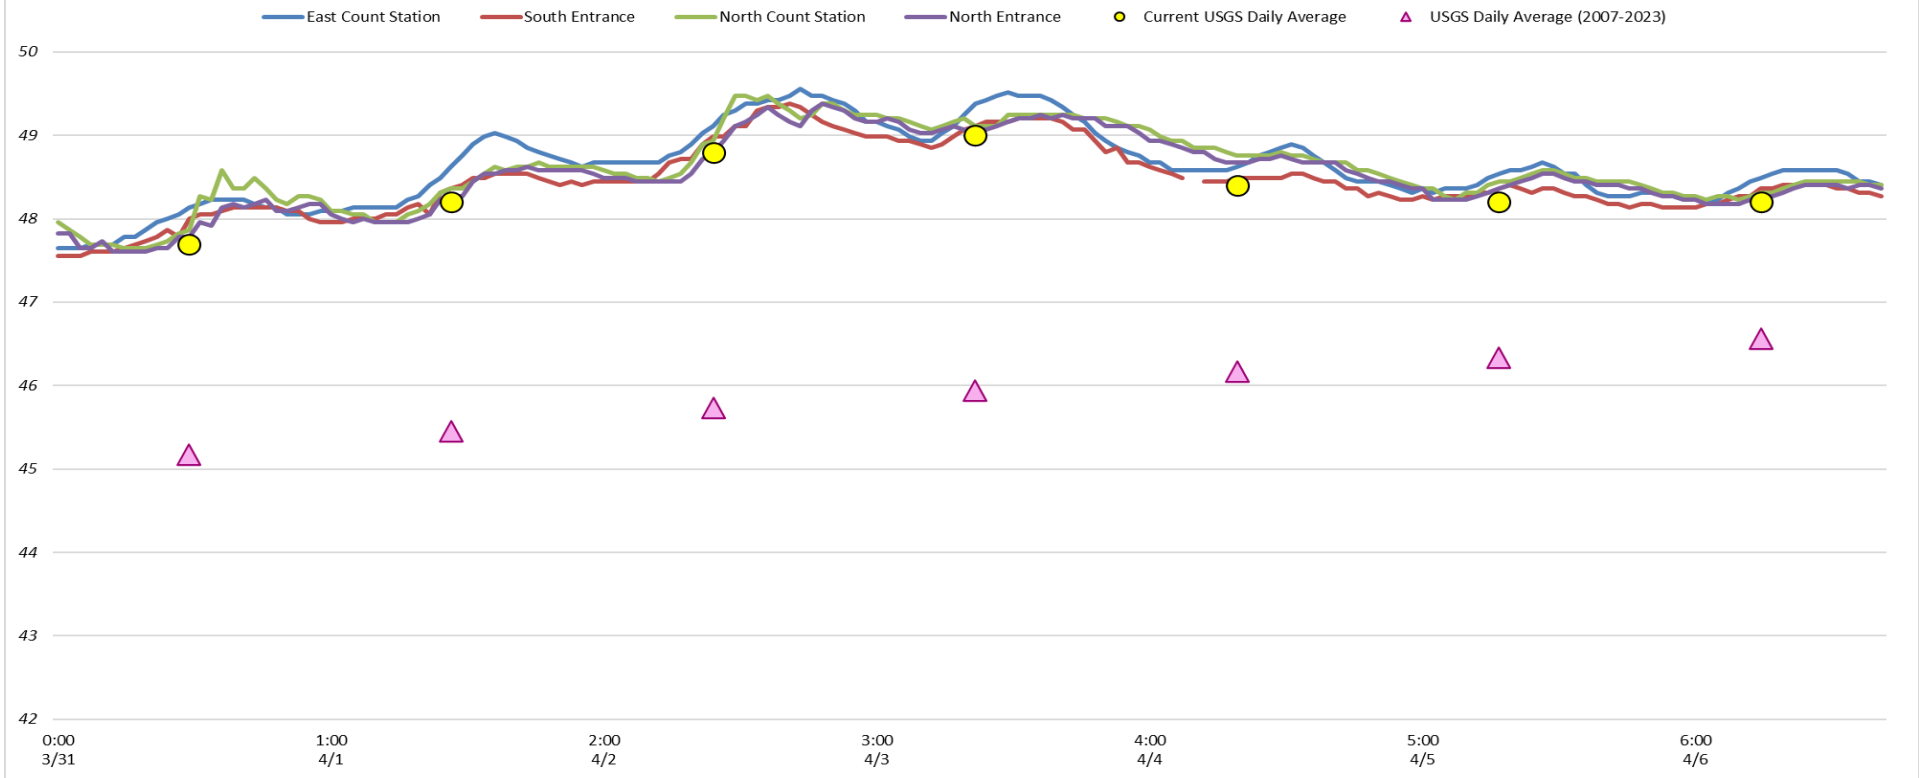
Fish Ladders-River Temperatures

Secchi:		USGS
5.0	Sun	47.7
5.0	Mon	48.2
5.0	Tue	48.8
4.0	Wed	49.0
4.0	Thurs	48.4
4.0	Fri	48.2
4.0	Sat	48.2
4.5	AVG	48.4

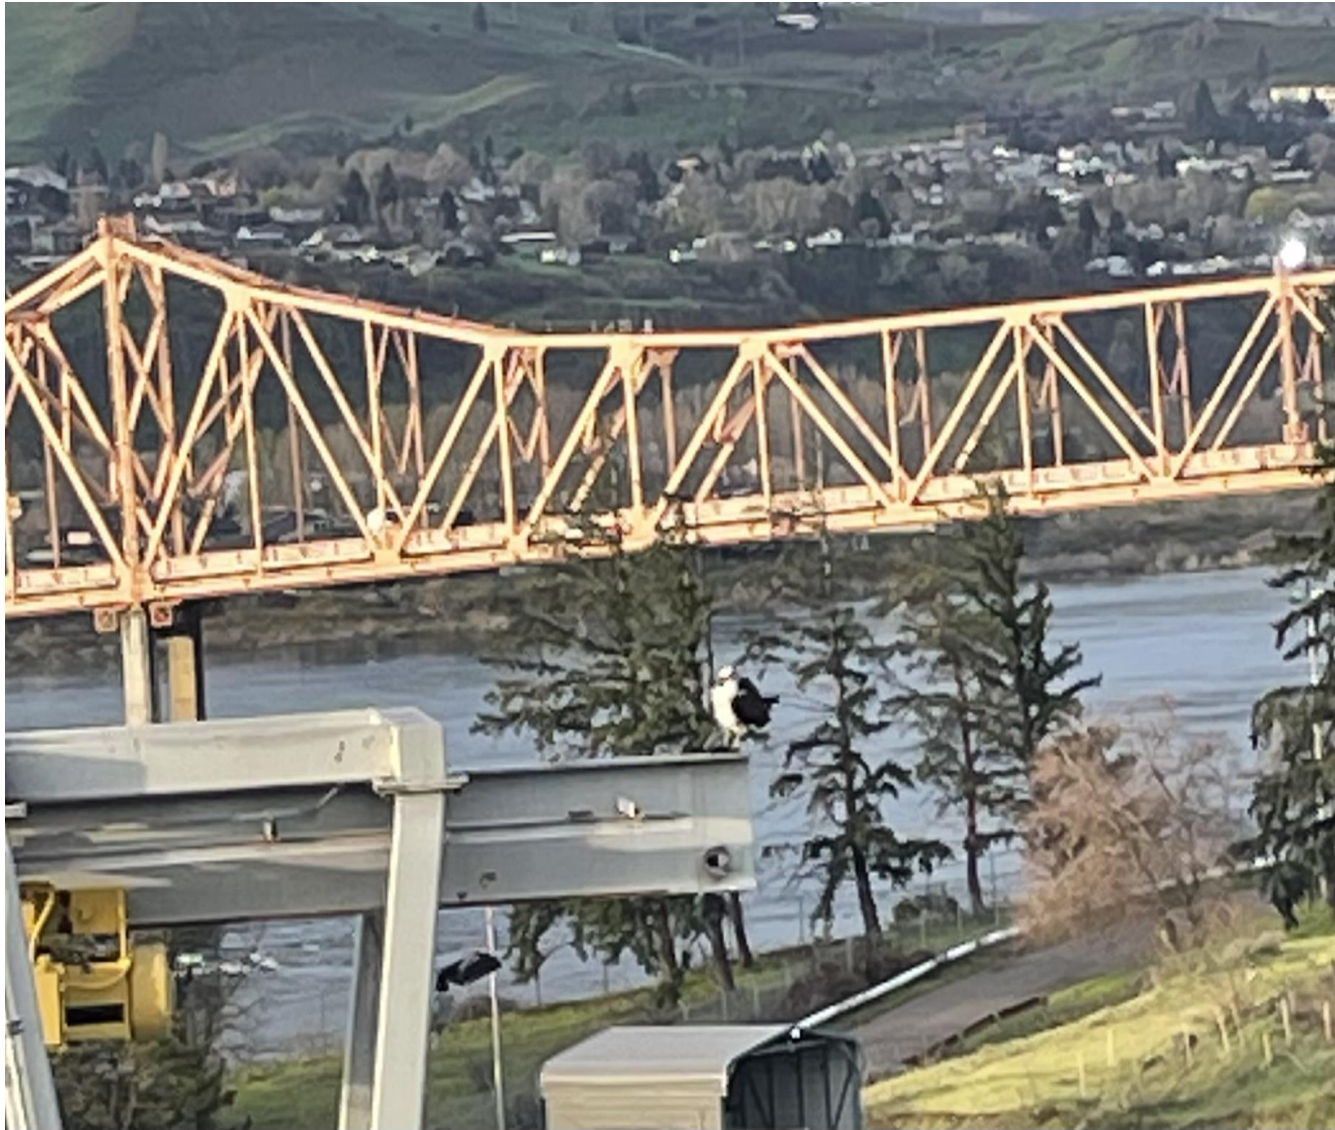
Osprey perched near nesting platform by PUD. Multiple PIT tags for salmon found under the nest platform last year. Nesting platform originally installed to prevent nesting attempts on working cranes and other equipment in the area.

The osprey have arrived for nesting. PIT tags recovered under nest platforms indicate significant juvenile salmon predation.
