# The Dalles Dam Fishway Status Report

Inspection Period 5/26 - 6/1, 2024

## THE DALLES DAM

US Army Corps  
of Engineers  
Portland District

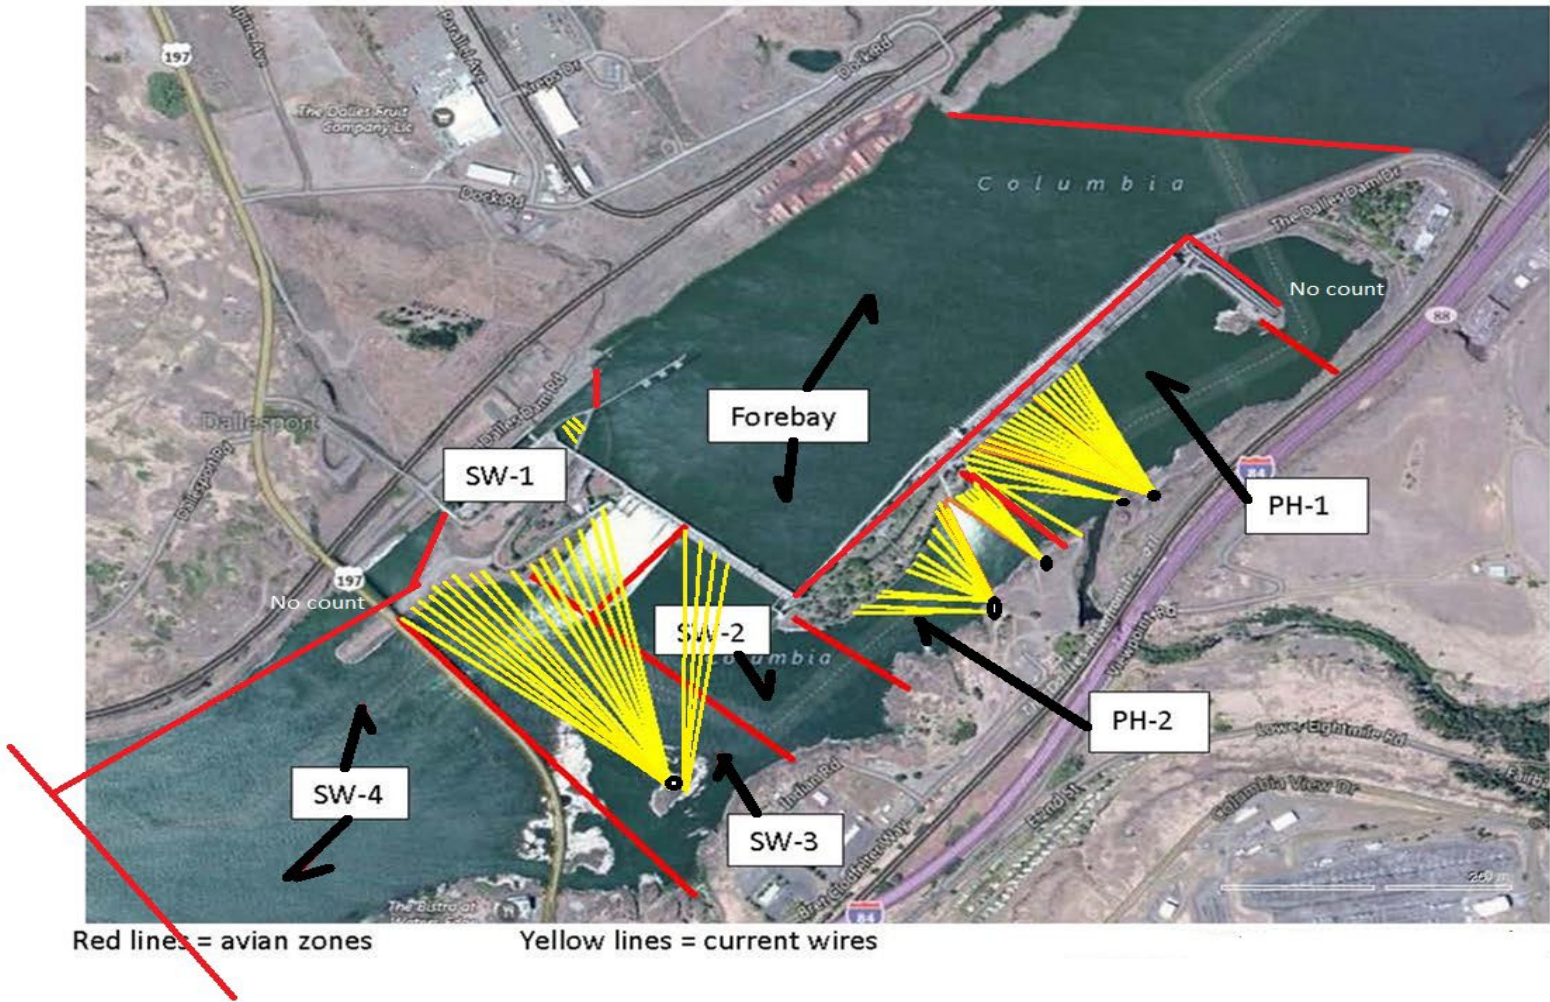
# Bird Count Zones, Avian Lines and Deterrent Sites

Avian predator tori lines and audio distress Bird Gard. 10/2023

Tori lines at East Ladder entrances.

Bird Gard audio deterrent.

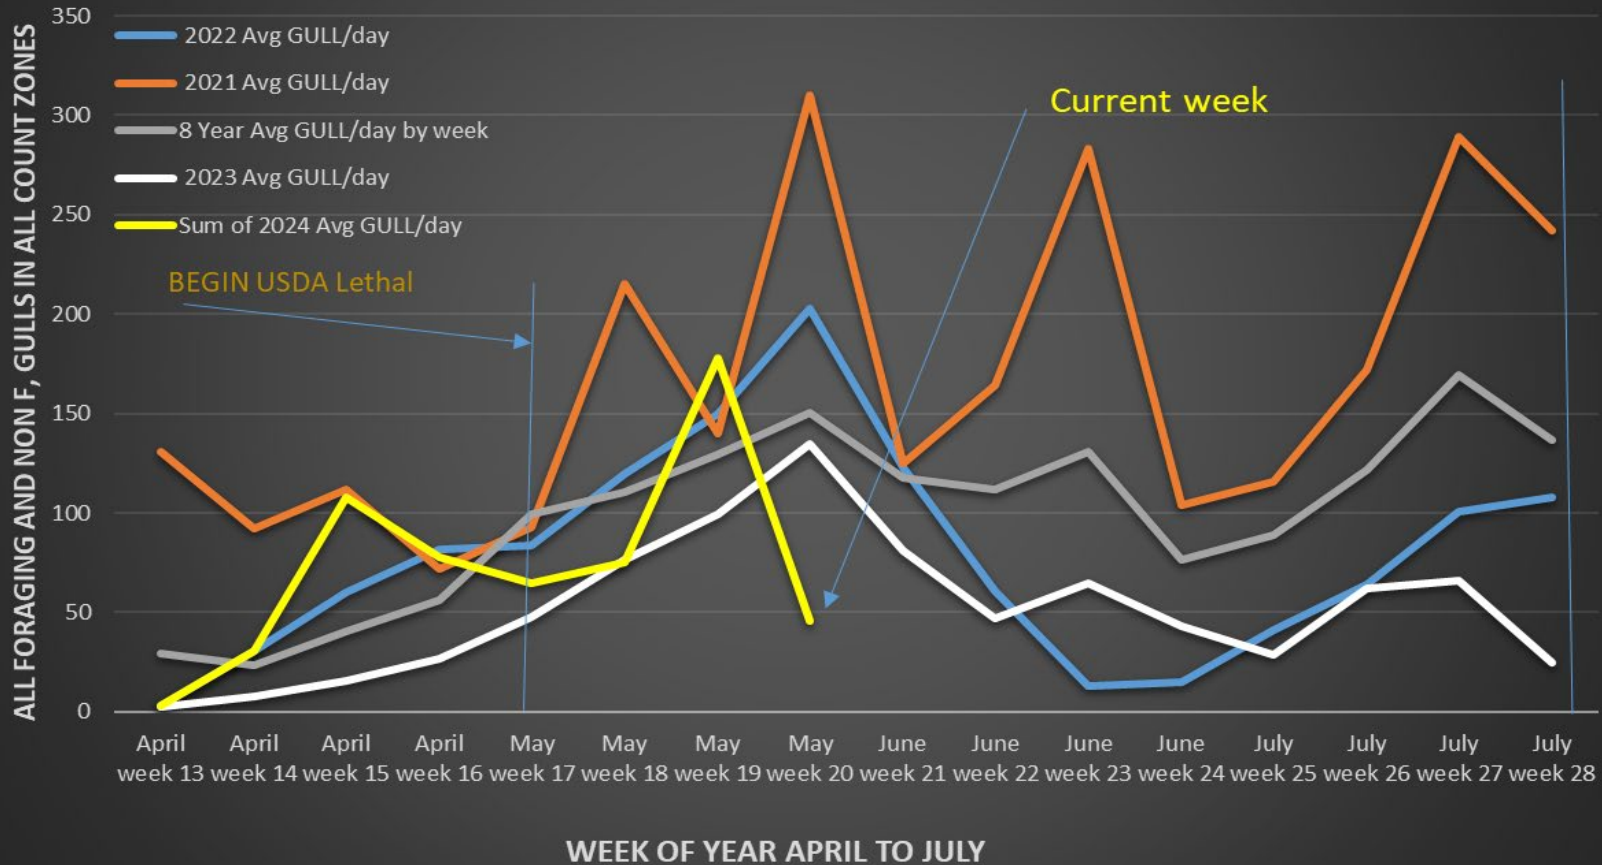
## TDA Daily Avg # of GULLs by Week, April to July 2021, 2022, 2023 and 2024 Compared to Previous 8 years Daily Mean.

Rising tailwater level, Lethal take-arrival of pelicans all pushing gulls out of foraging in count zones. Feeding aggressively under lines in SW3 .

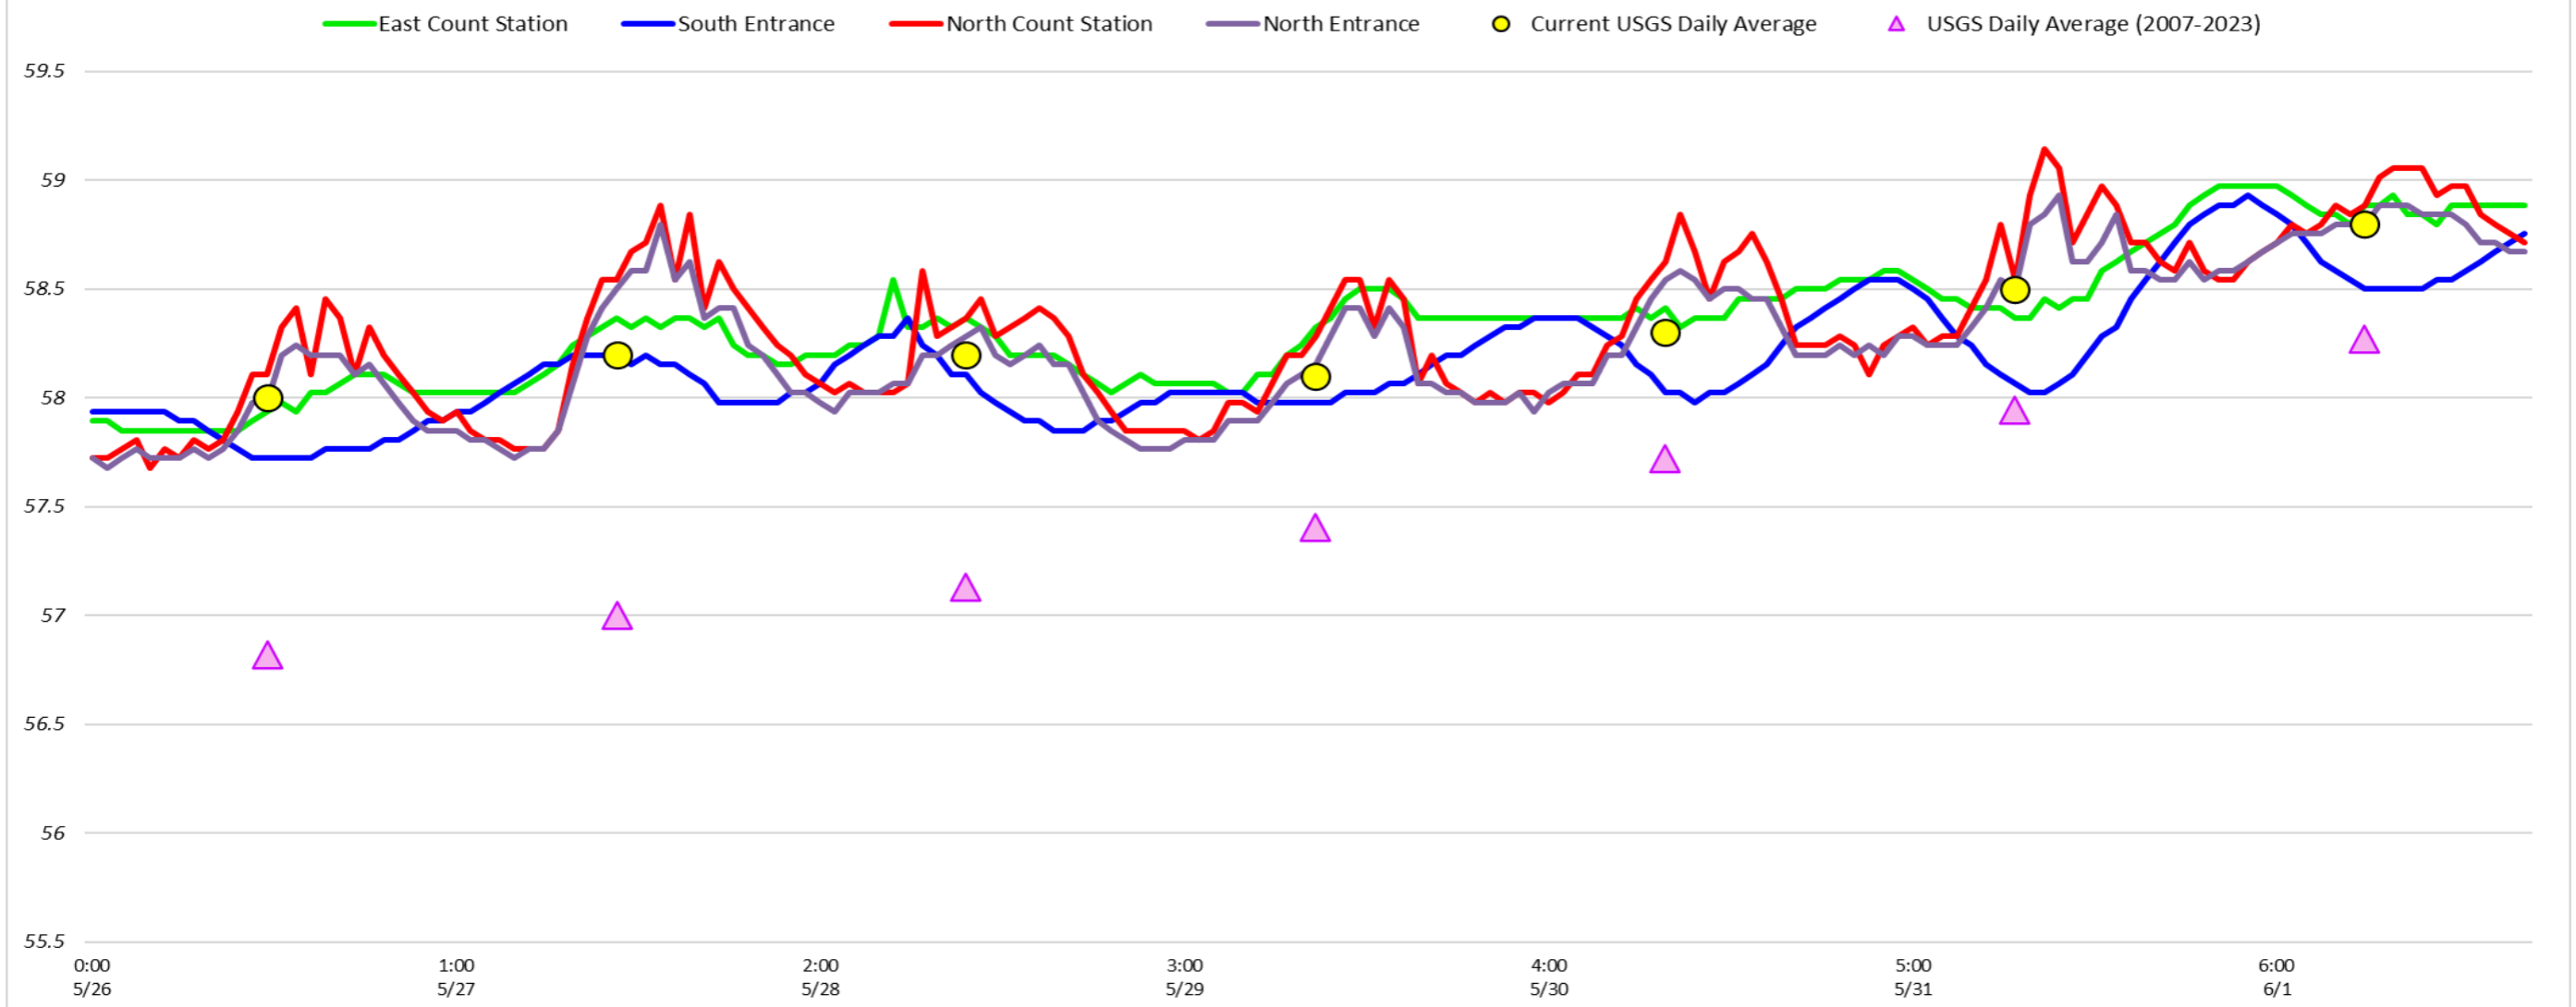
### Adult Fish Ladders-River Temperatures

Secchi:		USGS
4.0	Sun	57.7
4.0	Mon	58.0
5.0	Tue	59.0
5.0	Wed	60.0
6.0	Thurs	58.3
5.0	Fri	59.0
5.0	Sat	60.0
4.9	AVG	58.9

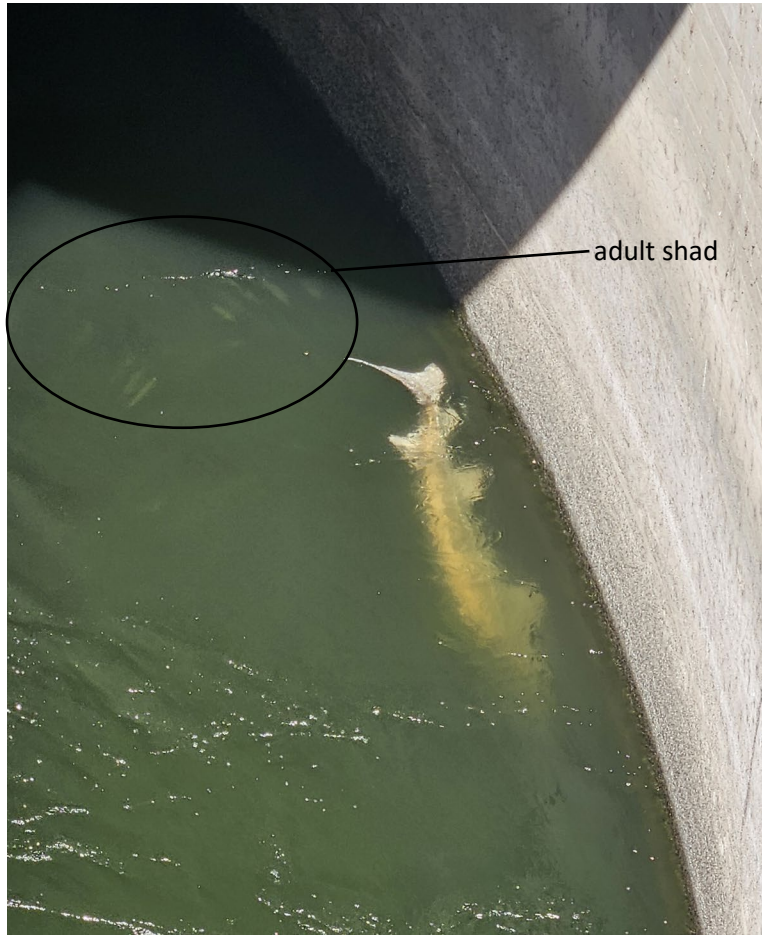
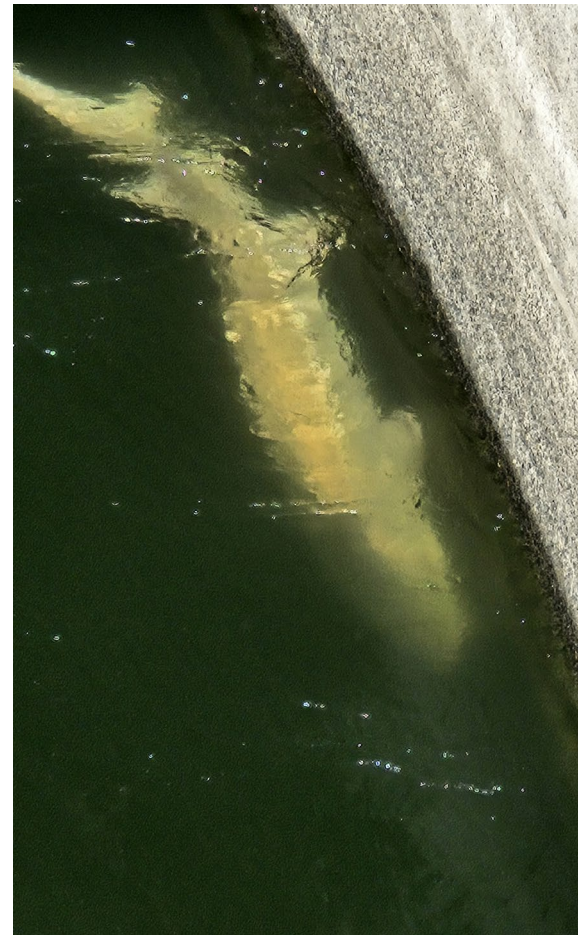
A White sturgeon in the Transportation Channel of the East Fish Ladder, near the Junction Pool. The left image includes some adult American Shad for size reference. These shad average 17-24 inches in length.

No recent otter sign or sea lion sightings. Pelicans increasing in numbers along with increasing shad numbers, foraging in SW4, SW3 and PH1.  
Large sturgeon busy in east channel feeding. SEE PHOTO  
Tori lines installed at east, west and south. Mobile Bird Gard operating in PH1. Gull effigies covered due to falconry.  
Falconry completed contract. 5/28/2024
