# FISHWAY STATUS REPORT

Date: 1/6/2013  
 Inspection Period: 12/30/2012 - 1/5/2013

## THE DALLES DAM

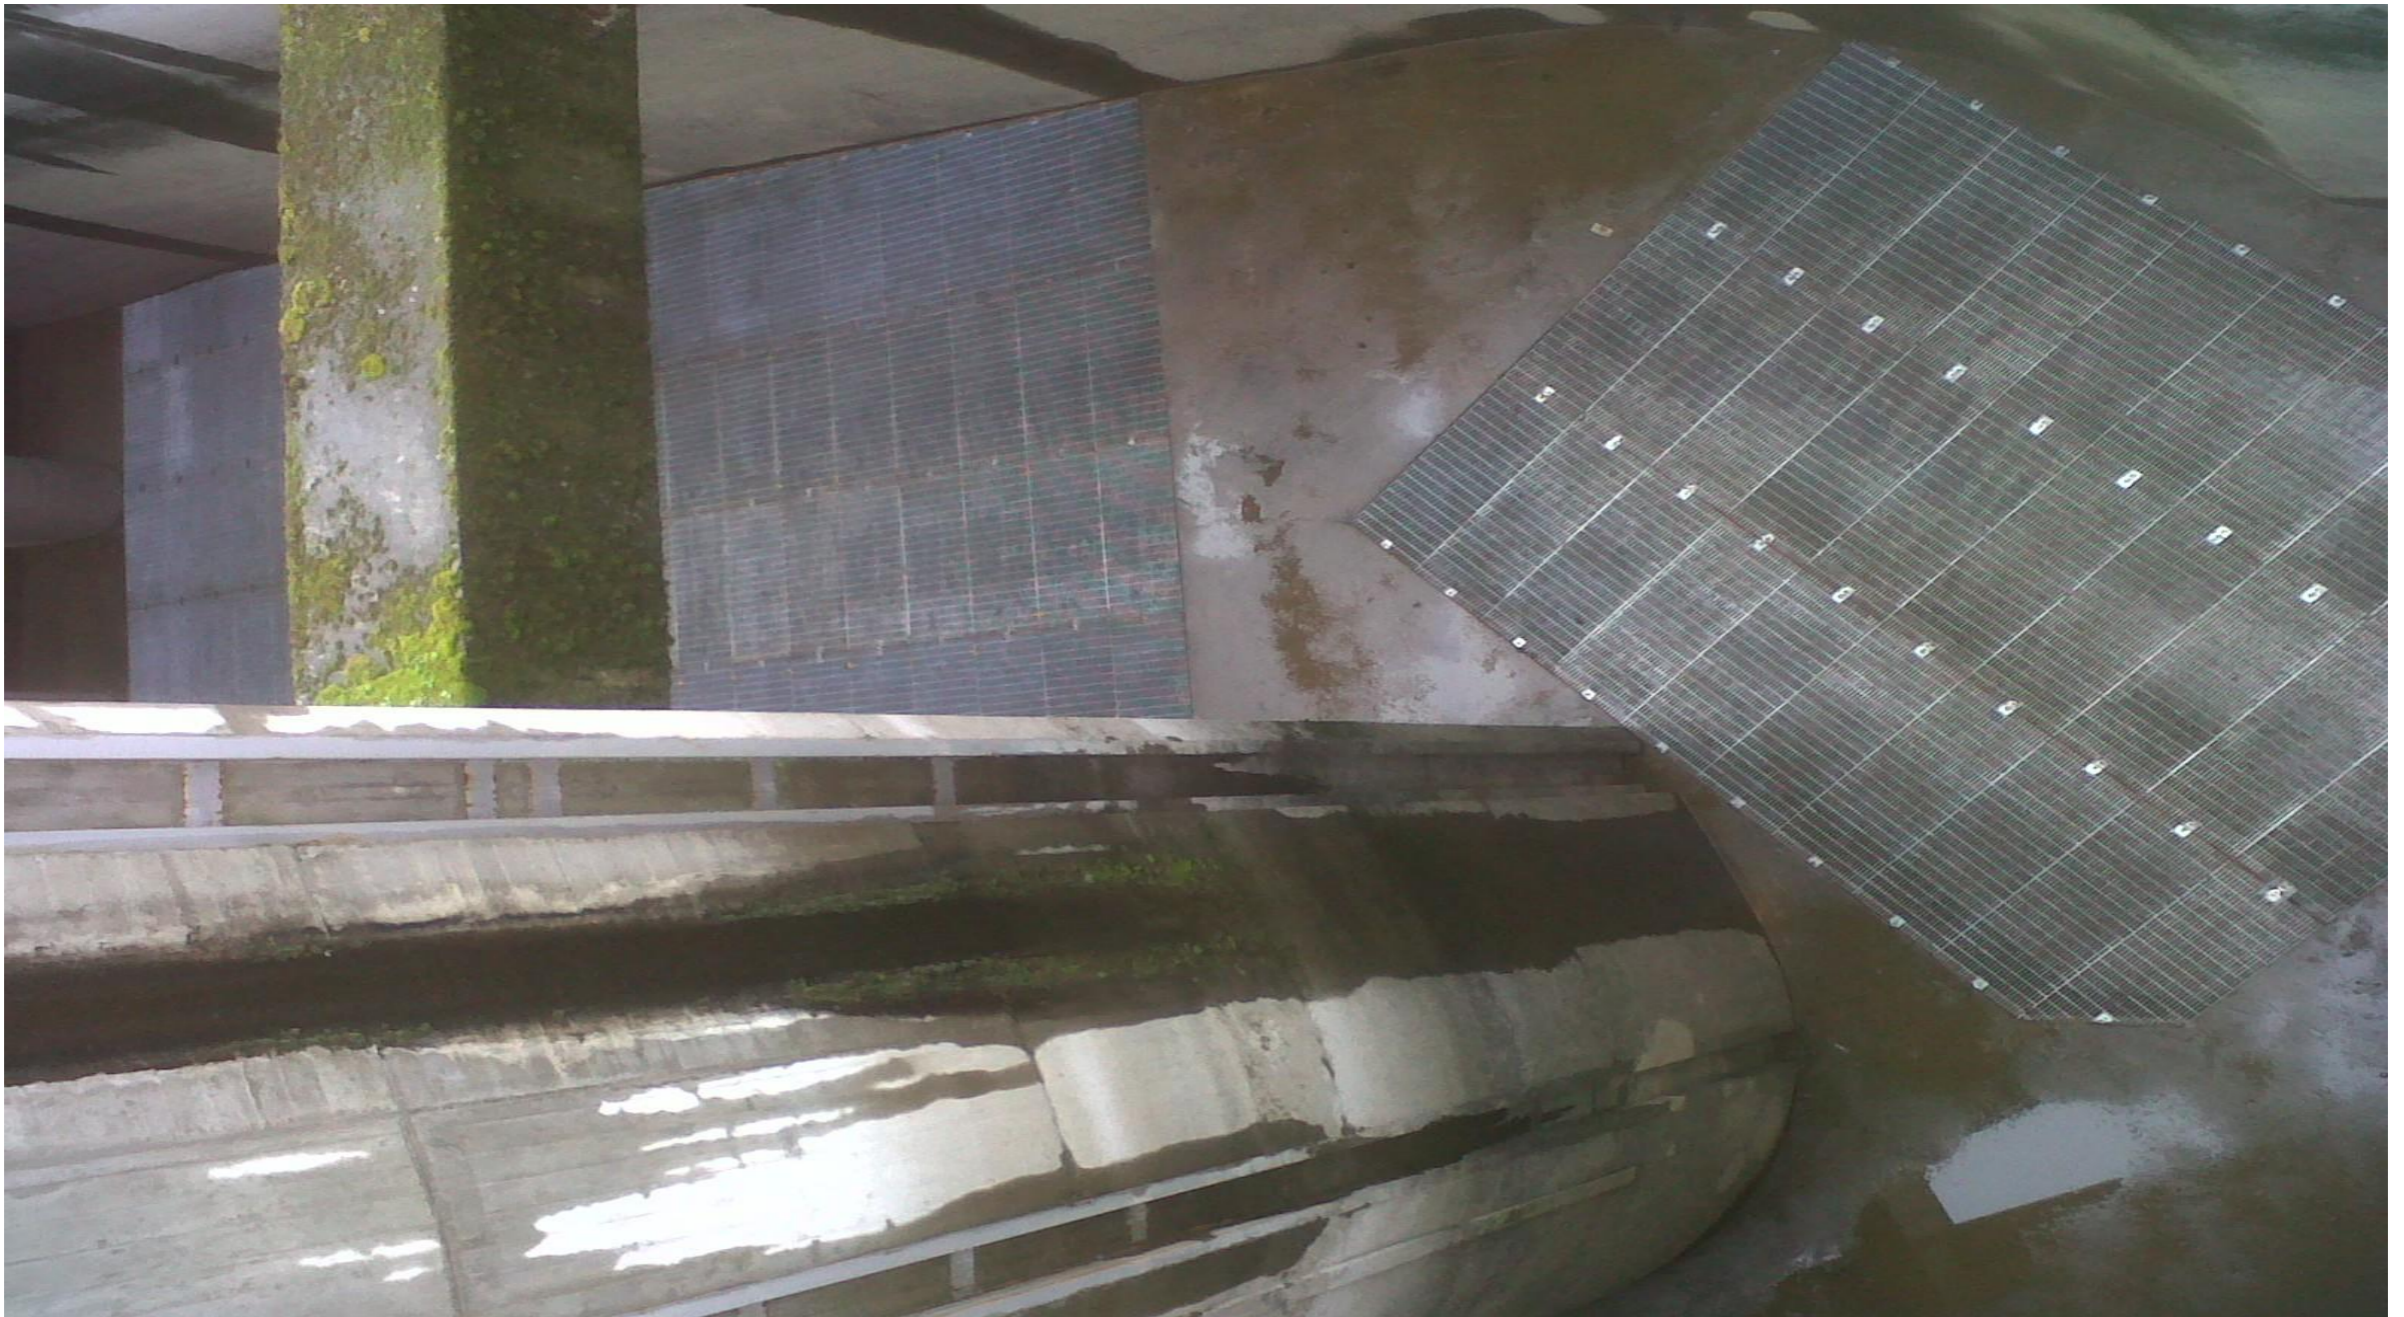
Several brittle attachment studs found in west diffuser grating install. Questionable attachments will be welded directly to support beam. Long term plan underway for better repair next winter.

New diffuser grating installed in the west entrance.
