# FISHWAY STATUS REPORT

Date: 3/3/2013  
 Inspection Period: 3/3 - 3/9/2013

# THE DALLES DAM

**US Army Corps  
of Engineers**  
Portland District

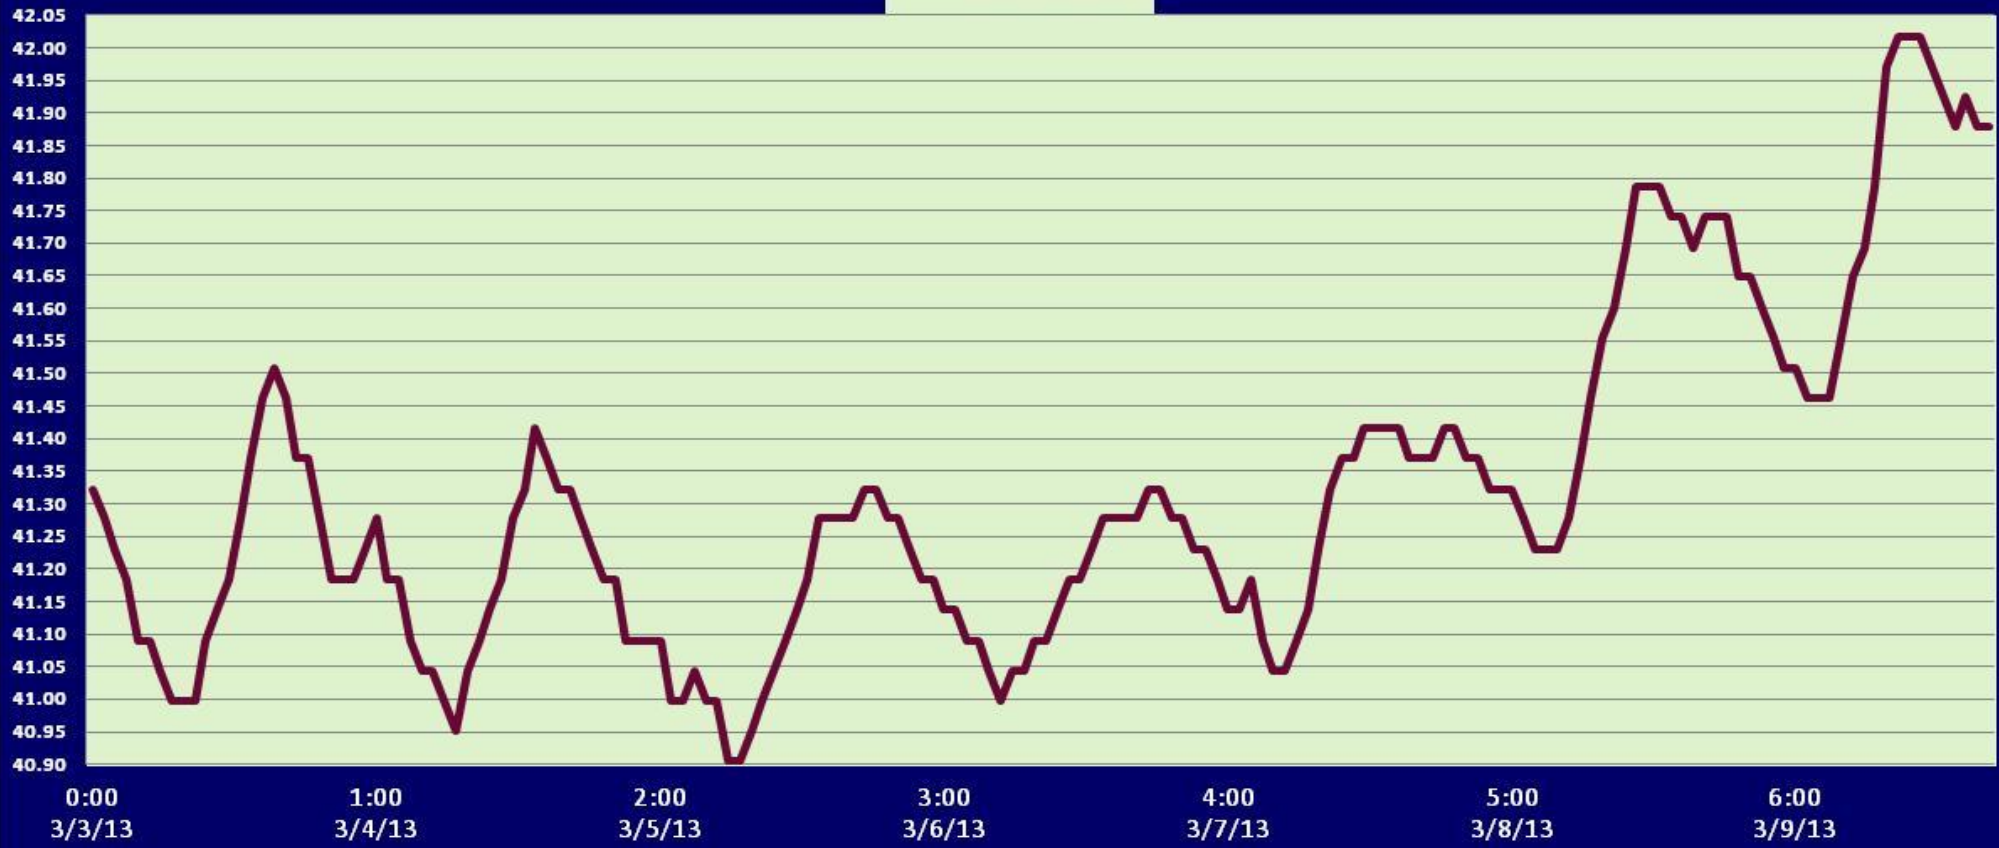
# East Adult Fish Ladder River/Water Temperatures

East Fish Ladder

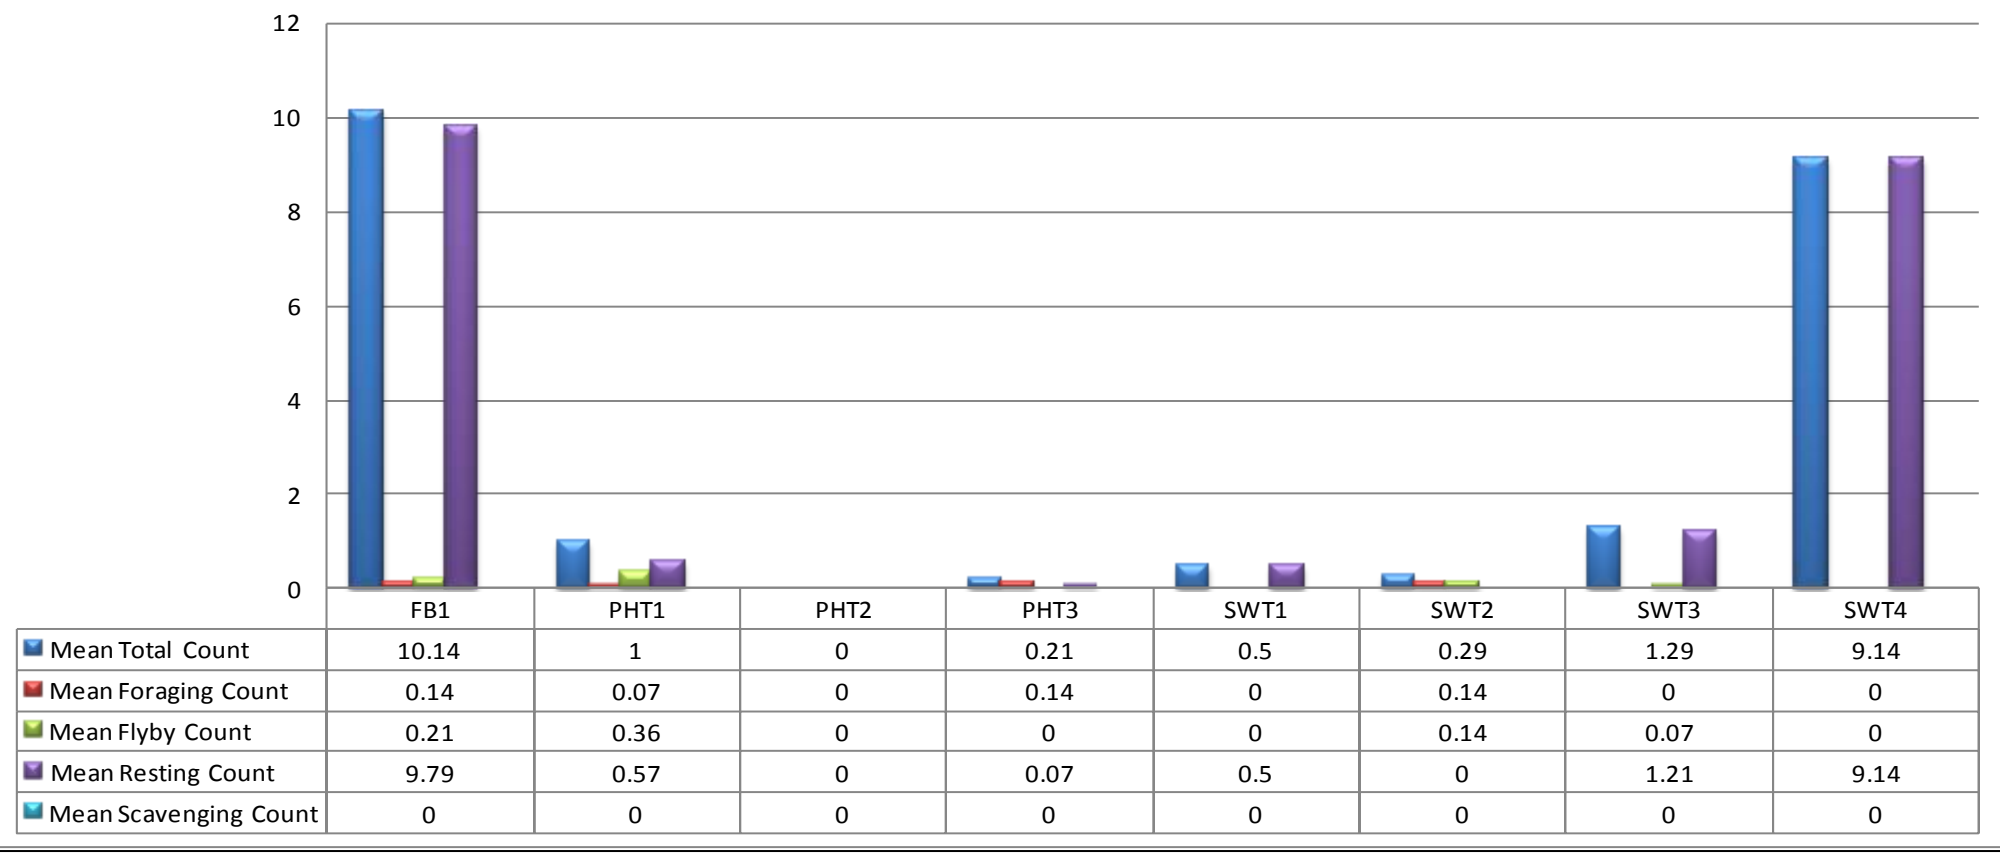
### Mean Counts by Behavior

Fisheries personnel conducts bird observations twice per day. See Avian tab for more observation results.

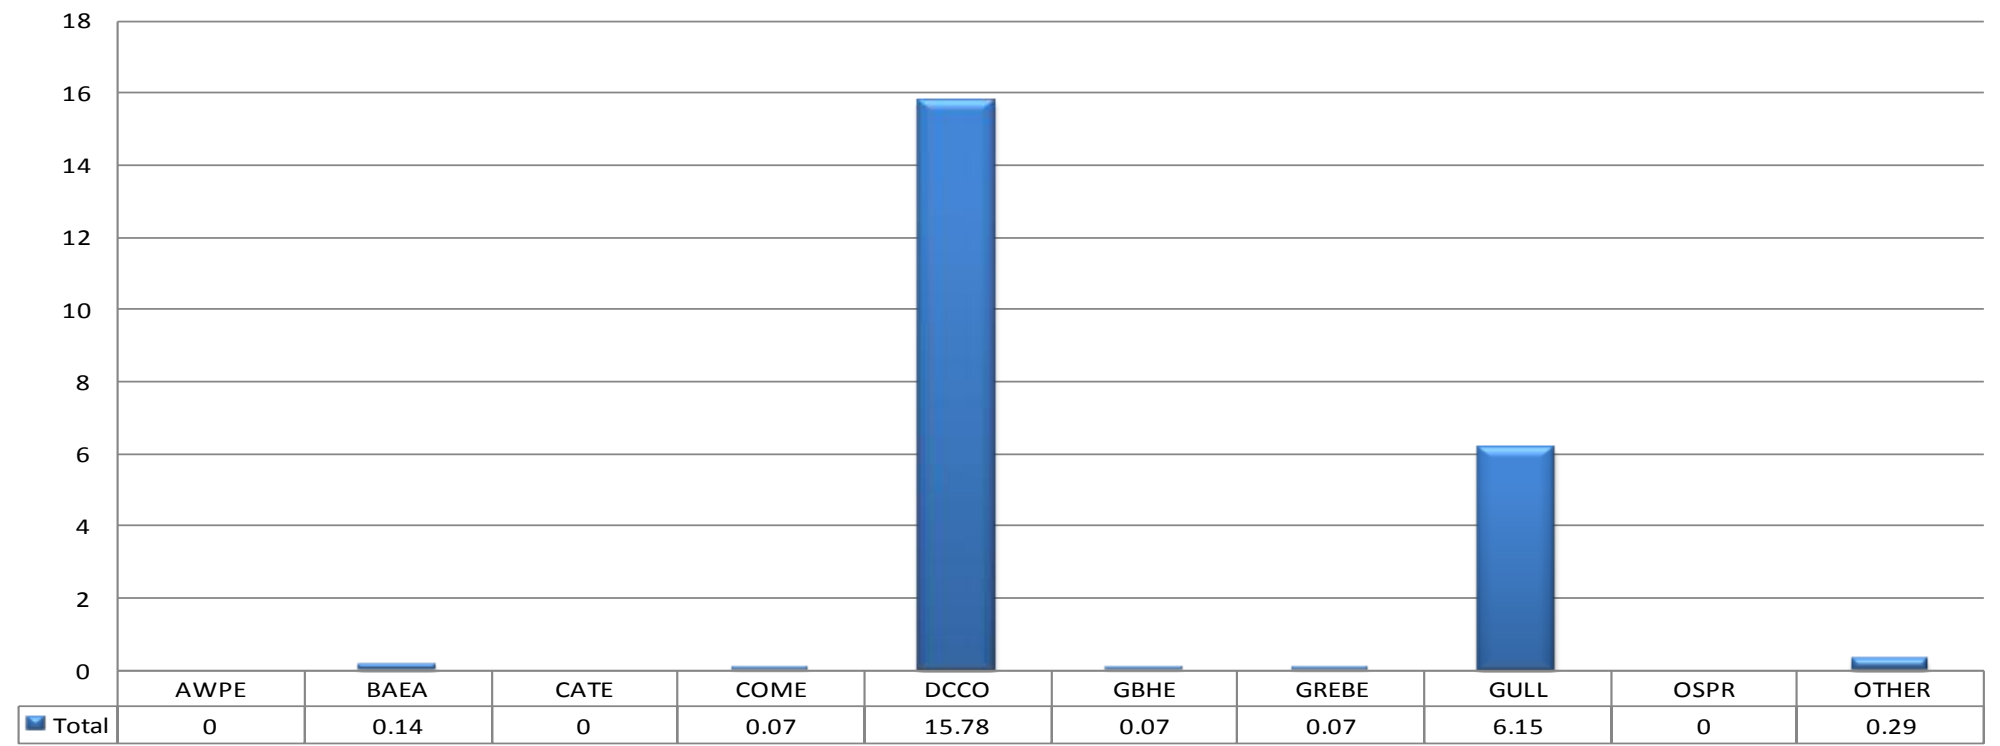
### Mean Counts by Species

GULL- any gull species, GREBE- Western or Clark's, DCCO- Double Crested Cormorant, AMWP- American White Pelican, CATE Caspian Tern  
 GBHE- Great Blue Heron, OSPR- Osprey, COME- Common Merganser, BAEA- Bald Eagle

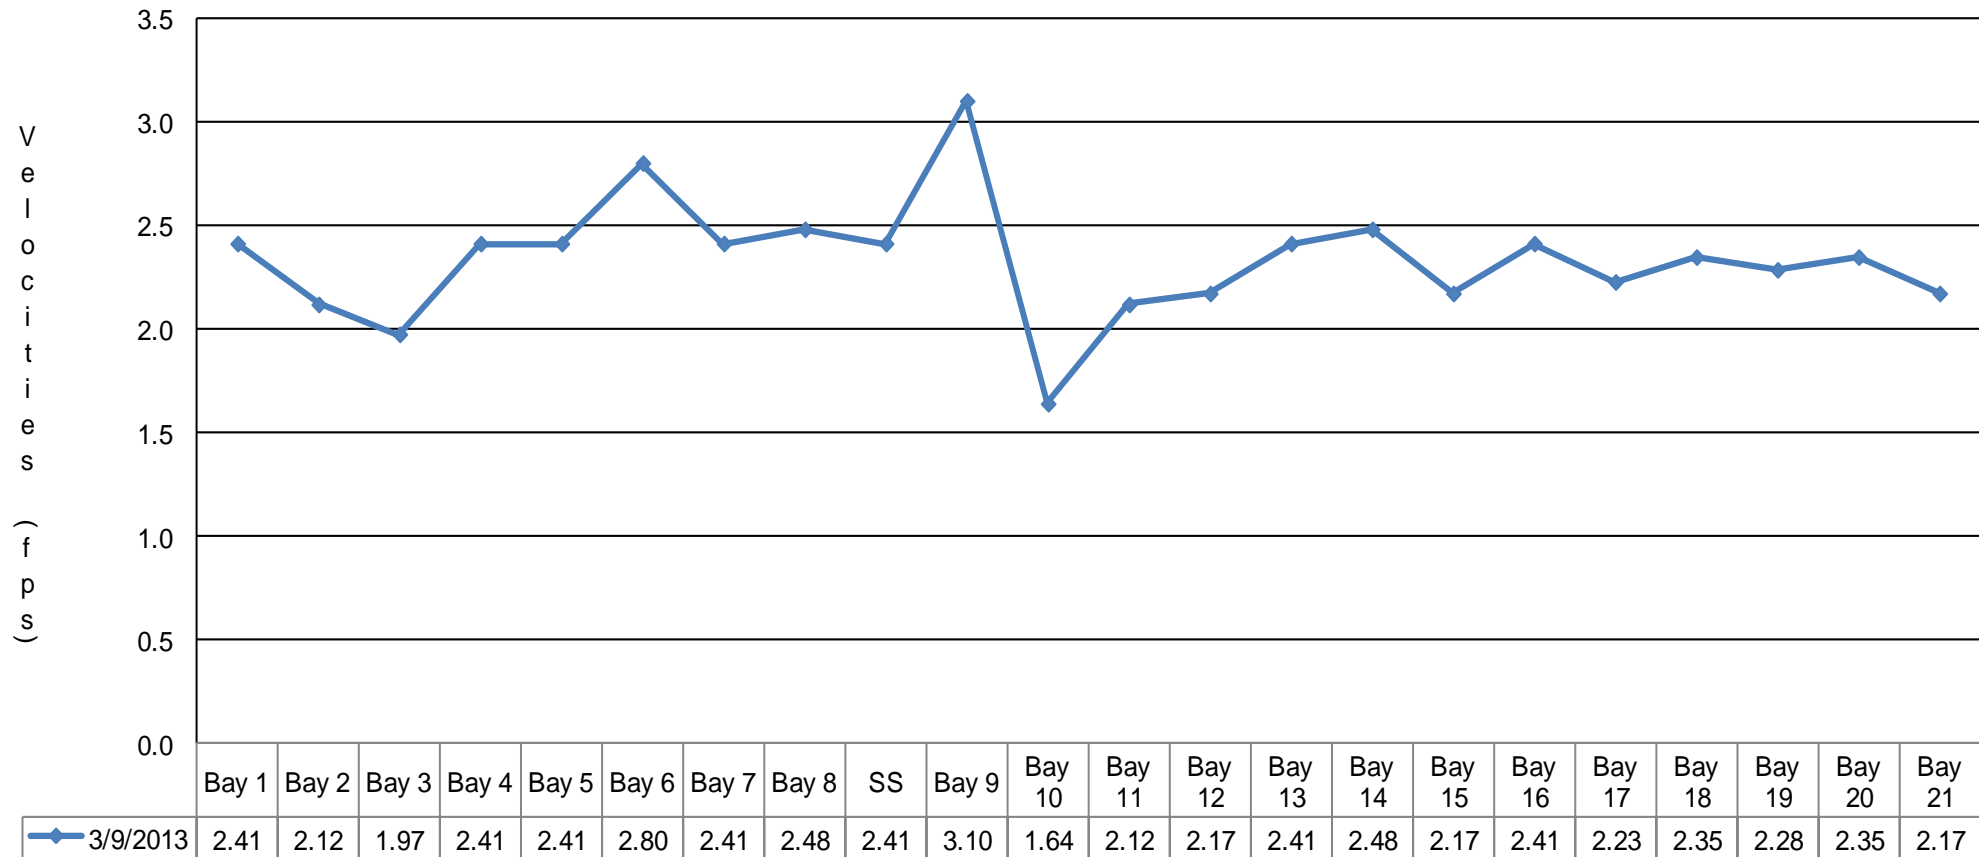
The Dalles Dam Collection Channel Velocities (fps)

Collection channel velocity	0	1.5 - 4 fps	Average	2.3		
Transportation channel velocity	0	1.5 - 4 fps	Average	2.7		
North channel velocity		1.5 - 4 fps	Average	N/A	Dewatered. Returned to service 3/11/2013	
South channel velocity	0	1.5 - 4 fps	Average	3.5		
West entrance differential	0	1.0' - 2.0'	Average	1.5		
Entrance weir W1		Closed	Bulkhead installed due to seized wheel on weir.			
Entrance weir W2	0	depth (≥ 8')	Average	8.7		
Entrance weir W3	0	depth (≥ 8')	Average	8.7		
South entrance differential	0	1.0' - 2.0'	Average	1.4		
Entrance weir S1	0	depth (≥ 8')	Average	8.2		
Entrance weir S2	0	depth (≥ 8')	Average	8.2		
<b>JUVENILE PASSAGE</b>						
Sluiceway operation	0	units 1,8,18	Gates 1-2, 1-3, 17-1 and 17-2 open as per Fish Passage Plan. Main Unit 18 out of service.			
Turbine trashrack drawdown		<1.5', wkly				
Spill volume		40%, 24hr	On seal.			
Spill Pattern		per FPP	On seal.			
Turbine Unit Priority		per FPP	Starts April 1
