FISHWAY STATUS REPORT

Date: 6/3/2013
 Inspection Period: 5/26 to 6/1/2013

THE DALLES DAM

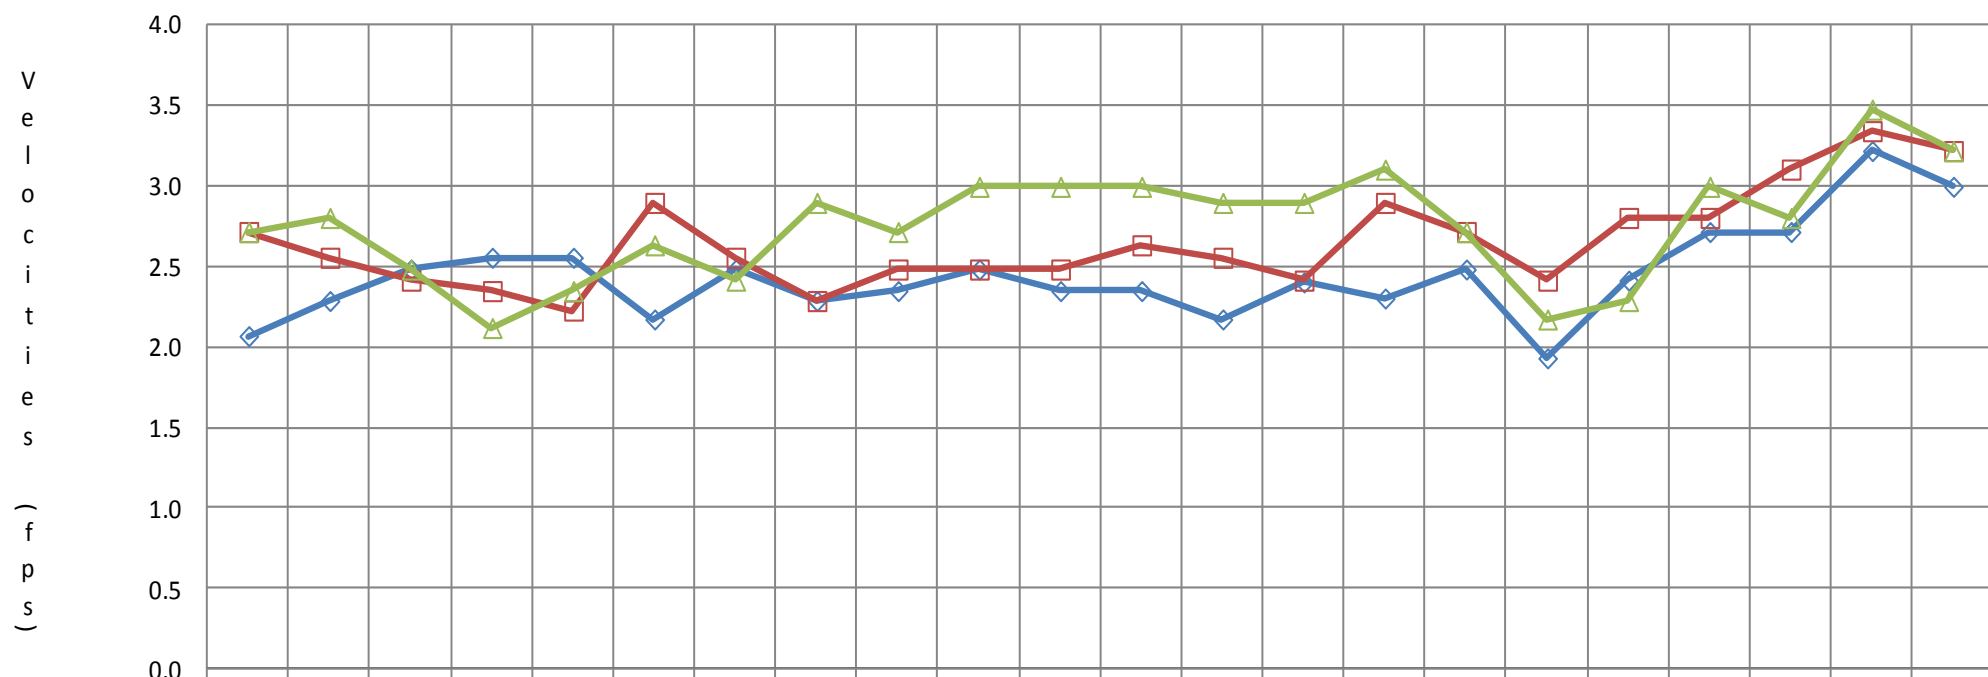
The Dalles Dam Collection Channel Velocities (fps)

Bay 1	Bay 2	Bay 3	Bay 4	Bay 5	Bay 6	Bay 7	Bay 8	SS	Bay 9	Bay 10	Bay 11	Bay 12	Bay 13	Bay 14	Bay 15	Bay 16	Bay 17	Bay 18	Bay 19	Bay 20	Bay 21
5/14/2013	2.1	2.3	2.5	2.6	2.6	2.2	2.5	2.3	2.3	2.5	2.3	2.3	2.2	2.4	2.3	2.5	1.9	2.4	2.7	2.7	3.2	3.0
5/22/2013	2.71	2.55	2.41	2.35	2.23	2.89	2.55	2.28	2.48	2.48	2.48	2.63	2.55	2.41	2.89	2.71	2.41	2.80	2.80	3.10	3.34	3.21
5/31/2013	2.71	2.80	2.48	2.12	2.35	2.63	2.41	2.89	2.71	2.99	2.99	2.99	2.89	2.89	3.10	2.71	2.17	2.28	2.99	2.80	3.47	3.21

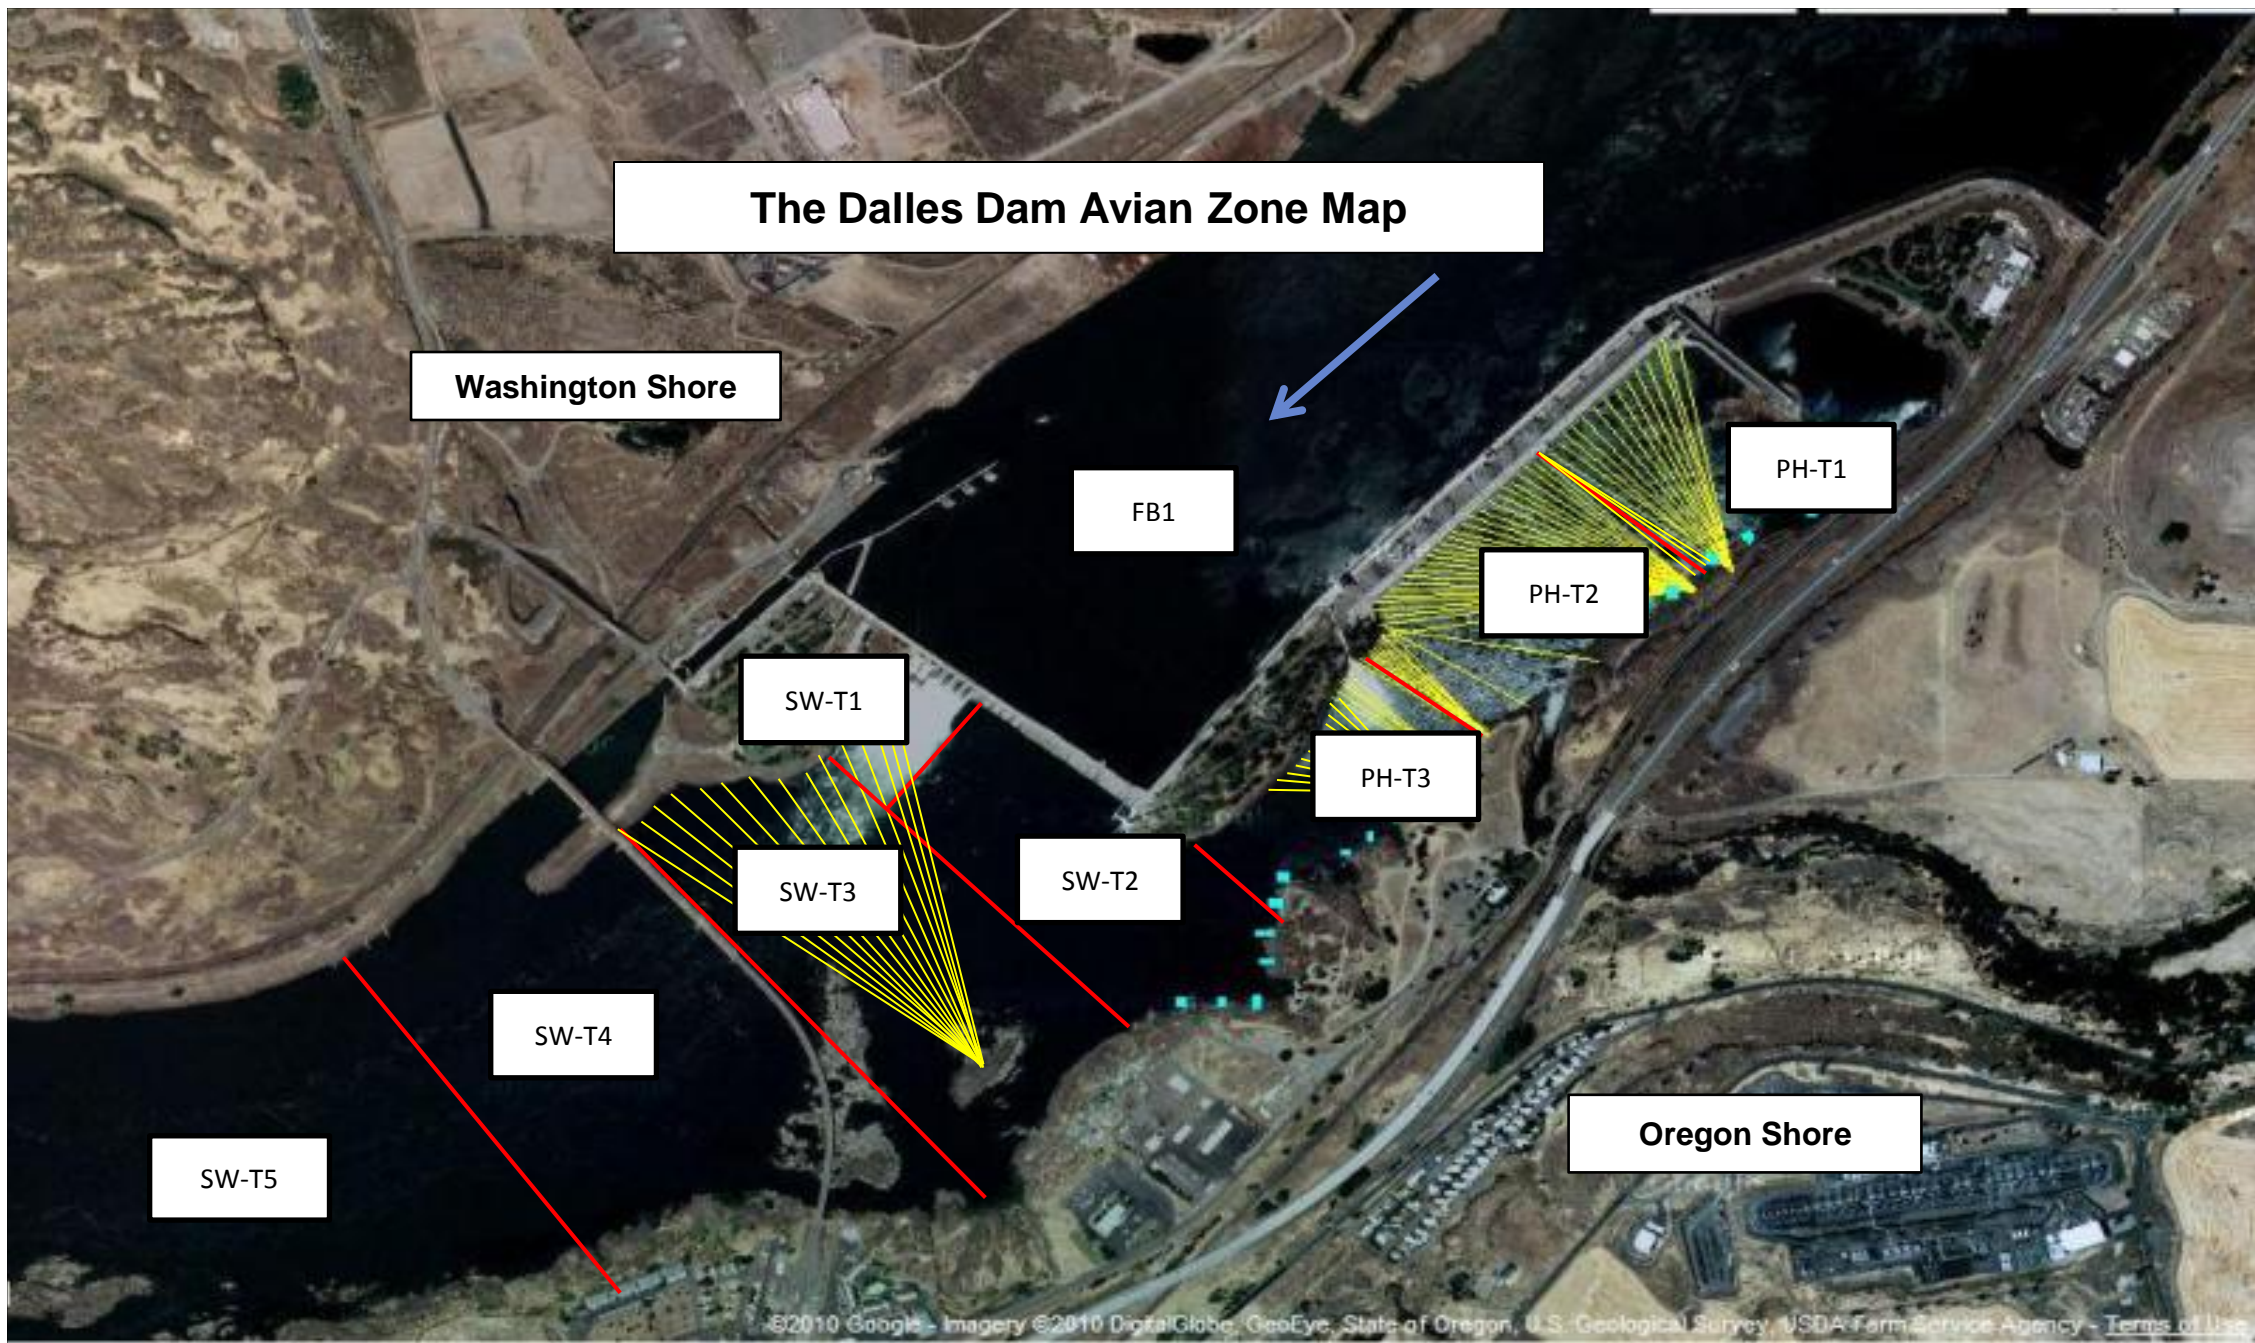
The Dalles Dam Avian Zone Map

Bird observation data collected twice daily. Primarily gulls, upstream and downstream of the bridge. Refer to map for details. There were no sea lion sightings this week.

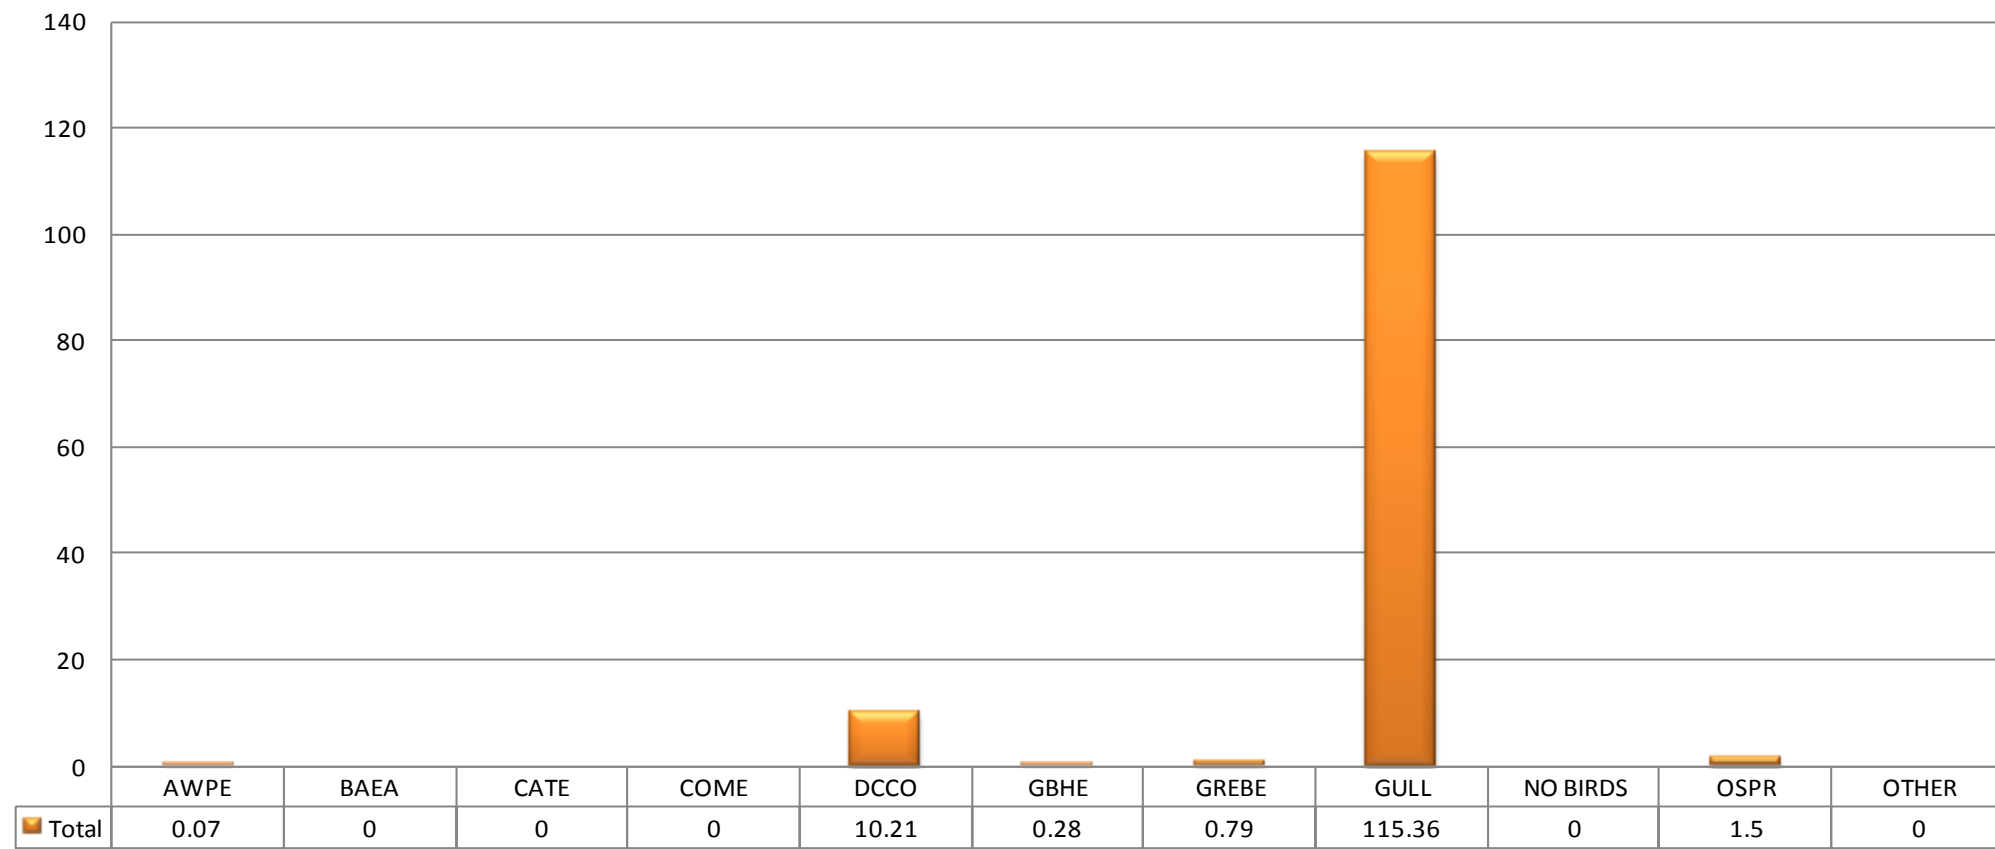
Mean Avian Counts by Species

AWPE - American White Pelican; BAEA - Bald Eagle; CATE - Caspian Tern; COME - Common Merganser; DCCO - double crested cormorant; GBHE - Great Blue Heron; GREBE - Grebe; Gull- Gull (all species); OSPR - Osprey

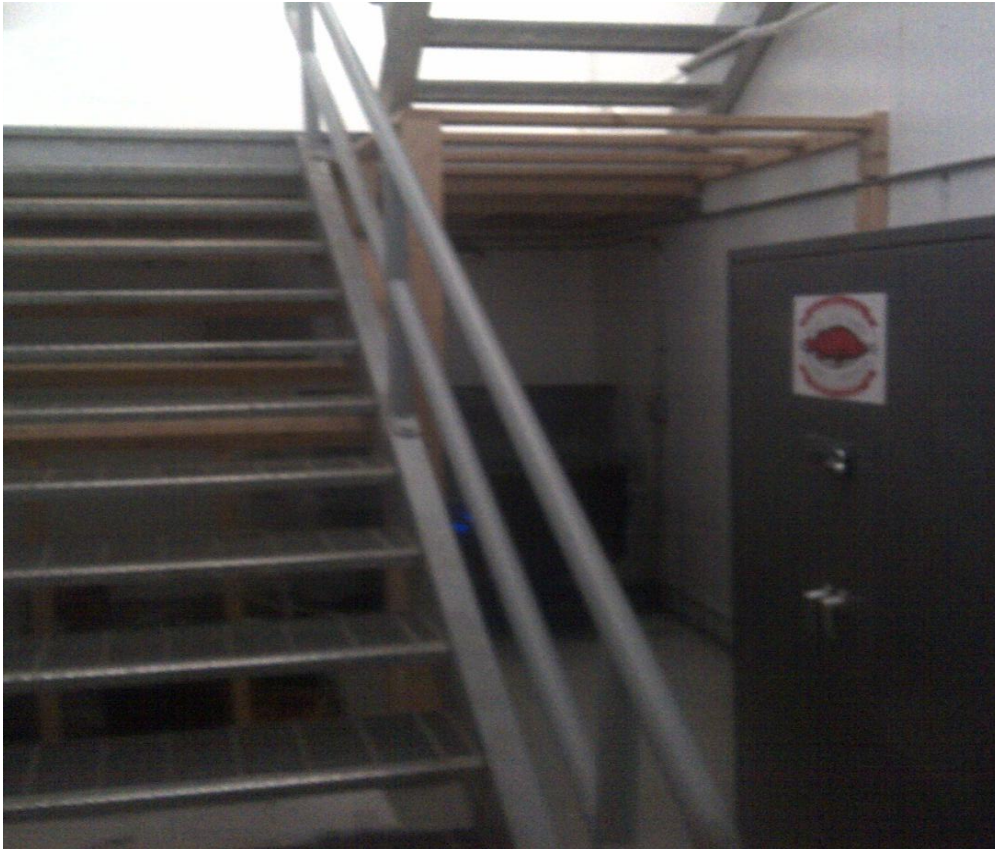
Project resource maintenance starting installation of enclosure to protect north count station PIT antenna equipment.

PIT - Temporary Thin Wall PIT tag Antenna continues to work successfully. Plans to replace all aluminum paneling over north count station to correct the noticeable minor interference. Walls being constructed by Natural Resources around north PIT computer room to protect equipment.
