FISHWAY STATUS REPORT

Date: 6/16/2013
 Inspection Period: 6/9 to 6/15/2013

THE DALLES DAM

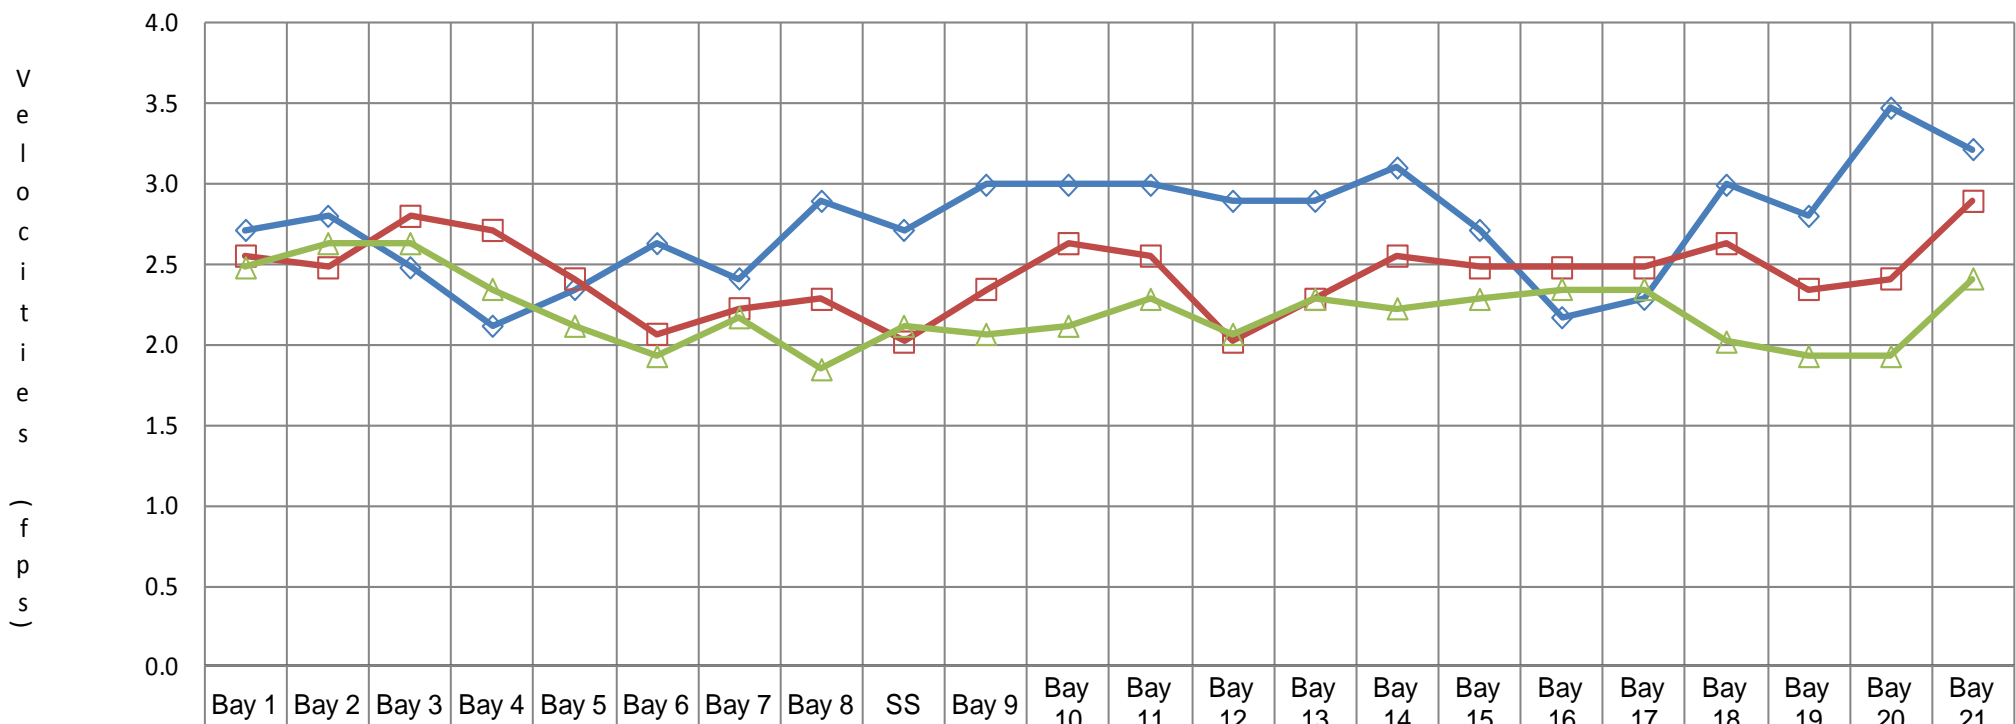
The Dalles Dam Collection Channel Velocities (fps)

Bay 1	Bay 2	Bay 3	Bay 4	Bay 5	Bay 6	Bay 7	Bay 8	SS	Bay 9	Bay 10	Bay 11	Bay 12	Bay 13	Bay 14	Bay 15	Bay 16	Bay 17	Bay 18	Bay 19	Bay 20	Bay 21
5/31/2013	2.7	2.8	2.5	2.1	2.3	2.6	2.4	2.9	2.7	3.0	3.0	3.0	2.9	2.9	3.1	2.7	2.2	2.3	3.0	2.8	3.5	3.2
6/6/2013	2.6	2.5	2.8	2.7	2.4	2.1	2.2	2.3	2.0	2.3	2.6	2.6	2.0	2.3	2.6	2.5	2.5	2.5	2.6	2.3	2.4	2.9
6/11/2013	2.5	2.6	2.6	2.3	2.1	1.9	2.2	1.8	2.1	2.1	2.1	2.3	2.1	2.3	2.2	2.3	2.3	2.3	2.0	1.9	1.9	2.4

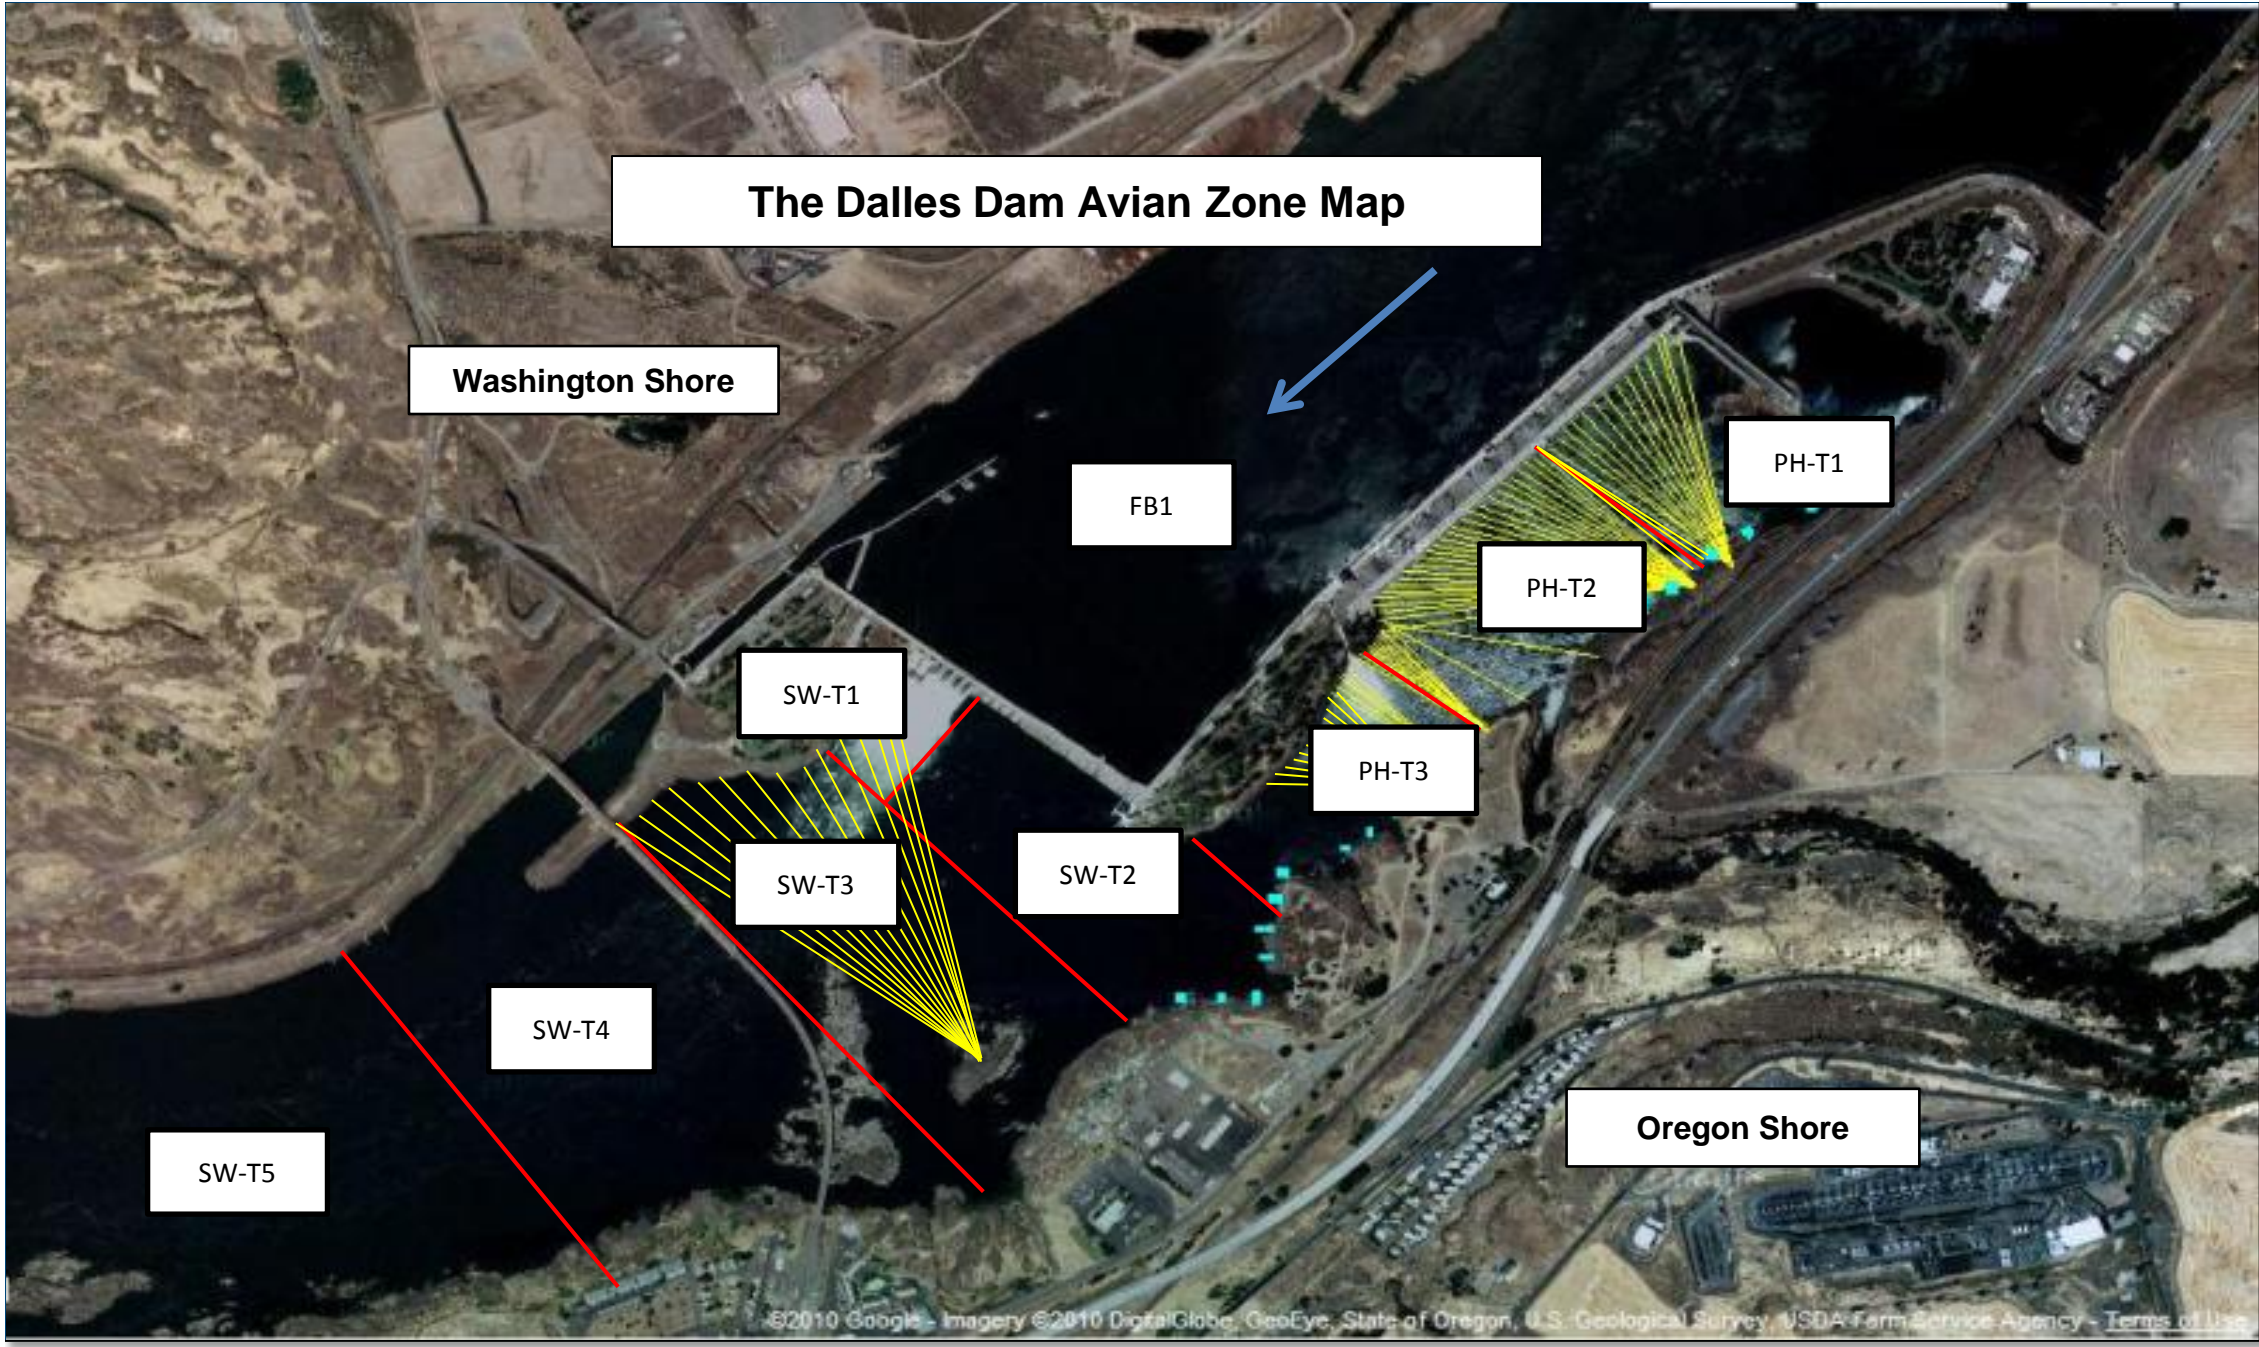
The Dalles Dam Avian Zone Map

Bird observation data collected twice daily. The majority of the foraging piscivorous birds are gulls, upstream and downstream of the bridge, See avian zones map and distribution tabs. There were no sea lion sightings this week.

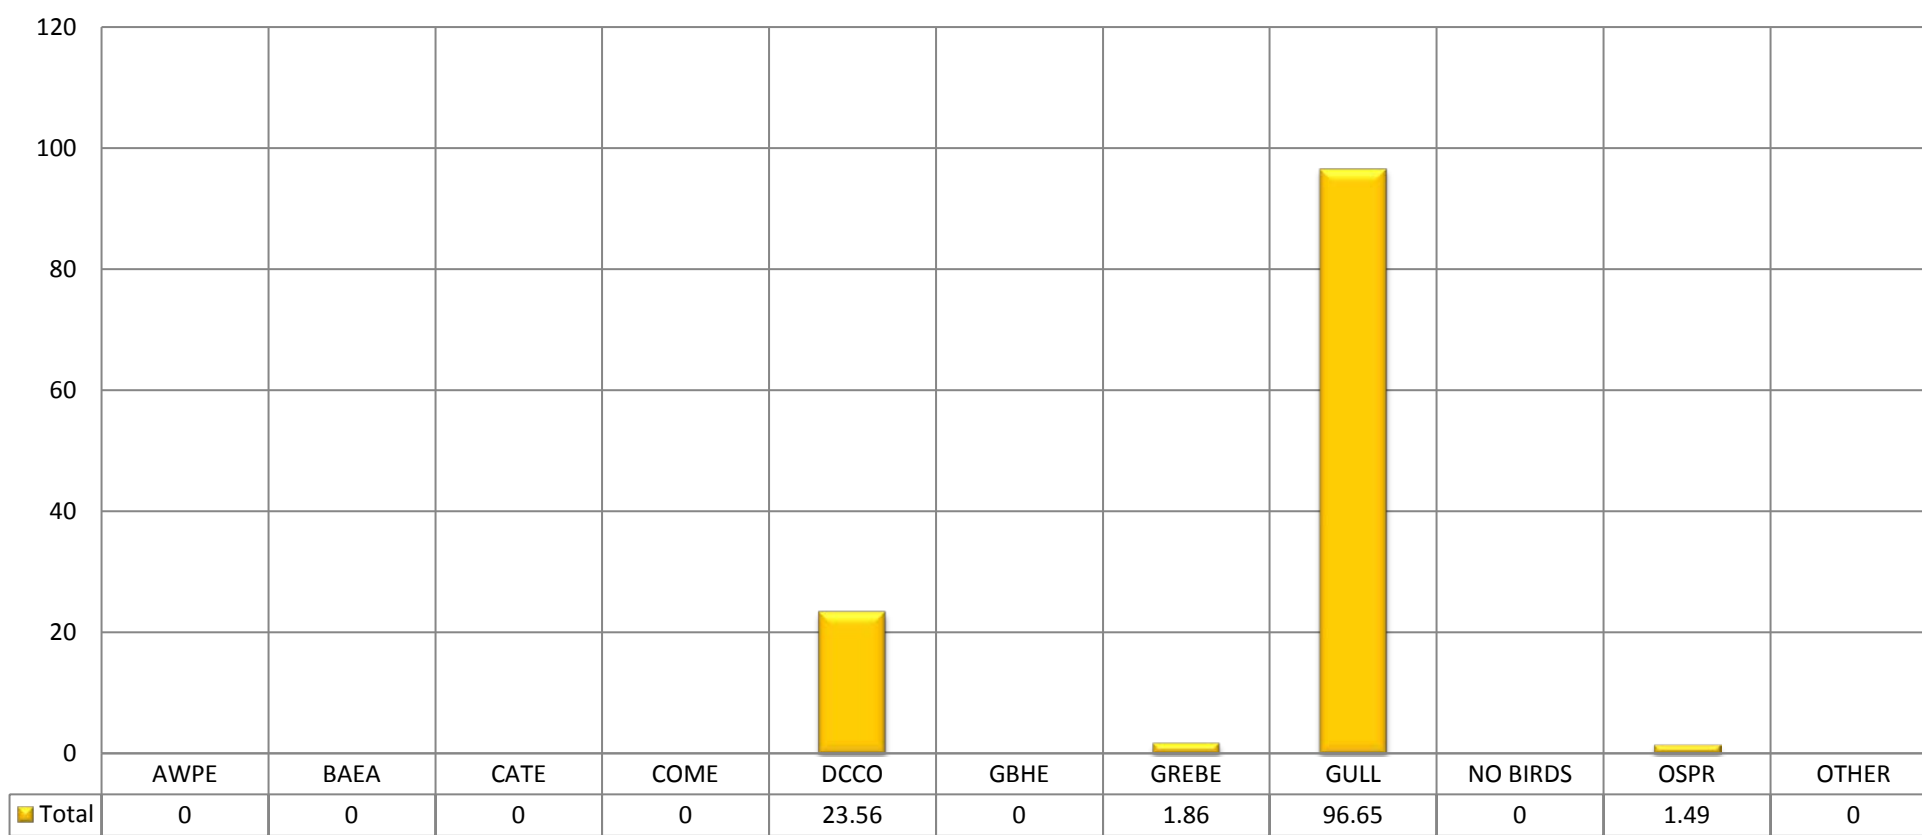
Mean Avian Counts by Species

AWPE - American White Pelican; BAEA - Bald Eagle; CATE - Caspian Tern; COME - Common Merganser; DCCO - double crested cormorant; GBHE - Great Blue Heron; GREBE - Grebe; Gull- Gull (all species); OSPR - Osprey

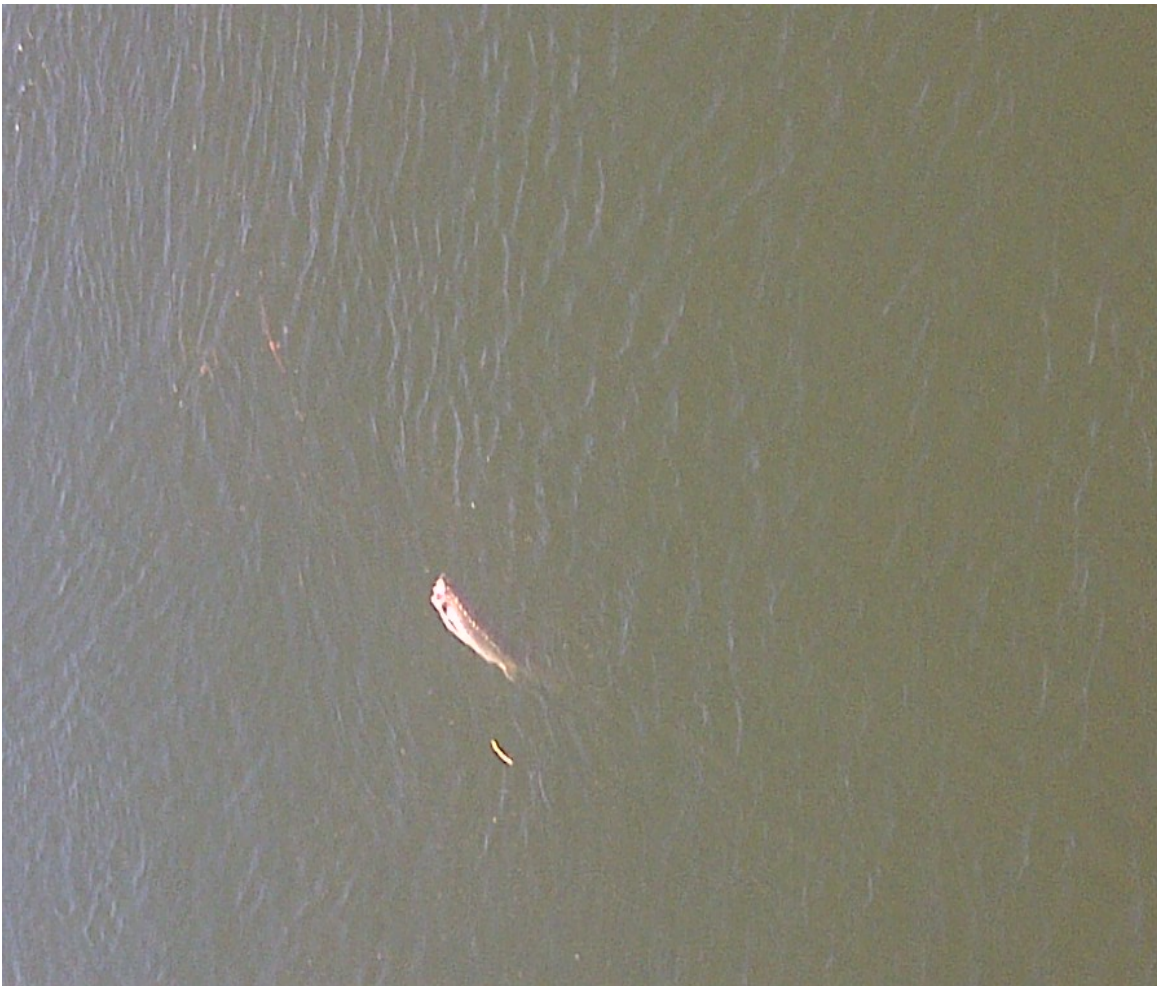
Decapitated sturgeon (~5') observed in tailrace below unit 15 (Pic tab). Likely not sea lion leftovers due to condition of body. Investigation continues.

Decapitated sturgeon observed in tailrace below turbine unit 15.
Investigation and further observations will continue.
