# FISHWAY STATUS REPORT

Date: 7/7/2013  
 Inspection Period: 6/30 to 7/6/2013

## THE DALLES DAM

**US Army Corps  
 of Engineers**  
 Portland District

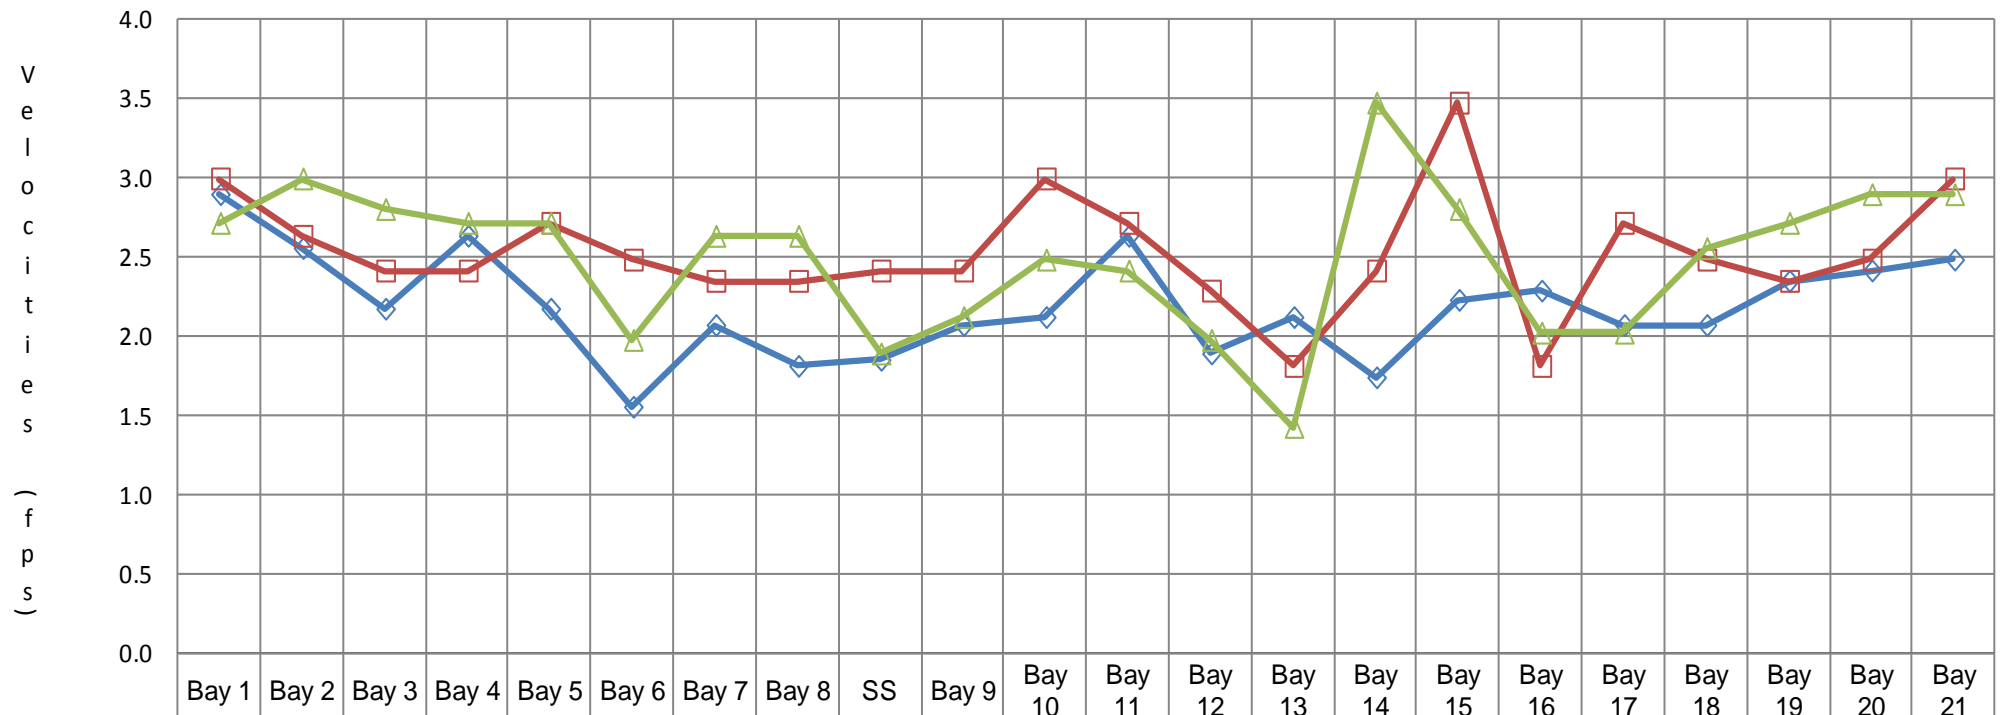
### The Dalles Dam Collection Channel Velocities (fps)

6/19/13	2.9	2.6	2.2	2.6	2.2	1.6	2.1	1.8	1.8	2.1	2.1	2.6	1.9	2.1	1.7	2.2	2.3	2.1	2.1	2.3	2.4	2.5
6/28/13	3.0	2.6	2.4	2.4	2.7	2.5	2.3	2.3	2.4	2.4	3.0	2.7	2.3	1.8	2.4	3.5	1.8	2.7	2.5	2.3	2.5	3.0
7/2/13	2.7	3.0	2.8	2.7	2.7	2.0	2.6	2.6	1.9	2.1	2.5	2.4	2.0	1.4	3.5	2.8	2.0	2.0	2.6	2.7	2.9	2.9

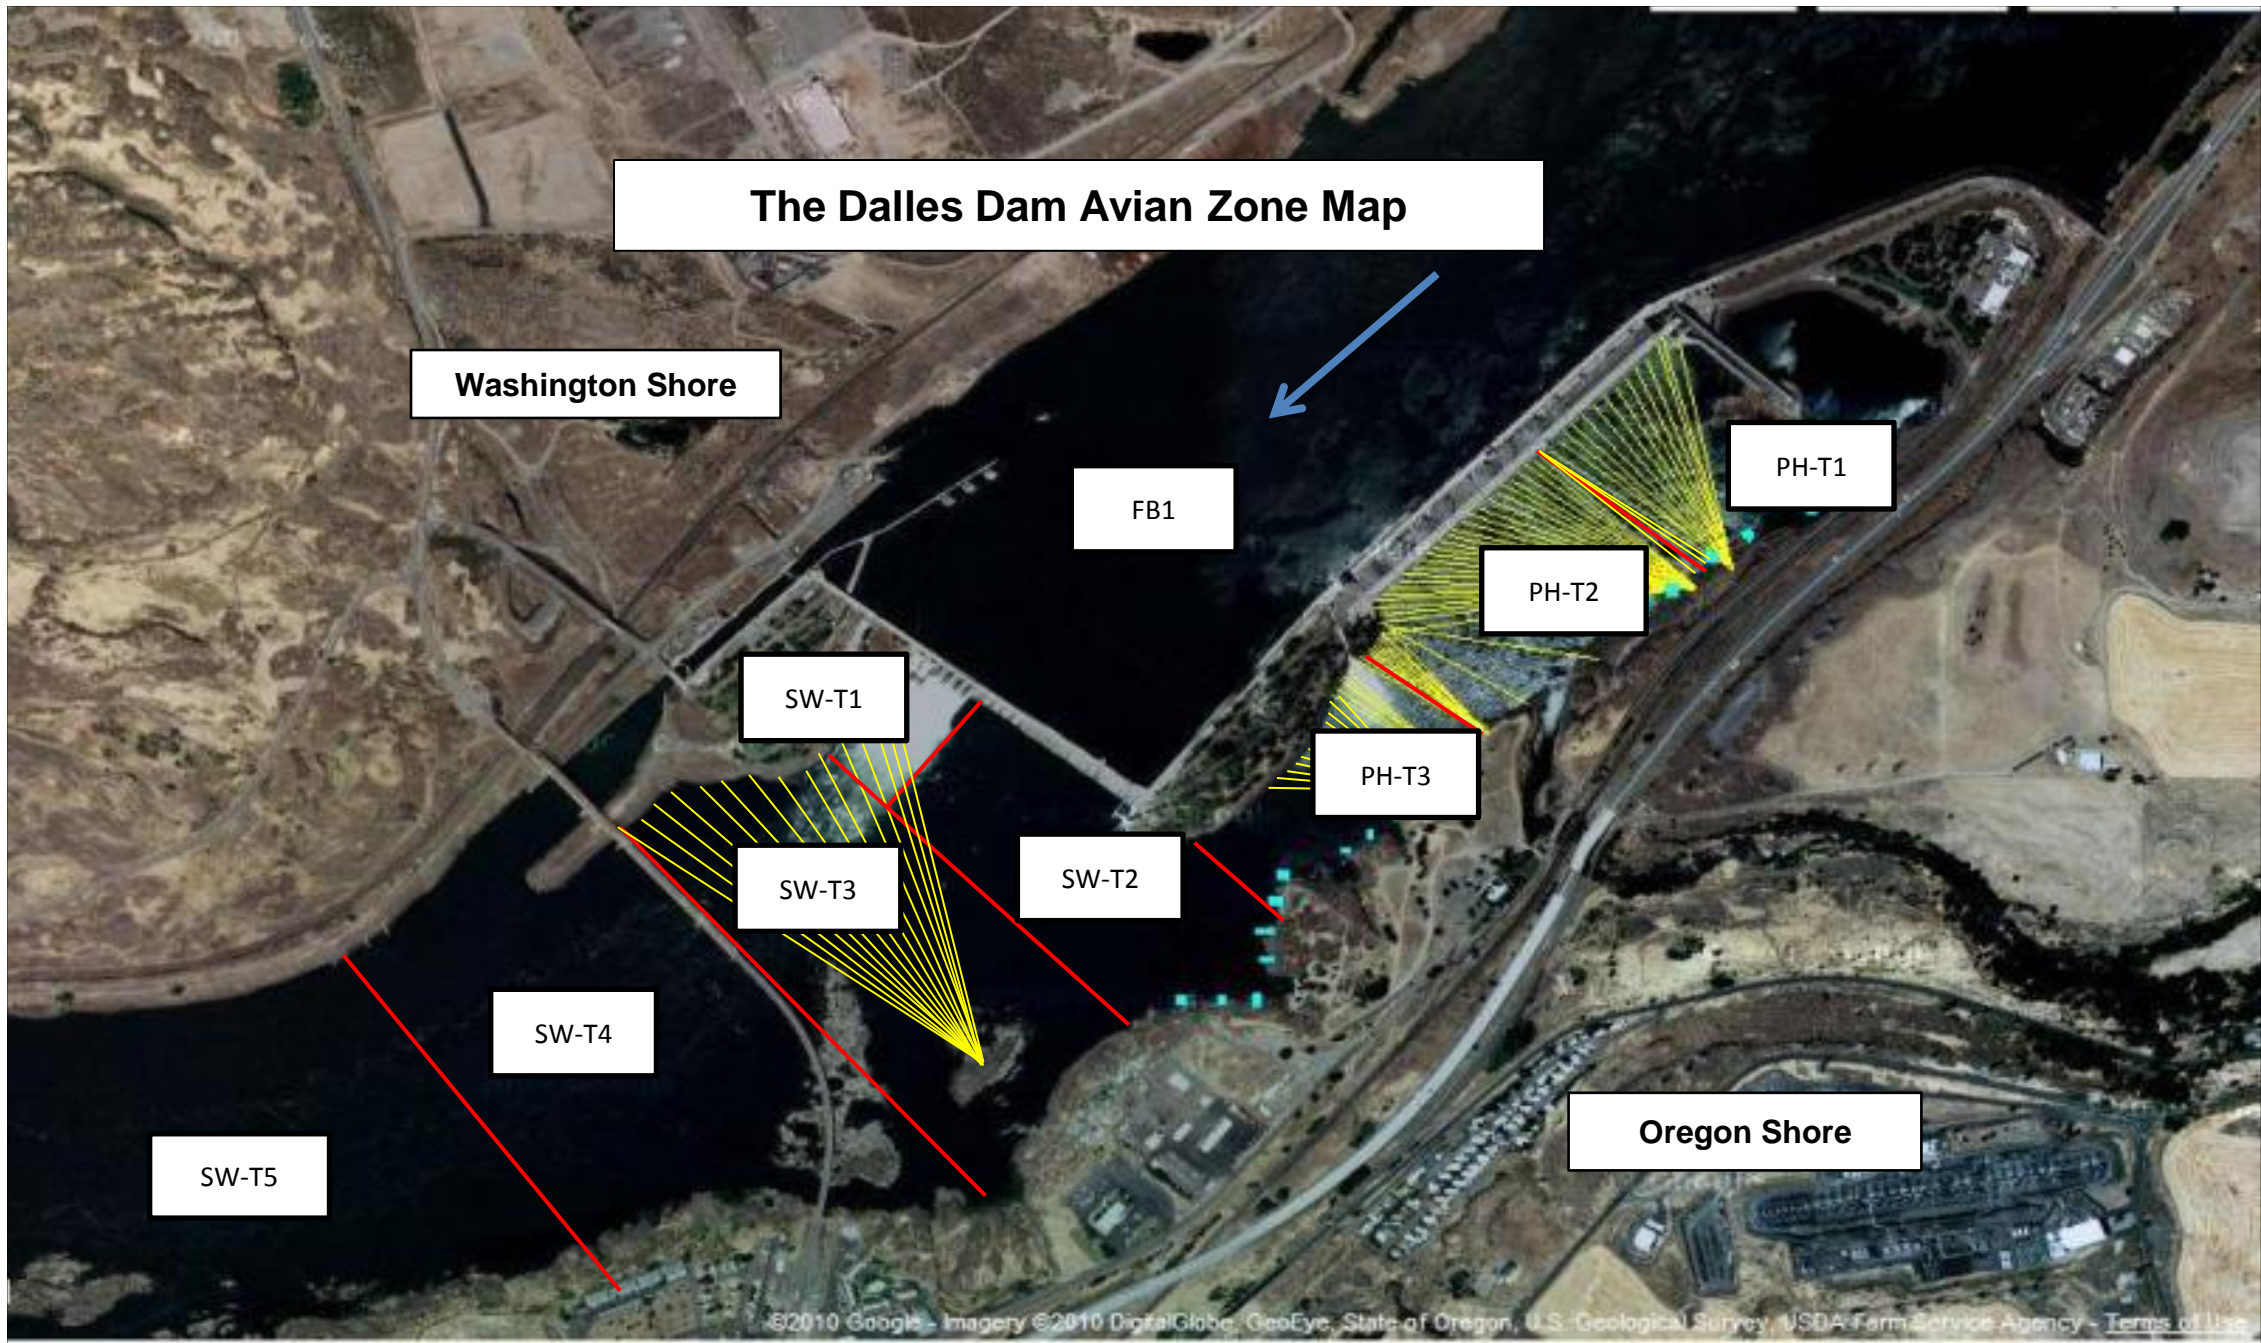
# The Dalles Dam Avian Zone Map

Bird observation data collected twice daily. The majority of the foraging piscivorous birds are gulls, upstream and downstream of the bridge, See avian zones map and distribution tabs. There were no sea lion sightings this week.

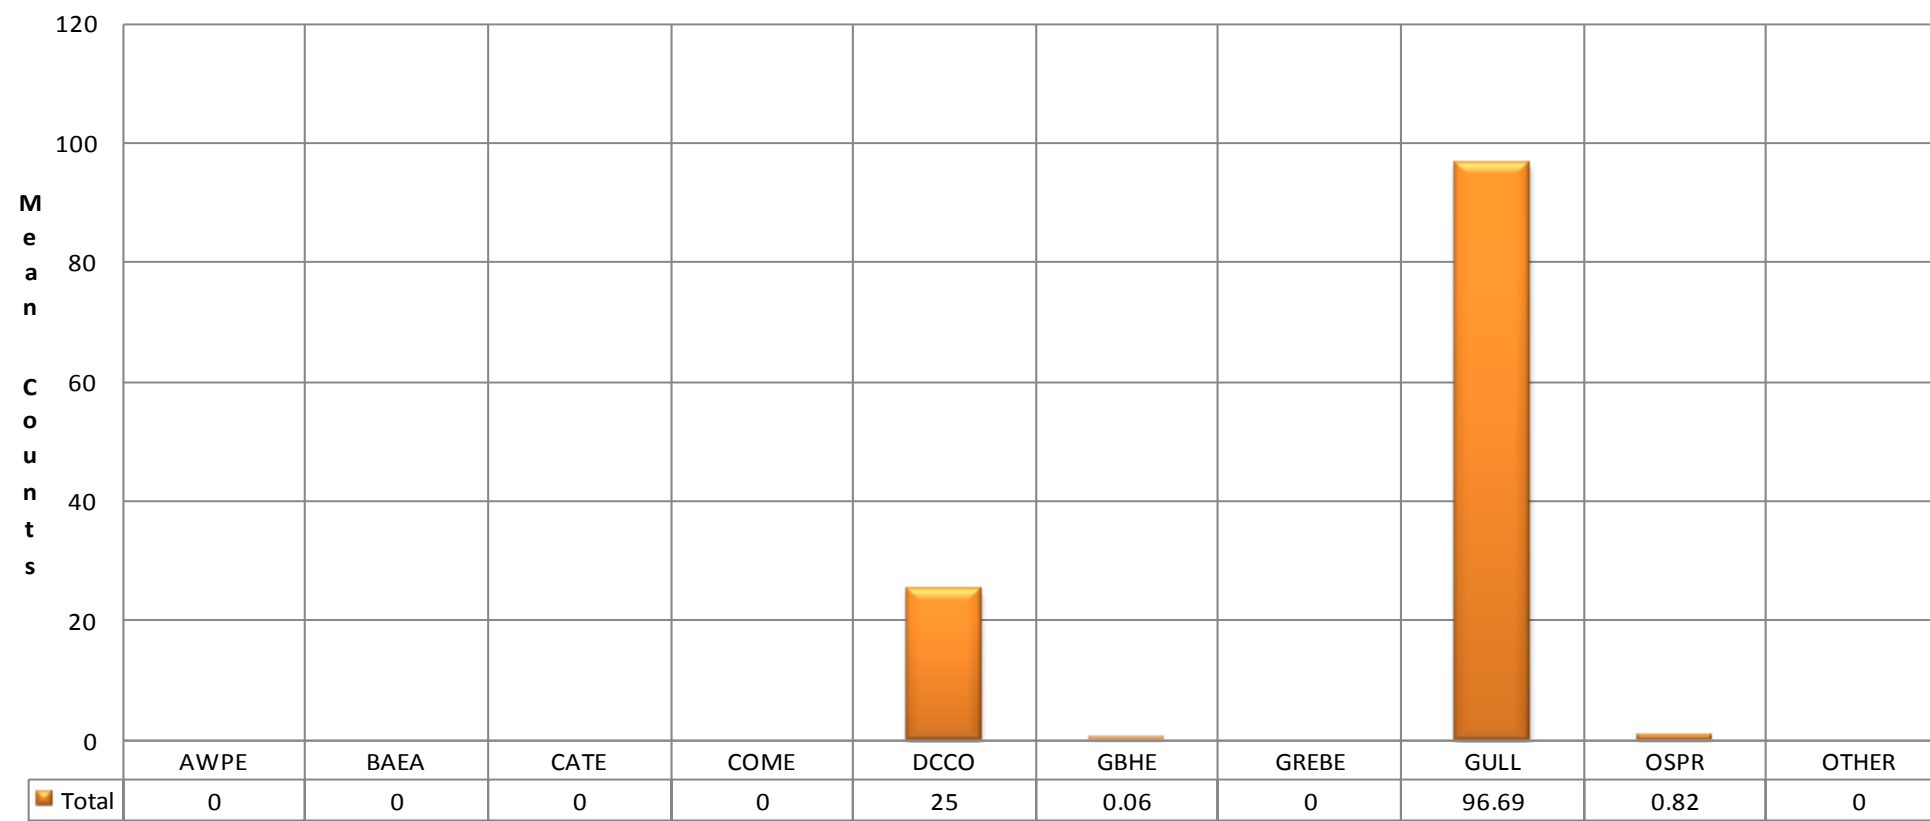
### Avian Mean Counts by Species

AWPE - American White Pelican; BAEA - Bald Eagle; CATE - Caspian Tern; COME - Common Merganser; DCCO - double crested cormorant; GBHE - Great Blue Heron; GREBE - Grebe; Gull- Gull (all species); OSPR - Osprey

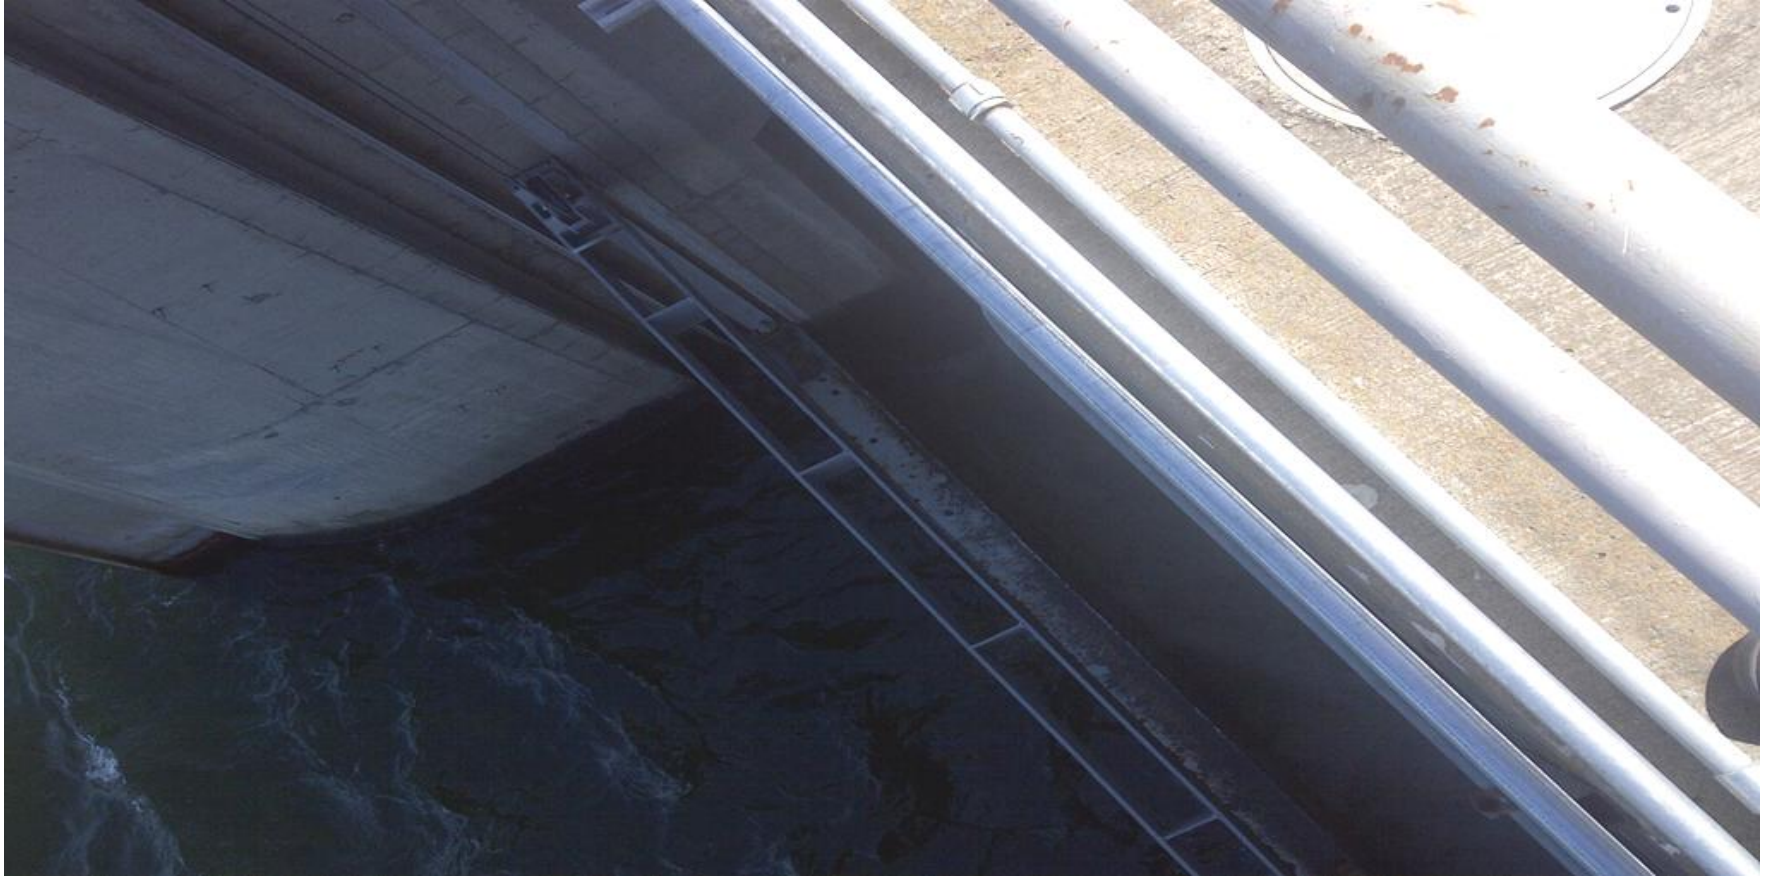
New lift beam with recessed bars installed at sluiceways 1-2 and 1-3.

New lift beams installed on sluiceway 1-2 and 1-3 providing a recessed bar for less passage interference.
