# The Dalles Dam Fishway Status Report

**Date:** 9/23/2013  
**Inspection Period:** 9/15 to 9/21/2013

## THE DALLES DAM

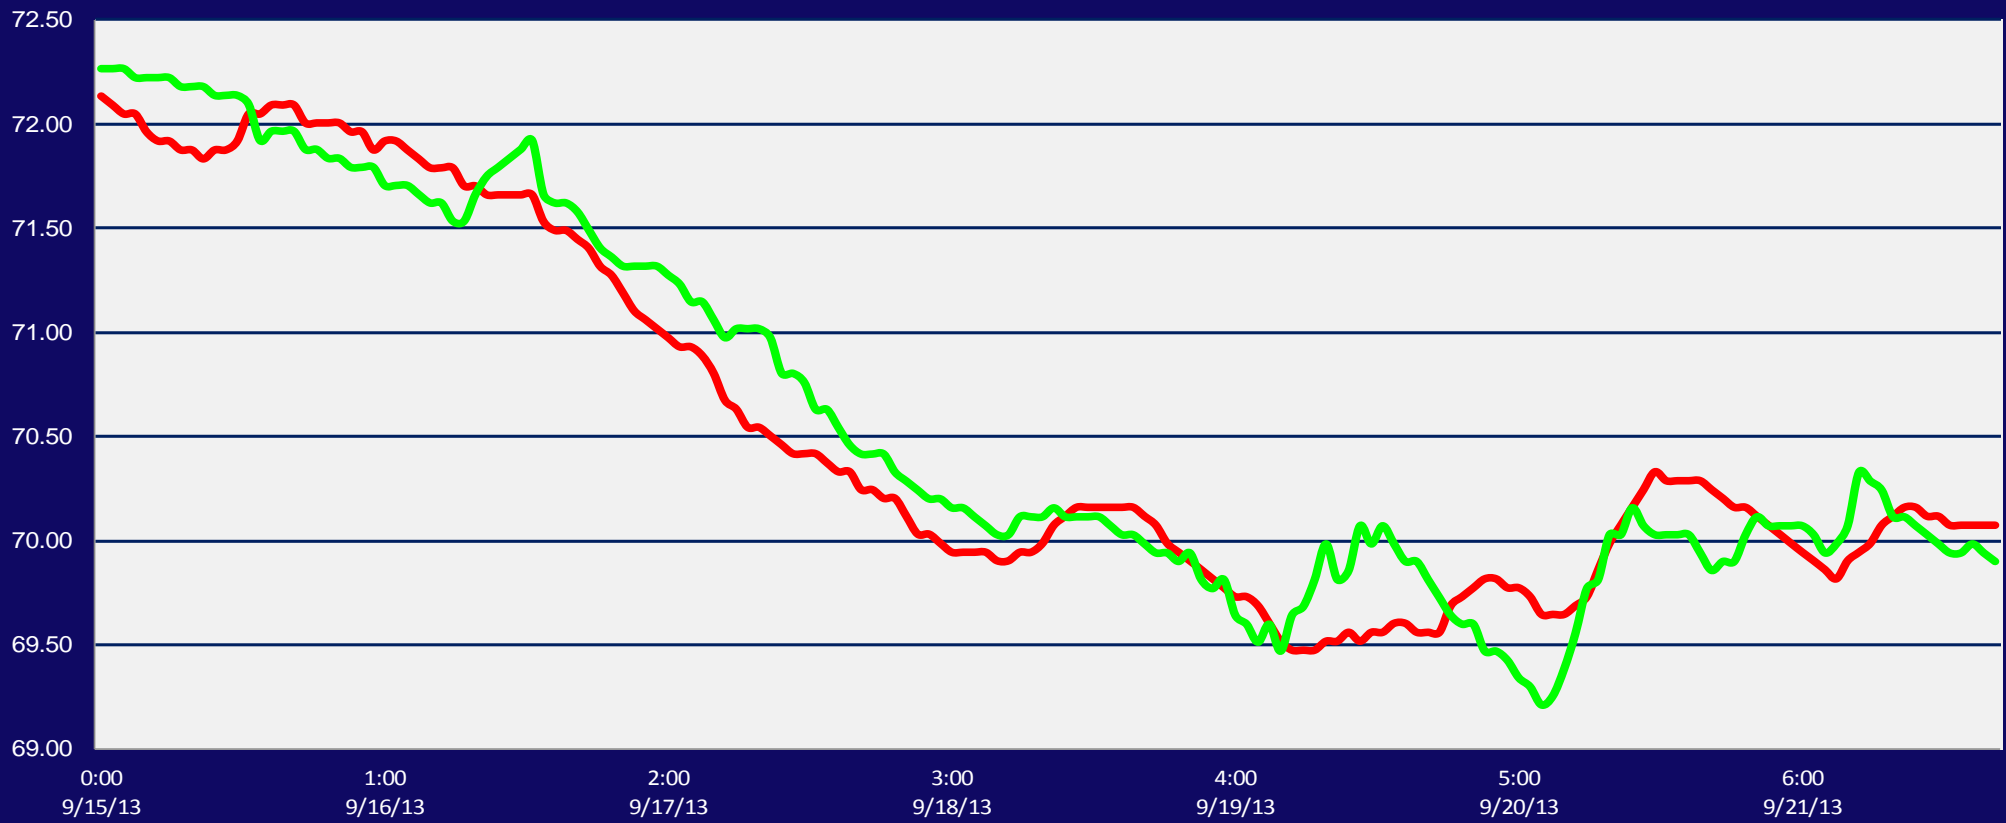
# The Dalles Dam Adult Fish Ladder River/Water Temperatures

East Ladder

North Ladder

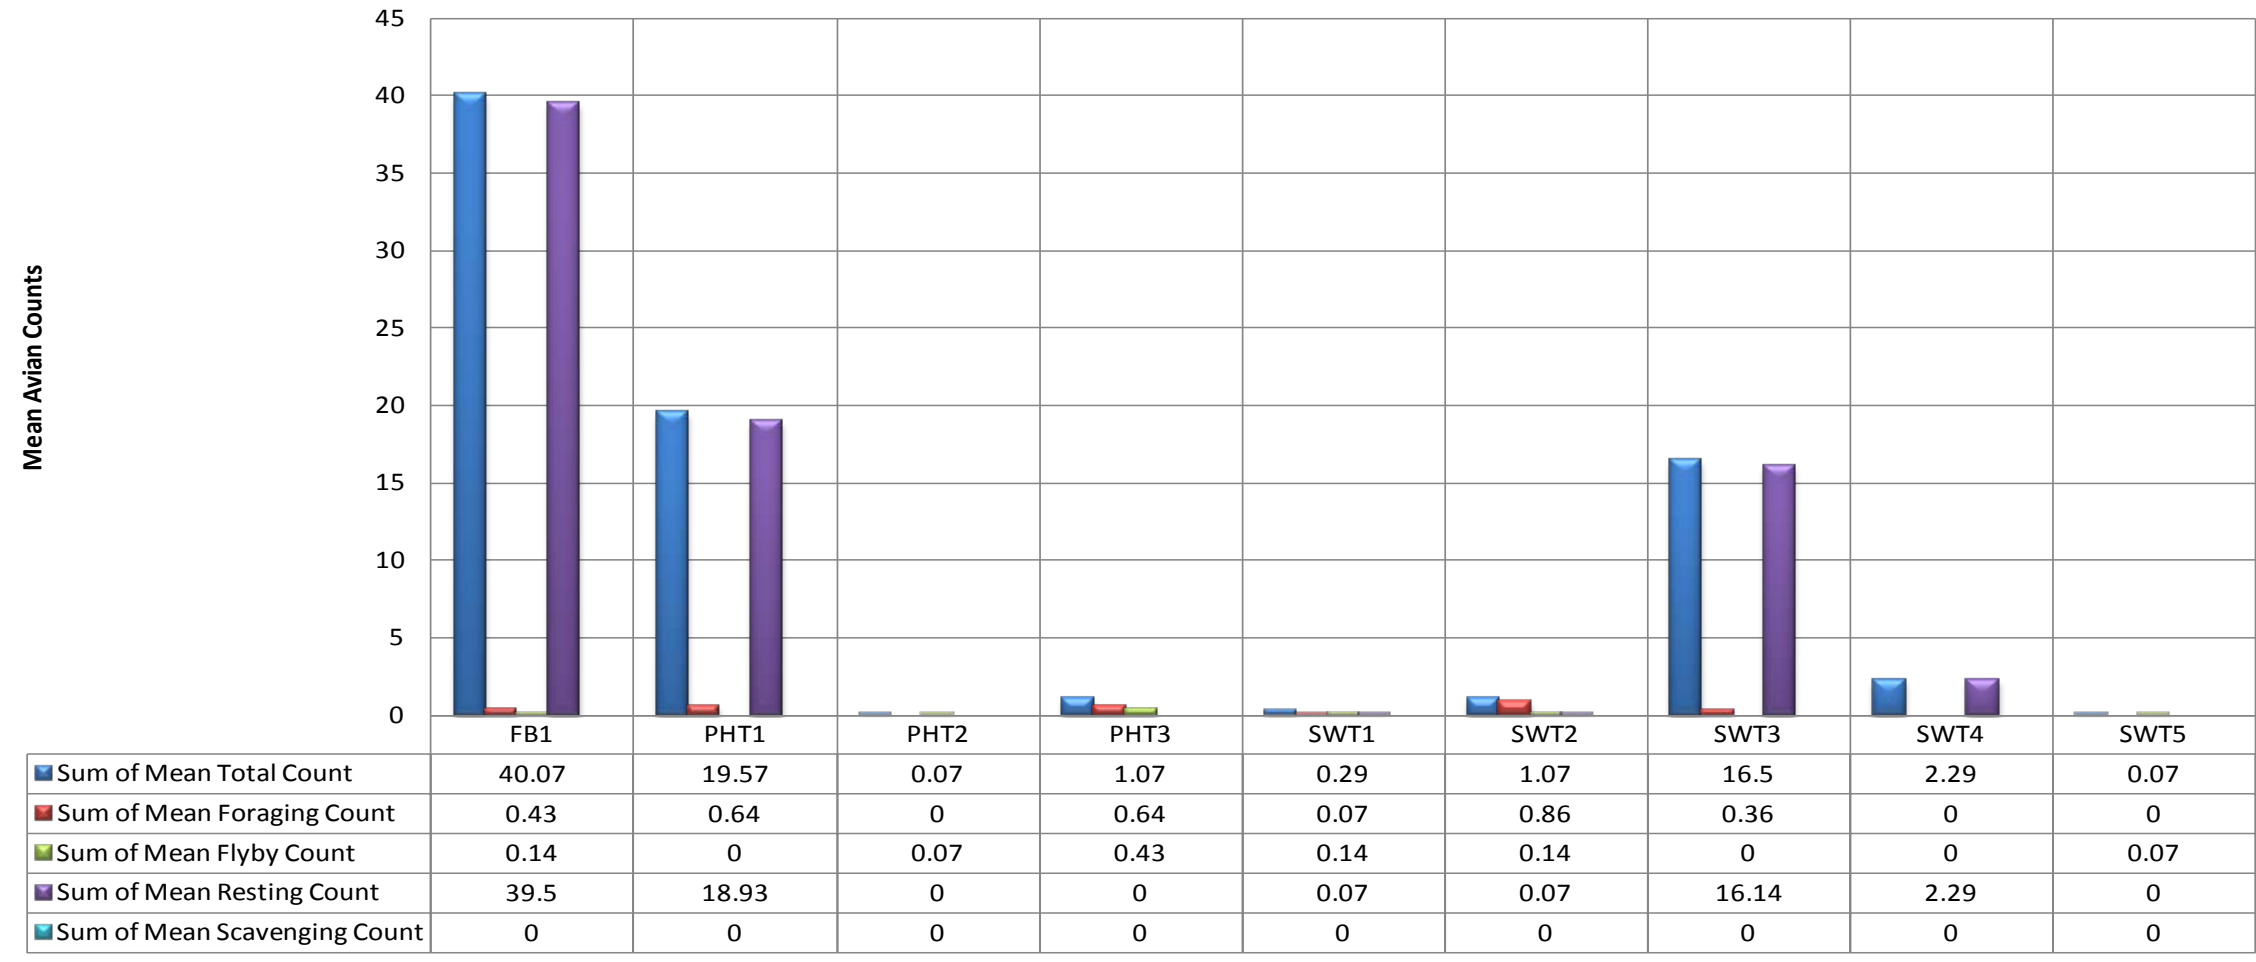
### Mean Avian Counts by Behavior

AWPE - American White Pelican; BAEA - Bald Eagle; CATE - Caspian Tern; COME - Common Merganser; DCCO - double crested cormorant; GBHE - Great Blue Heron; GREBE - Grebe; Gull- Gull (all species); OSPR - Osprey

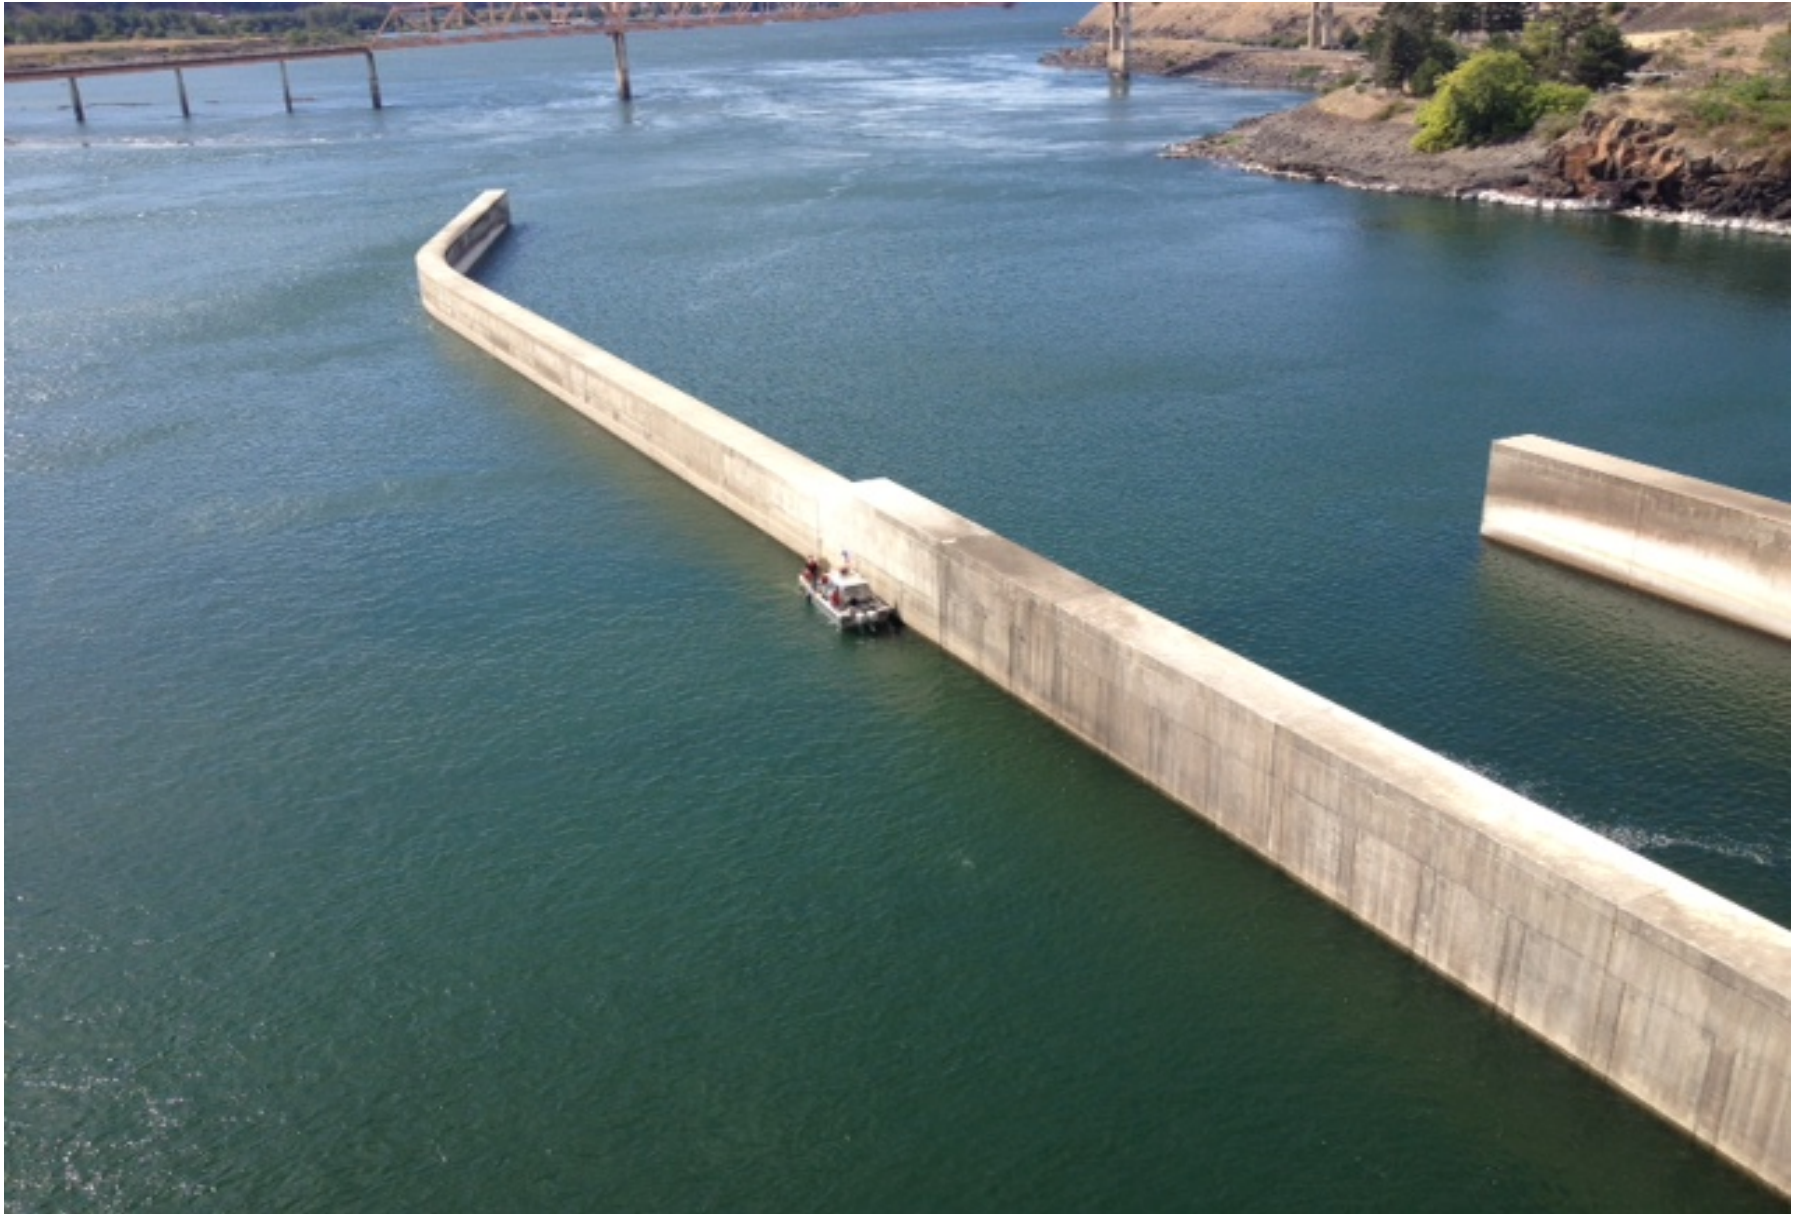
Dive inspection of spillwall to check for erosion.

Spillway out of service 0728 hrs. 9/17 for dive inspection of spillwall. Diving was done during day light hours and returned to service 1700 hrs. 9/18.
