### UPDATE ON FOSTER DOWNSTREAM PASSAGE IMPROVEMENTS (FISH WEIR)

Fenton Khan Fish Biologist Portland District February 12, 2020

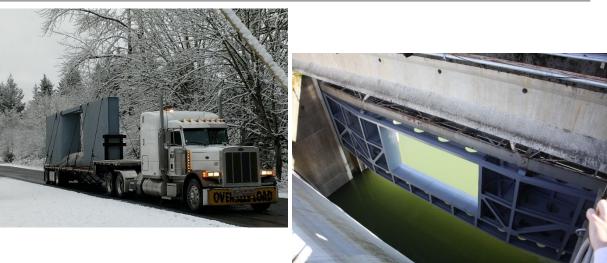
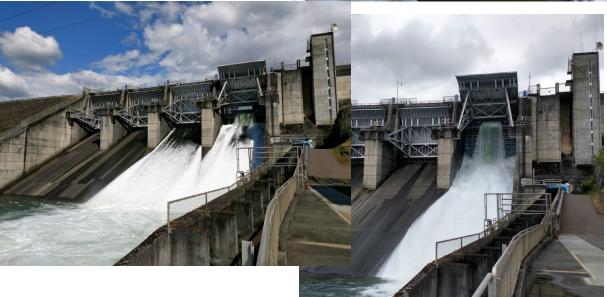
- The new fish weir was installed March 2018
- Commenced post construction evaluation
- Results from the studies indicate:
- Significant improvement in collection (attraction and passage) – we are passing more fish!
- A high rate of injury on the spillway
  - Impact of weir jet hitting spillway surface; however, improved compared to the old weir.
  - Fish tumbled/slid down the surface, leading to abrasion type injuries.
- Similar or lower overall survival compared to the old weir
- The engineering team (PDT) is working on design improvements

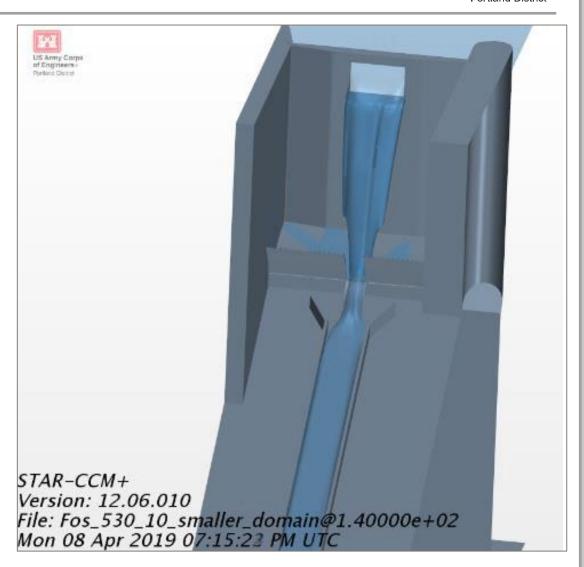
- The PDT brainstormed alternatives
- Dam safety requirements spill bay must be returned to regular spill during high water events or as needed
- The solution under evaluation:
- Create a landing pool, or jet redirection, at the bottom of the weir jet with bottom-hinged crest weirs
- Create a channel down the spillway to maintain deeper water to prevent fish from tumbling down
- Ongoing hydraulic modeling to inform the design

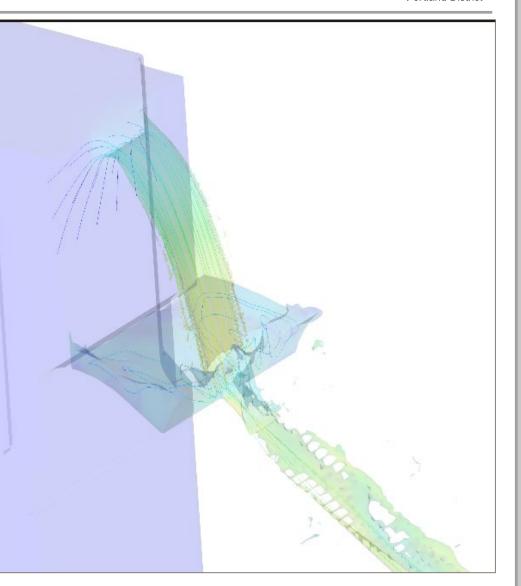
#### Is the overall impact reduced from the spill hitting the spillway?

- Modeling using history probe particle tracking with mass-based particles and abrupt changes in velocity.
  - Validate with PNNL sensor fish data.

How much water is spilling over the sides of the crest weirs, and how many fish are in this water?

Mass-flux boundaries over crest weirs to check for overspill, check for marker particles passing through flux planes.

Retention time of fish in created pool.

– Life-cycle time of marker particles in the model.

Hydraulic Profile Down Spillway Chute.

Due to transition zone, looking at an adjustable or temporary channel to mitigate risk of modifications to spillway.
