Biological Fish Injury and Survival at Green Peter Dam, Oregon, 2015

Background

Study conducted to provide the USACE with direct survival/injury information for consideration when designing fish bypass systems at high head dams

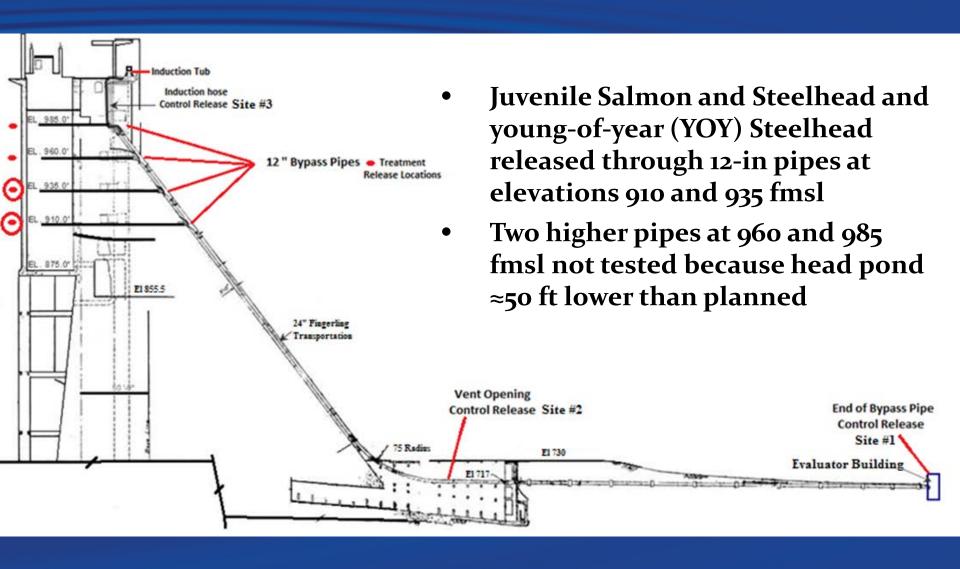
Schematic of Migrant Bypass Pipe

Remaining bypass system consists of four 12-in bypass pipes that discharge into a 24-in bypass pipe which empties into fish evaluator

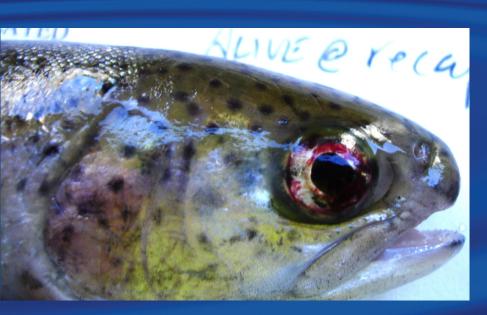
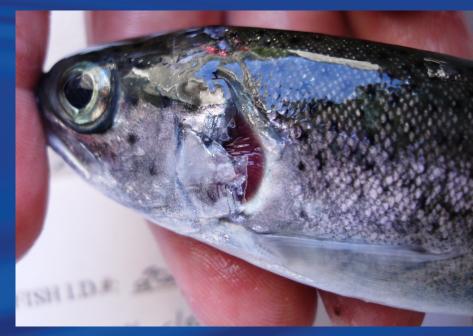
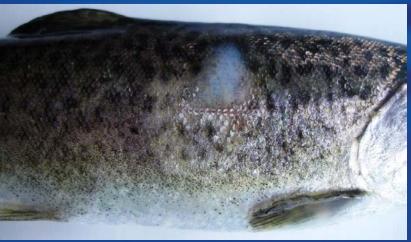
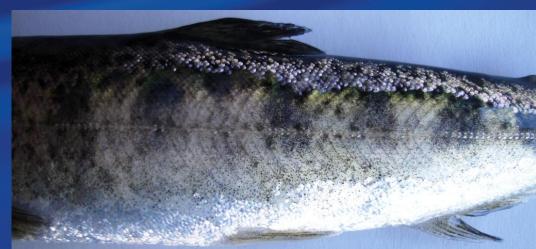
Examples of Injuries

- 6.4% of treatment Chinook visibly injured
- 3.3% of treatment Steelhead visibly injured
- 2.3% of YOY Steelhead visibly injured
- Chinook primary injuries were scale loss (2.8%), scrapes/bruises(1.8%), and hemorrhaged eye (1.5%)
- Steelhead primary injuries were scrapes/bruises (1.3%) and hemorrhaged eye (1.1%)
- YOY Steelhead primary injuries were hemorrhaged eye (1.8%)
