**US Army Corps
of Engineers**

Portland District (CENWP)

**BRADFORD ISLAND
FISHWAY MODIFICATION EDR
FINAL SUBMITTAL**

August 2012

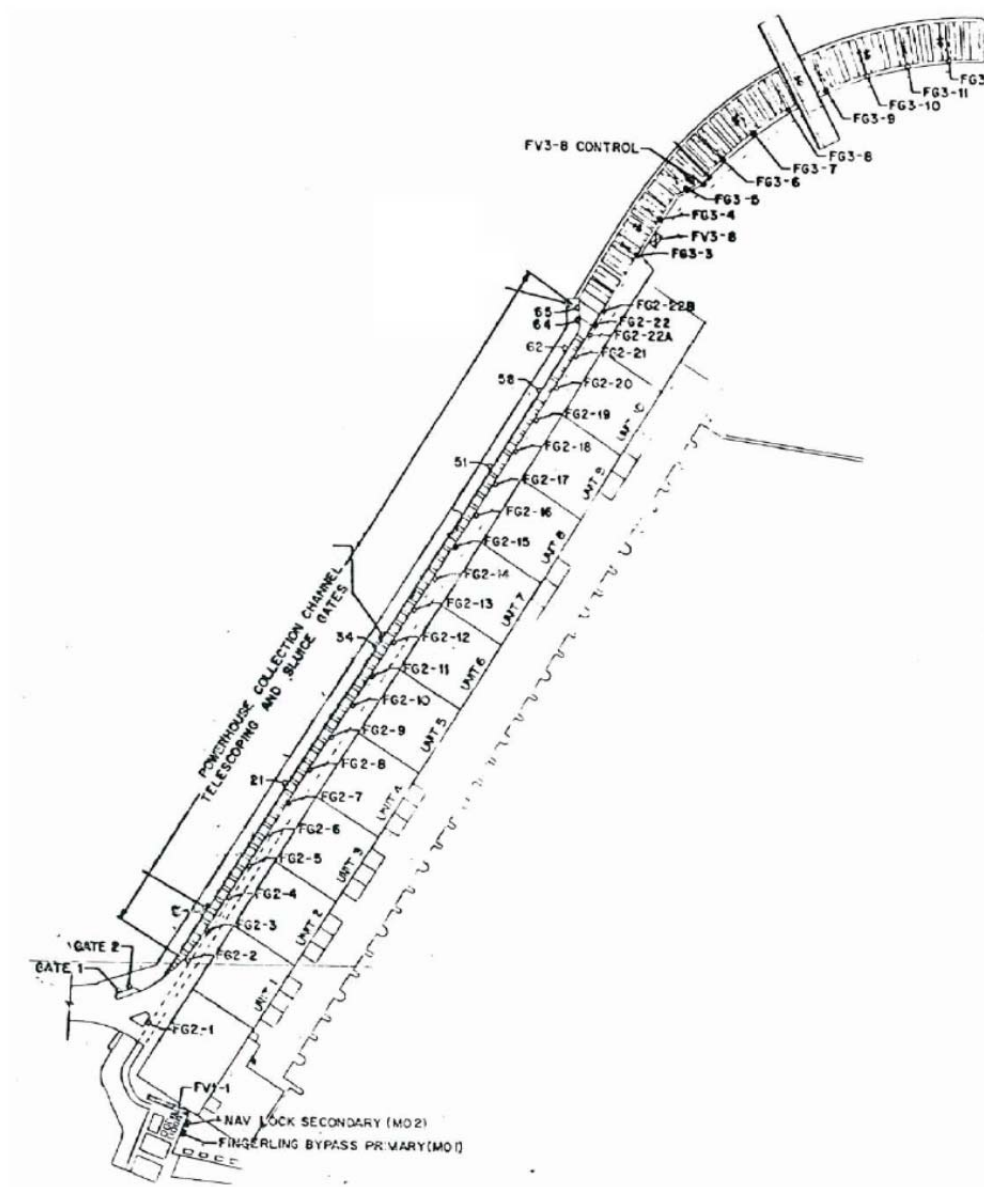
Figure 2.2 Bradford Island A Branch Diffusers

Figures 2.1 and 2.2 provide a good overview of the project, but don't clearly show all features described in the text and rated in the decision matrix (Figure 2.2 is too small and blurry to see diffuser numbers, valve locations, etc., etc., etc.)

The north entrances to the A Branch are WG-64 and WG-65, not WG-63 and WG-64 as labeled in Figure 2.2

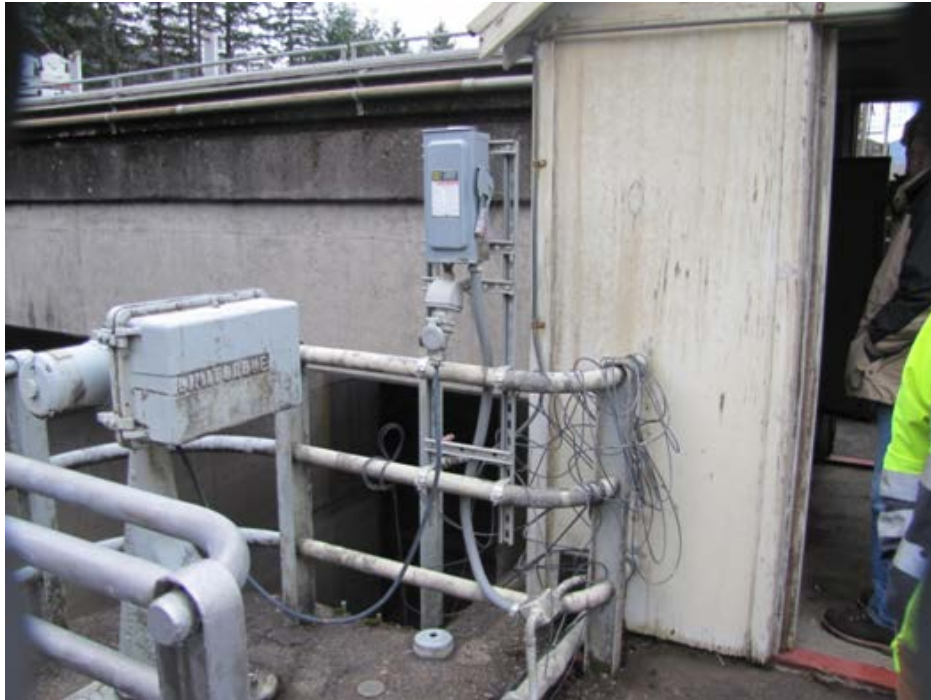
Figure B1.6.6 Limitorque Operator with Disconnect Switch

We noted some changes to some of the controllers, mainly the addition of disconnect switches to bring these controllers in line with the National Electrical Code requirements. Entrance gates have Duropot position transmitter to indicate gate position to PLC.

These operators were manufactured Limatorque and, except for normal weathering, were in very good condition.

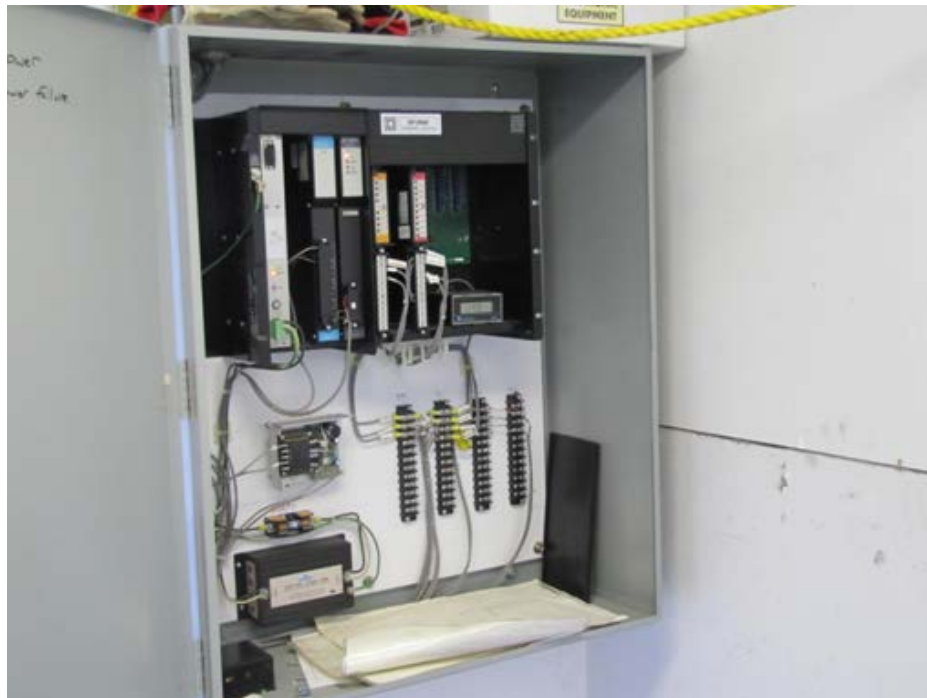
Figure B1.6.8 Enclosure with Remote I/O Rack

The automatic functions of the gate operators are controlled by a PLC. This PLC will take operator commands and cause the various elements to operate in such a manner as to comply with the operator's intent. The I/O rack is in good condition, but is getting old. Much like similar electronic devices, the I/O components have a limited time where manufacturer support and spare parts are available. The I/O racks that form the part of the PLC operating the fish ladder system are obsolete and spare parts may be difficult to obtain. (See paragraph B1.6.3.2.)

The Corps of Engineers has opted to go to a different type of input/output (I/O) integrated with a PLC processor. Consideration may be given to update this fish ladder PLC.

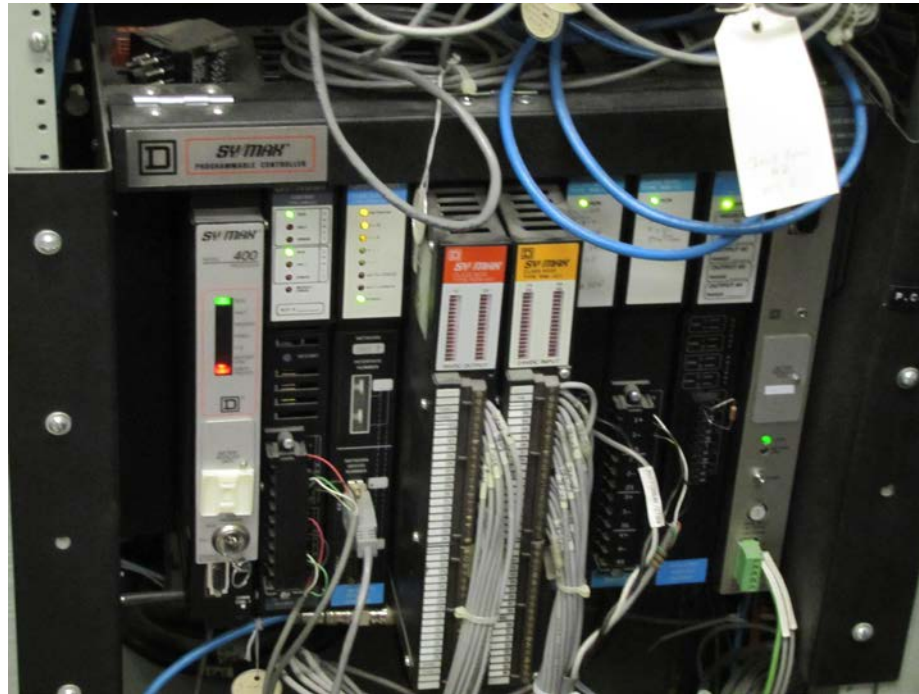
Figure B1.6.13 Remote I/O rack for communication with PLC

The SoftPLC is fully functional but the remote I/O racks are of old design and are obsolete. The Corps has a stock of spare parts available for these remote I/O racks but new spares are not being manufactured. The SoftPLC can accommodate a variety of I/O from various manufacturers so replacement is not an issue should the spares be depleted

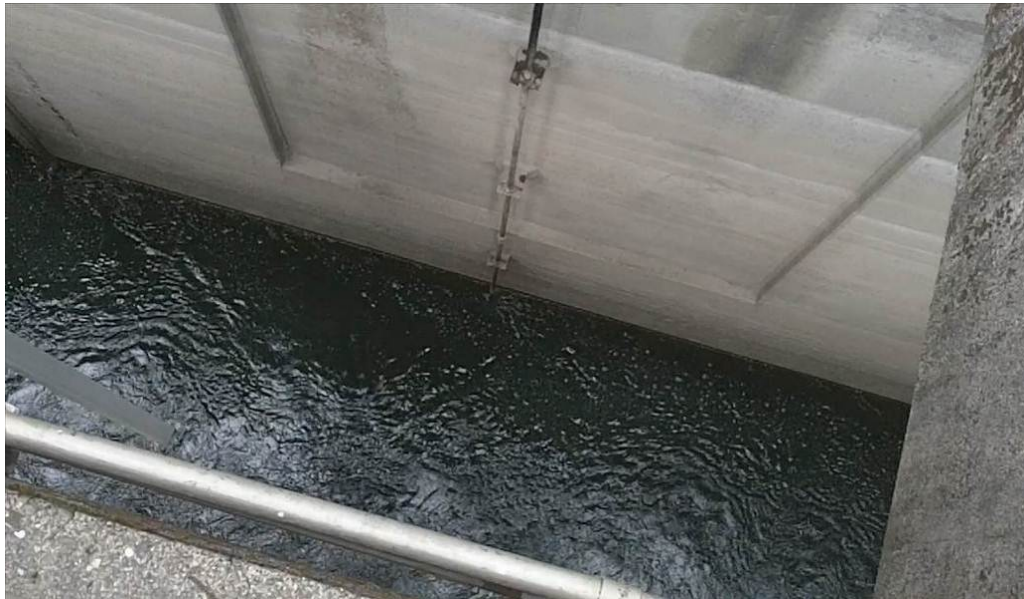
Figure B2.4.3 Collection Channel at the Location of FG2-6

This area was only dewatered to tail-water elevation (approximately El. 15 feet) at the time of inspection see Figure B2.4.3.

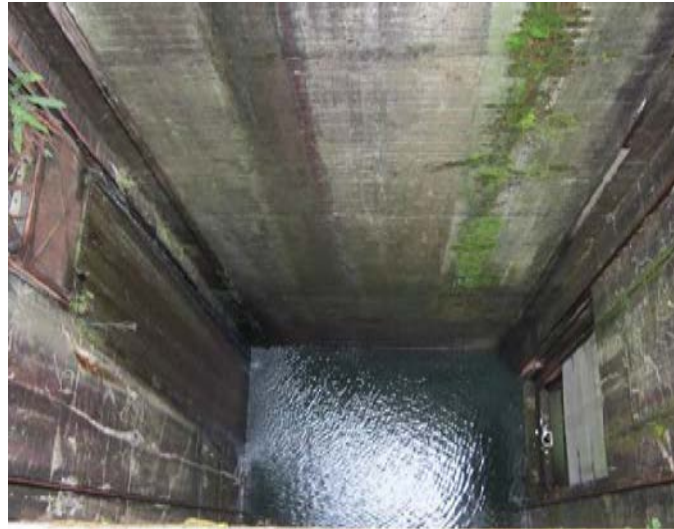
Figure B2.4.7 Fish Lock Chamber

The fish lock is a defunct fish elevator system that was installed during original fishway construction for the purpose of backing up the fish ladder. The system is comprised of two elevators, each with openings to the equalization chamber and collection channel. Water supplied to the fish lock was provided by FV1-3 and FV1-4. Both FV1-3 and FV1-4 remain in place but are no longer operable. The lock elevators are located on the south side of Powerhouse 1 and just west of FV1-1. Use of the fish lock system was discontinued about 50 years ago. See Figure B2.4.7.

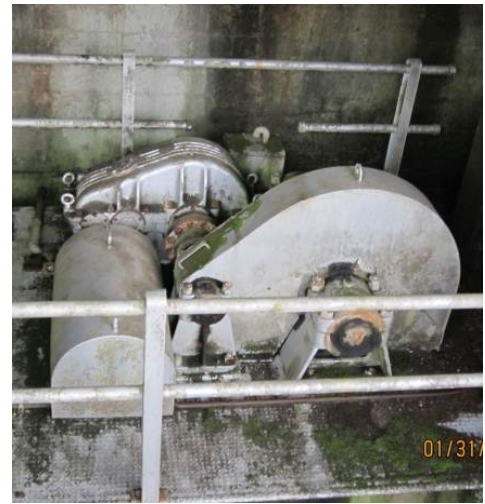
Figure B2.4.36 FV3-8

Mechanical components have not been used in years and were not inspected. See Figure B2.4.36.

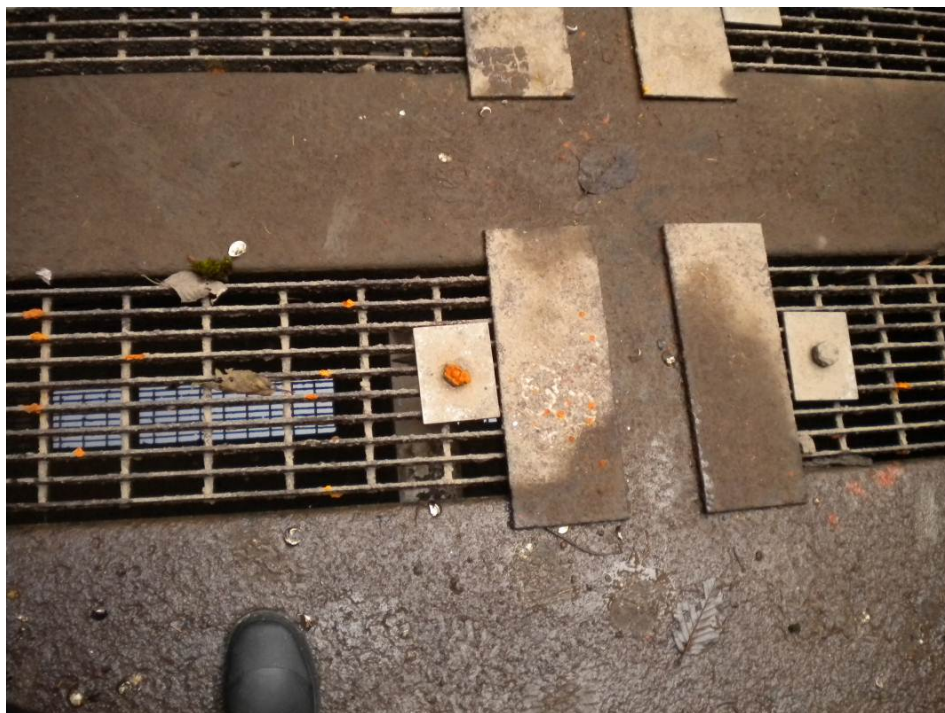
Figure B3.4.6 Diffuser Grating

The Bradford Island fishway has 20 diffusion chambers. The chambers fill with water from the auxiliary water conduits and then uniformly disperse the water through the diffuser gratings into the fish ladder. The gratings and fasteners are always corroding which leads to failure. Sometimes debris in the chamber builds up blocking water from passing through the diffuser grates, to the point where the pressure blows the grating off. Below the slots are the diffusion chambers. See Figure B3.4.6.

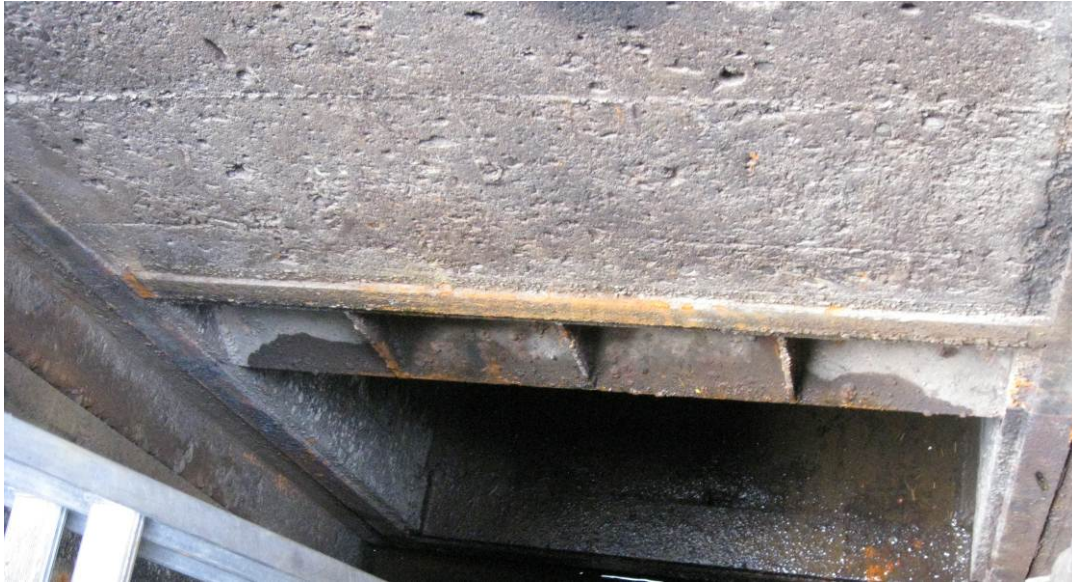
Figure B3.4.7 FG3-26 Deflector

Both FG3-26 and FG3-28 had deflectors installed to reduce the amount of damage caused by vibration. This modification has been done to several of the gates that cannot retract out of the flow but not all of them. At the time of the inspection Project personnel were unsure of which ones have or still need a deflector. The deflectors extend into the opening between the AWS conduit and the diffuser.

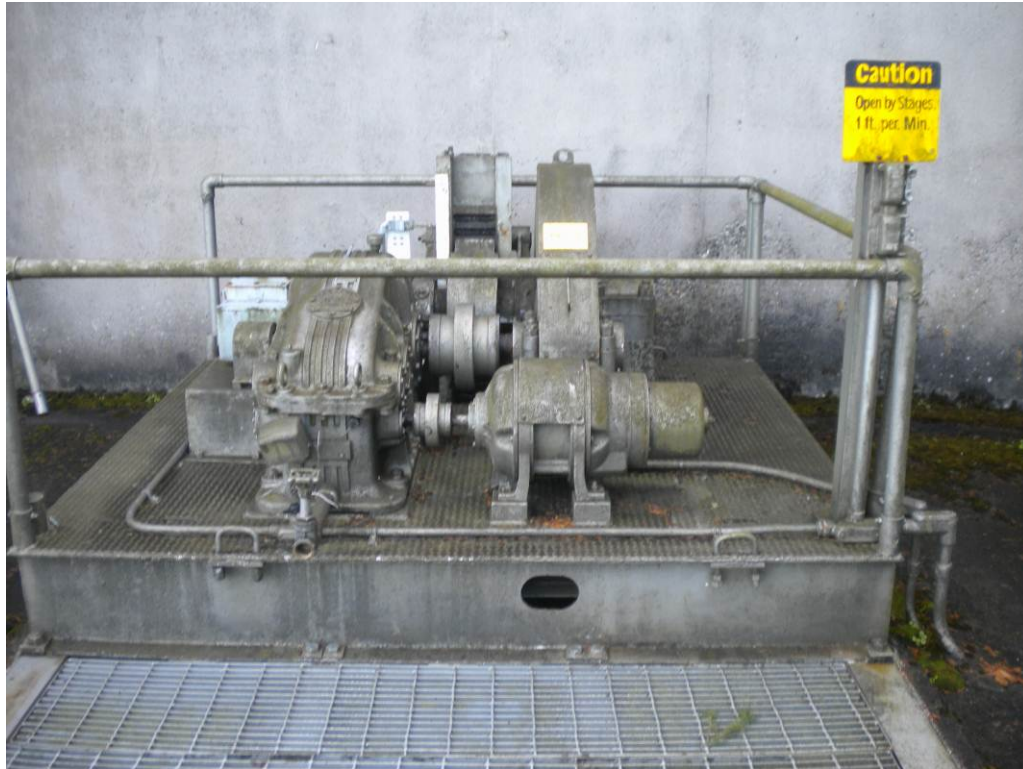
Figure B3.4.11 Electrical Actuators for FV4-3.

No noticeable change from Phase 1 inspection. See Figure B3.4.11.
