10 Post-2020 Survey Summary and Analysis

15 Appendix B – Post-2020 Stilling Basin Conditions

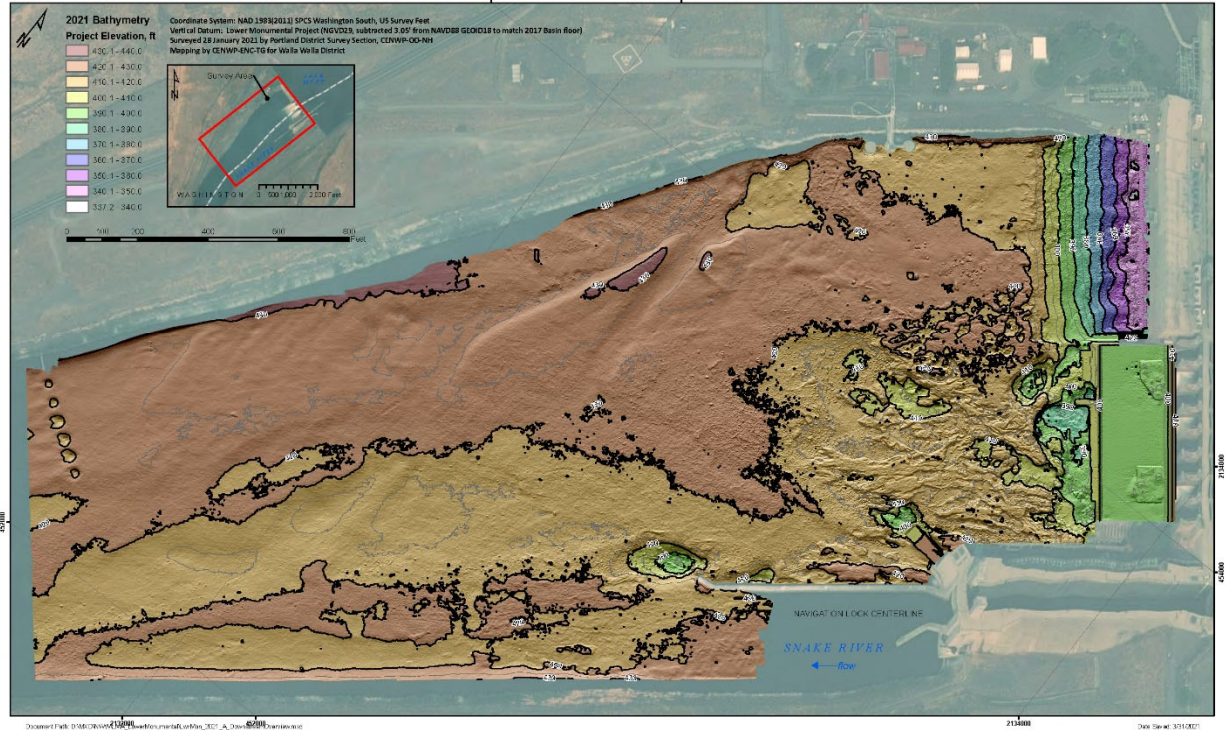
US Army Corps of Engineers **Lower Monumental Dam - 2021 Bathymetry, Map B: Stilling Basin**

The 2021 Lower Monumental survey shows some accumulation of rock within the stilling basin. There is no noticeable difference in erosion of the stilling basin from the 2017 survey, movement of material has occurred downstream of the end sill within the immediate tailrace.
