# MCNARY SPILLWAY STATUS

FPOM  
5 October 2023

# MCNARY SPILLWAY

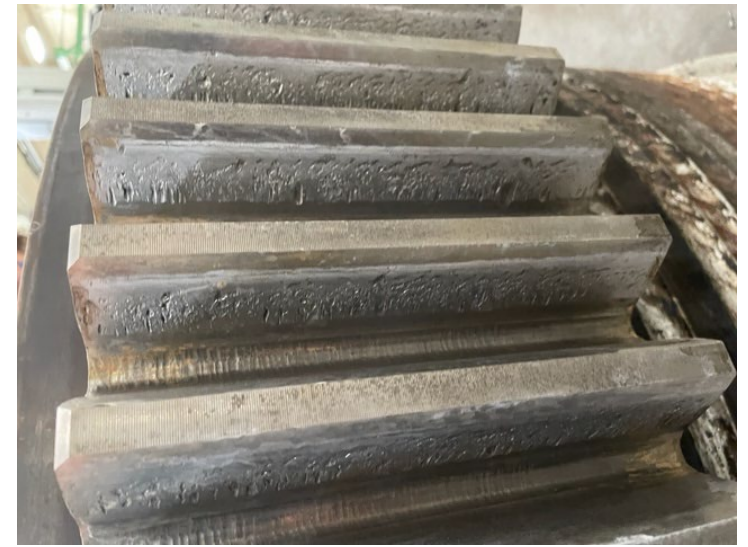
- 2022, Hoist #6 failed, gears showed severe pitting due to material fatigue from high contact stresses, replaced with hoist from bay #16. Bay #16 RTS after about three month outage.  
Hoist #15 OOS for one week for repairs  
Hoist #20 taken OOS for repairs  
Hoist #21 gearbox coupler failed and brakes failed during closure causing gate to fall on sill
