Refurbishing The Dalles Fish Water Turbine-Generators, Phase 1A Final Report

The Dalles Fish Water Units 1 and 2

Final Report – REVIEW DRAFT

May 2019

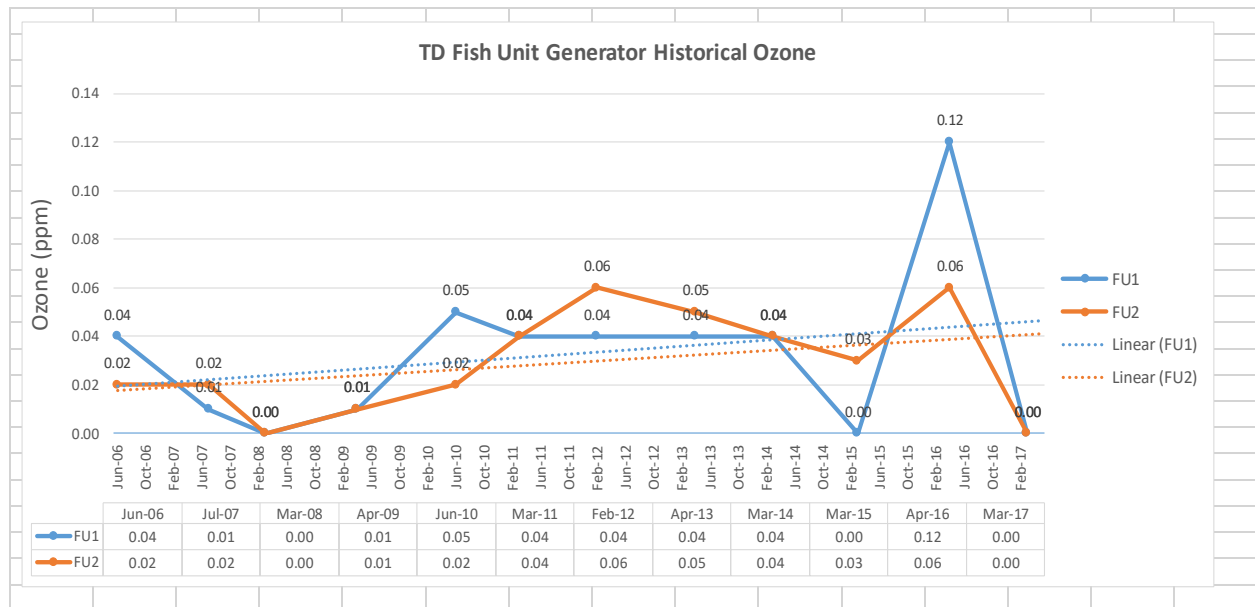
Figure 17. Ozone Data

With the exception of June 2016 measurement on unit 2 (0.12 ppm), the level in both units were found acceptable. The ozone level appears trending upward. This is an indication of more slot discharge activities.

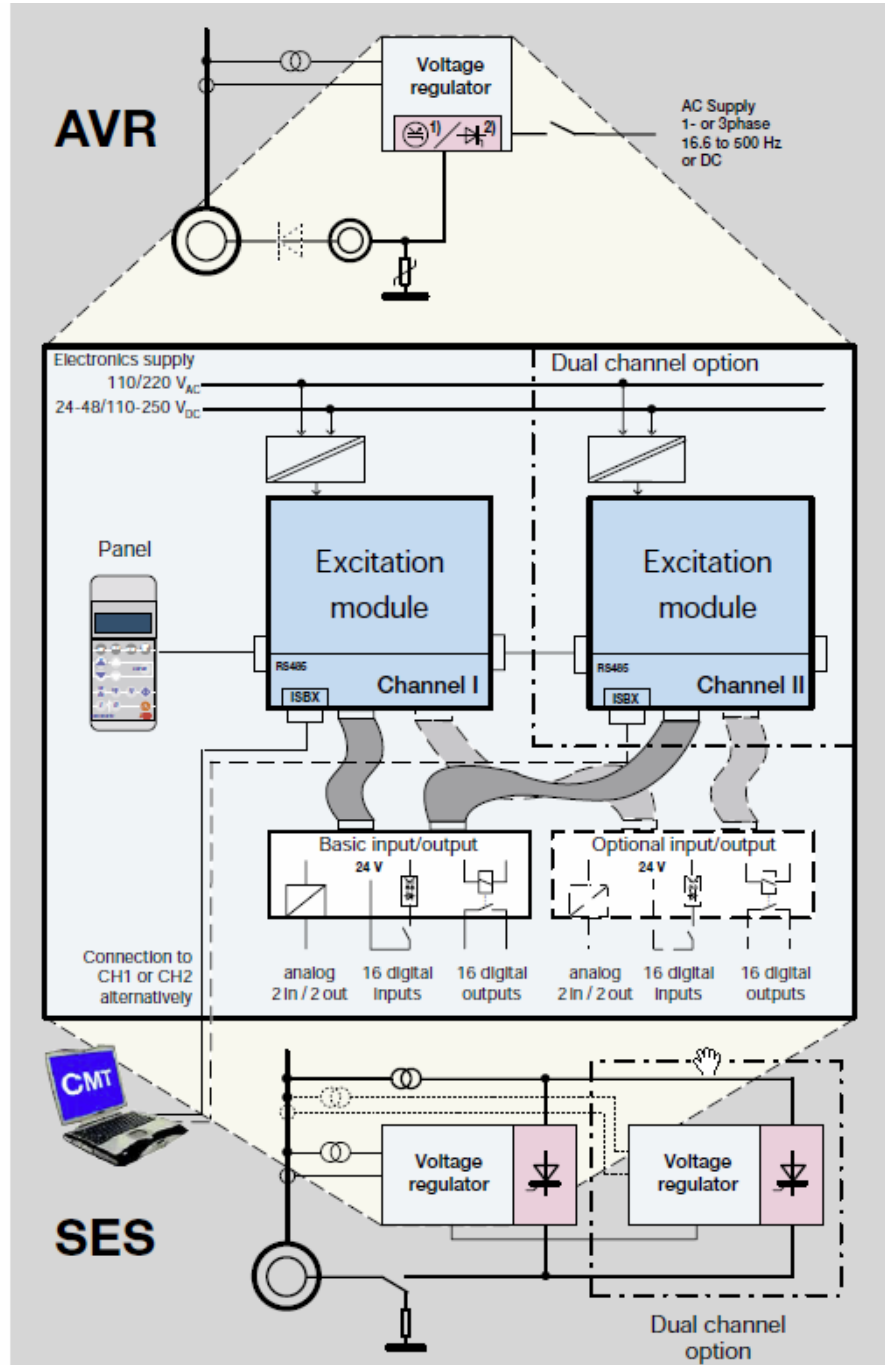
Figure 18. Unitrol F System Configuration

The original rotating excitation systems were replaced with the UNITROL F Series solid state excitation systems by ABB in 2000. While the excitation systems are in satisfactory condition, replacement parts are difficult to locate or are no longer available.

No failures occurred on the excitation system. However, there was a failure on the main Unit 13, which also has UNITROL F model.

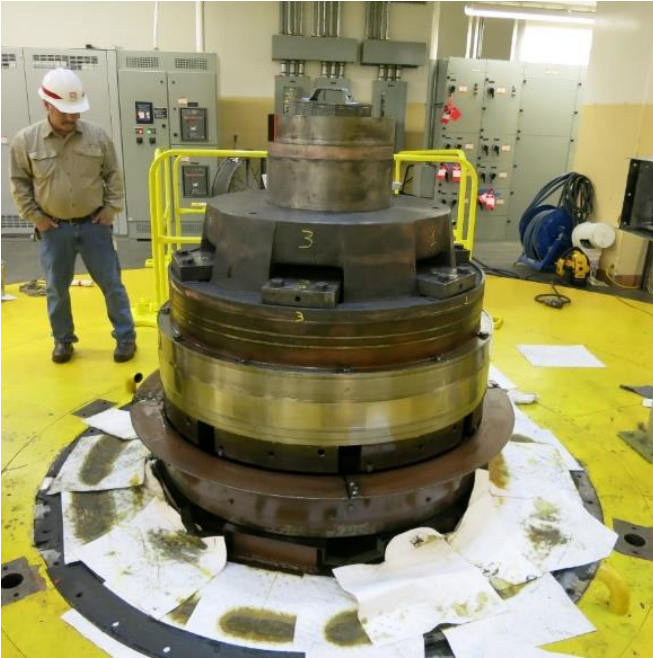
Figure 25. Unit 2 Disassembled Showing the Combination Generator Thrust Bearing/Upper Guide Bearing

Based on historical operation with no known issues, the turbine guide bearings appear to be in good working condition. There is no historical or operational evidence of issues associated with the guide bearings. However, critical surfaces of the bearings are not visible without disassembly and the existing condition of the babbitted bearings and water-lubricating bearing can only be known after disassembly. Nevertheless, it is common for babbitted bearings of this age and vintage to have disbonding of the babbitt.

The Dalles has a spare turbine guide bearing for the fish water turbines. These bearing will have to be inspected and refurbished.

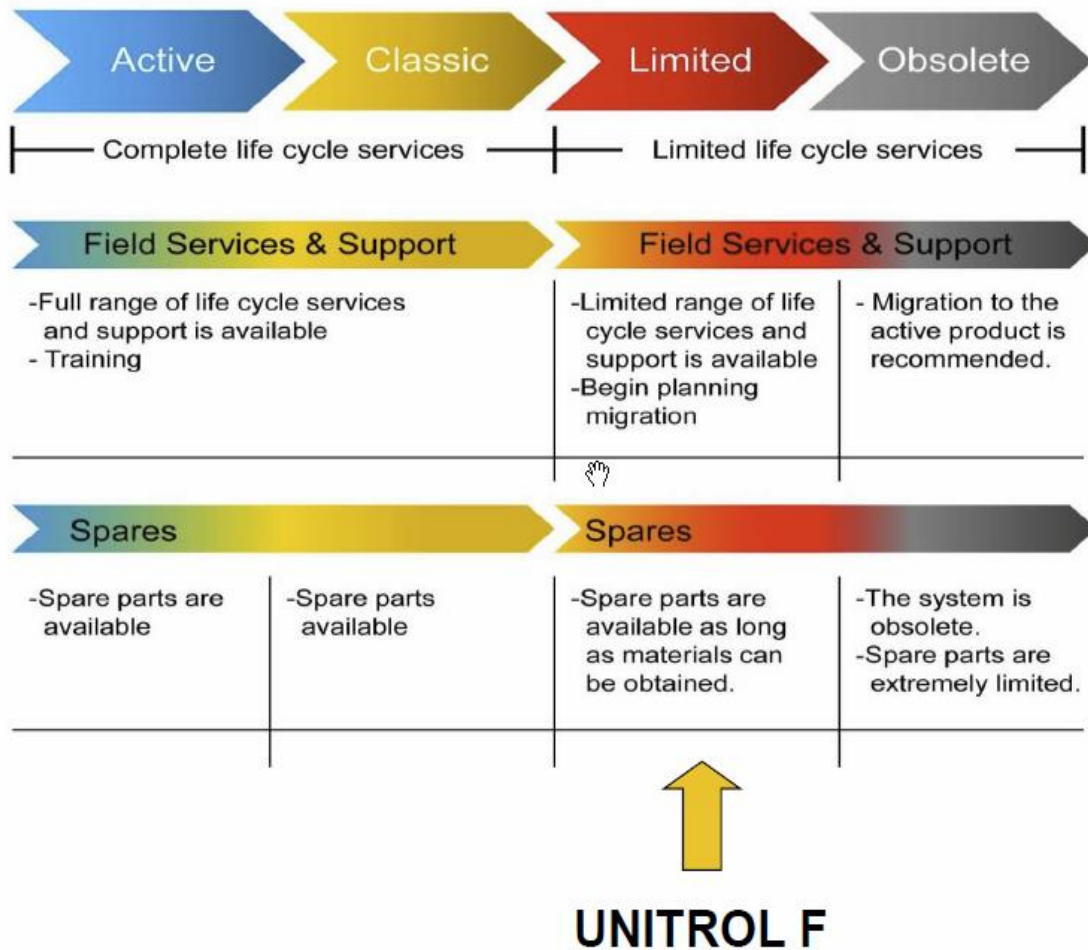
Figure 33. ABB Excitation System Life Cycle Cost Management. The figure was obtained from ABB web site.

From the beginning of 2017, UNITROL F system is in the limited phase of its life cycle. ABB cannot guarantee life cycle services and support due to scarcity of electronic components and limited technical know-how.

Based on the current status of a customer’s installed based, ABB recommends to begin migration planning to replacement the UNITROL F model. Figure 33 shows the current state of product support.

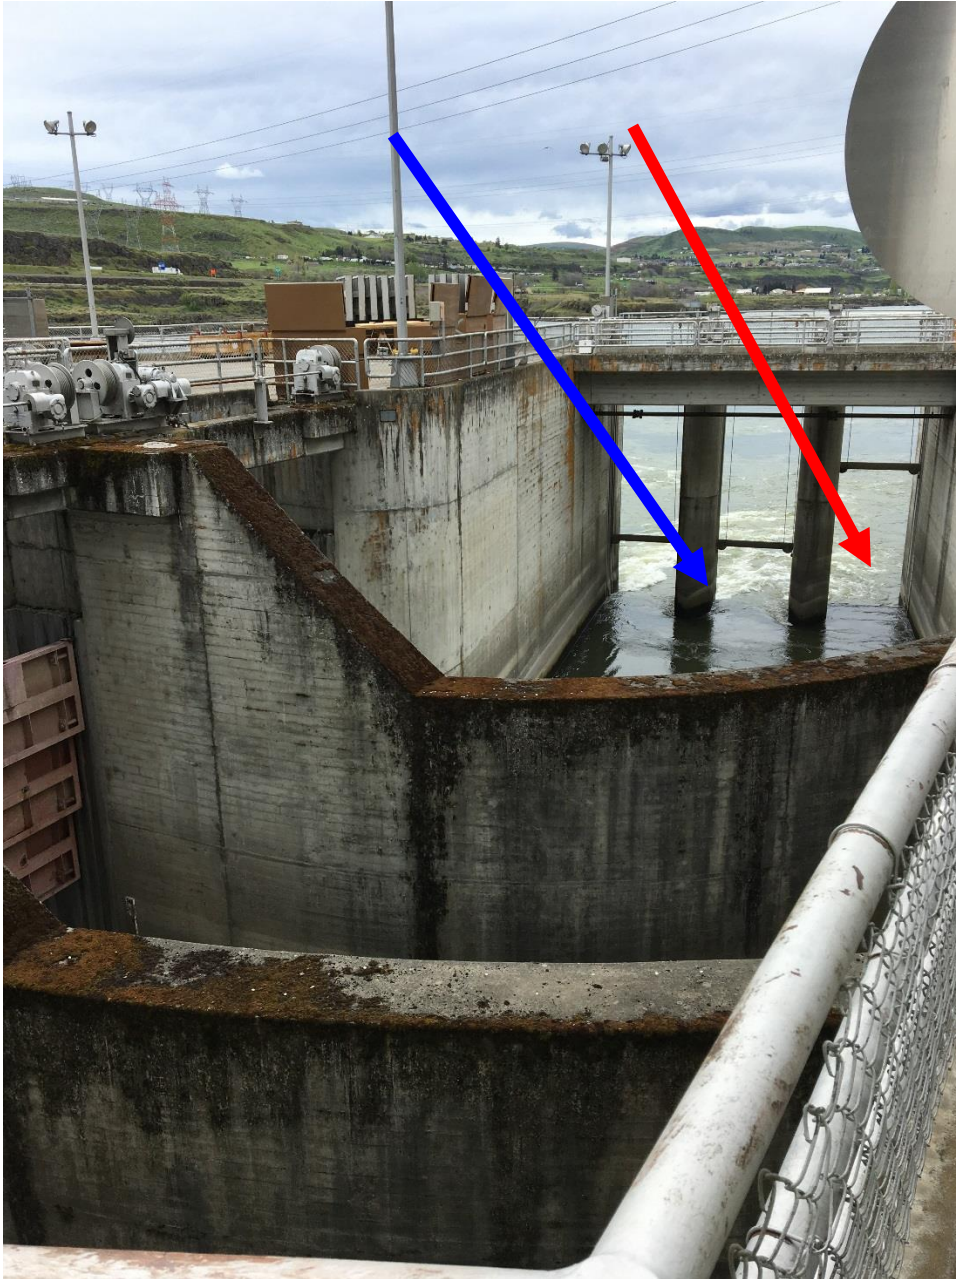
Figure A2-1. East EFL Entrance – Looking D/S w/ The Dalles, OR in the Distant Background.

Location on 111.5 ft deck of TW reading for E. Entrance.

Note two weirs are discharging, E3 and E2 (E1 on the right nearest to the Powerhouse is closed).

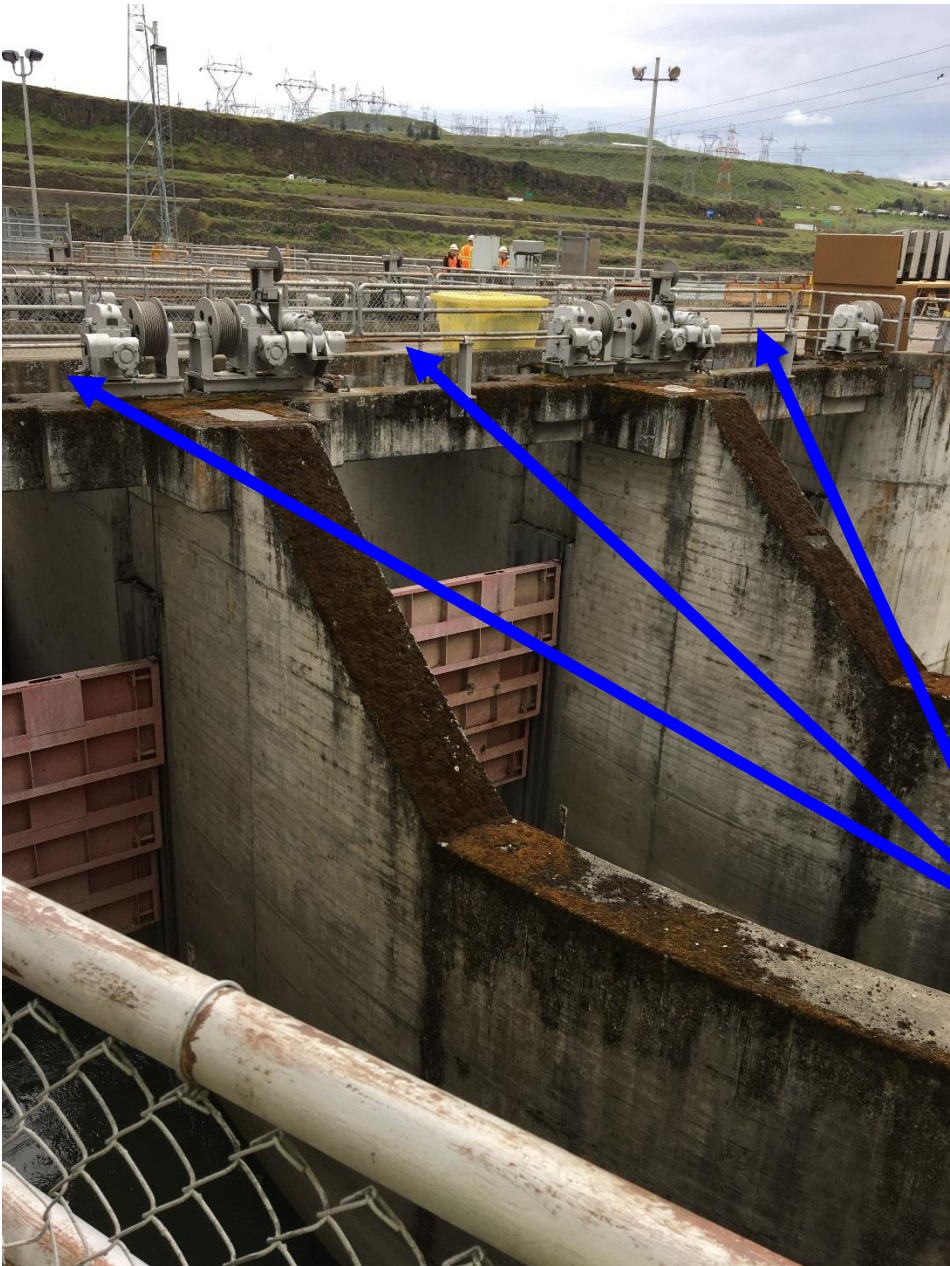
Figure A2-2. Looking u/s Toward Junction Pool, w/ Fish Ladder to the Left of the Photo. East EFL Entrance is just outside of the photo to the right.

Three readings taken u/s and d/s from bridge deck, at end of Junction Pool, bridge deck curbing elev. = 112.0 ft.

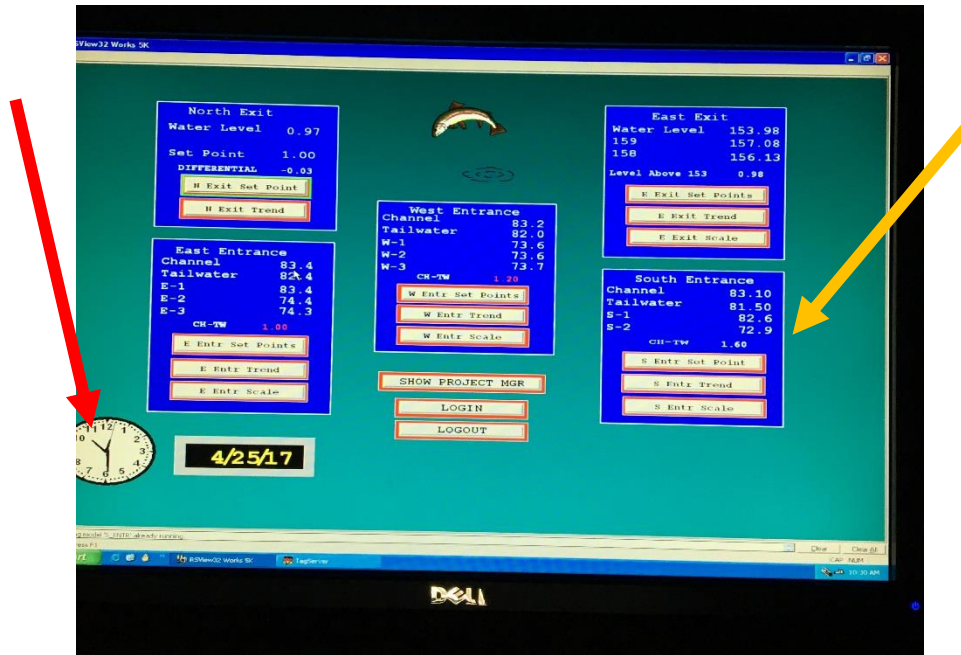
Figure A2-3. Operator's Status Screen within Powerhouse.

Note time on clock. Weir difference in ft is third entry, typ.

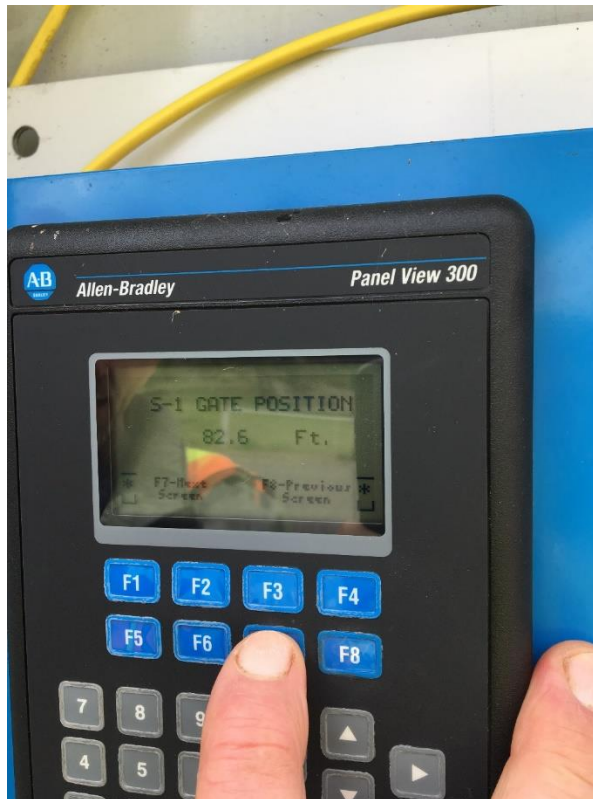
Figure A2-4. Panel Outside of PH Showing Gate Position in EFL Entrances.

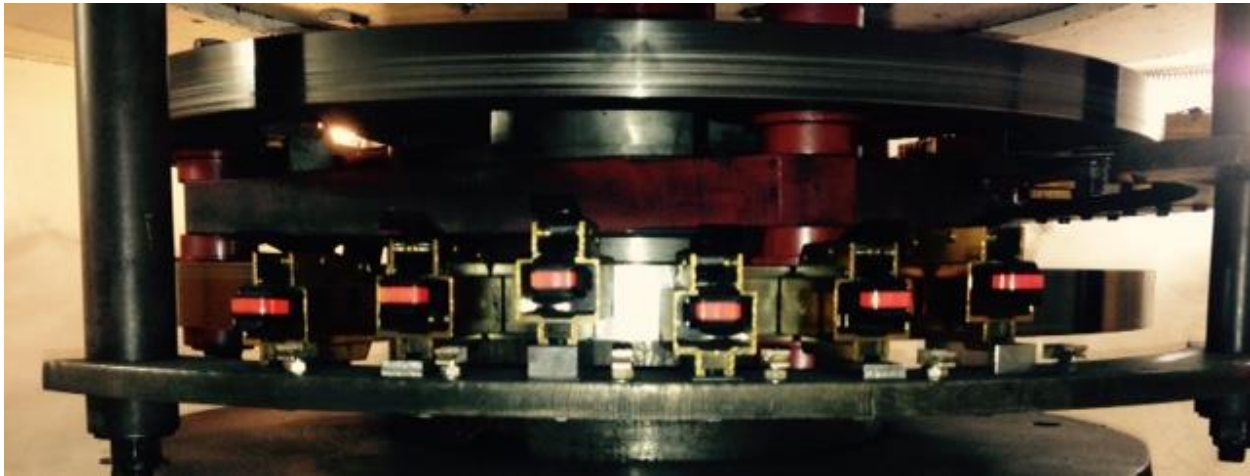
Figure H-4. Brush height distribution
