B-Branch Adult Fish Way - Erosion Repair
Design Document Report
October 2016

99% DDR

B-Branch Adult Fish Way - Erosion Repair

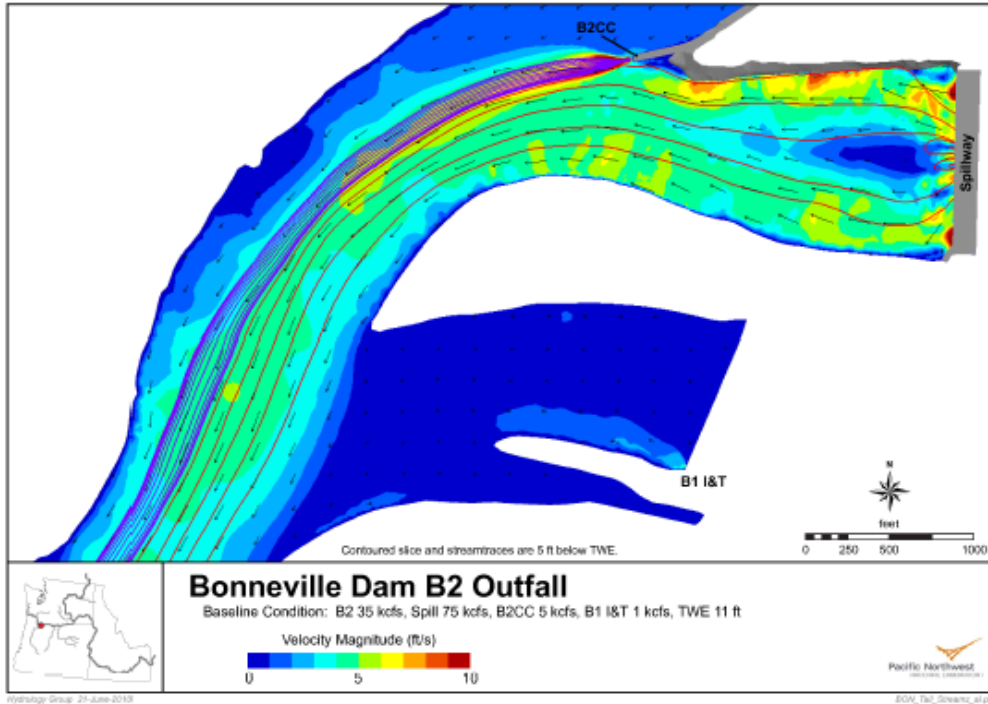
Figure 4 - CFD velocities in the Spillway Tailrace – Spill of 75 Kcfs

- The CFD results showed velocities in the 10 to 12 fps range (see example CFD plots in Figure 4 and Figure 5 (PNNL 2012)). But the CFD runs were limited to total spill volumes of just over 300 Kcfs. Previous CFD model studies were conducted to develop design load conditions on the Bonneville 2nd Powerhouse Corner Collector Outfall (PNNL 2001). Flows in excess of the 100 year event (680 Kcfs) were pushed through the spillway. The results between the two models were compared for 100 Kcfs, 125 Kcfs, 200 Kcfs and 300 Kcfs through the spillway. In the area of repair the two models showed similar velocities. The 100 year event showed velocities less than 10 fps in the area of interest (See Figure 6 from PNNL 2001).

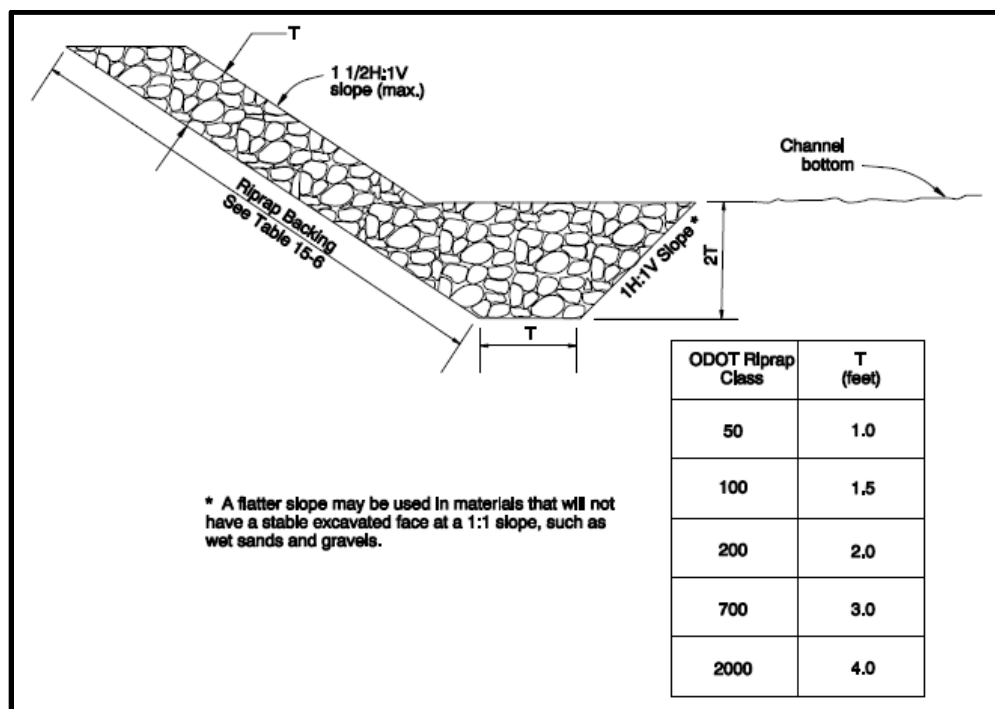
Figure 9 - Standard Riprap Section from ODOT

This will work well in areas that can be excavated, however interpretation of the geology suggest that bedrock may be encountered within the neat line for the excavation therefore some alternate method of toe protection may be required.

PDT recommends that the contract base their work on the standard rip rap section presuming excavation with a clamshell bucket. If refusal is met, the contractor may elect to remedy this differing condition with Method 4 (minimal rock excavation) or Method 5 (balance of fill as toe berm).

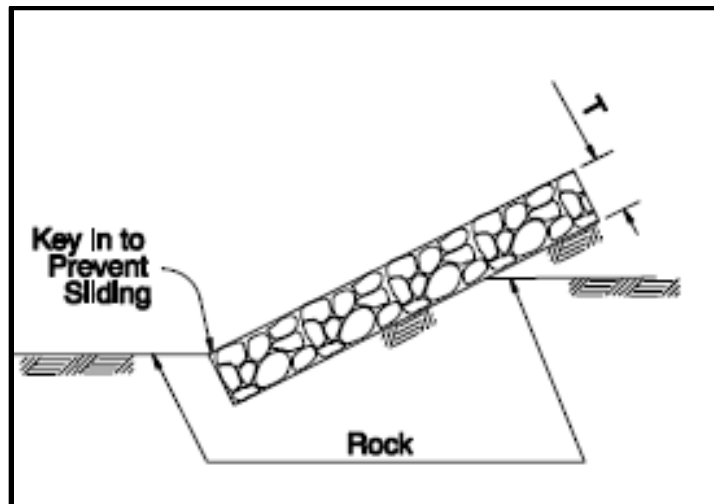
Figure 10 - Section View of Scour Protection Method No.4 from ODOT

The excavation of bedrock is a significant effort to be planned for.

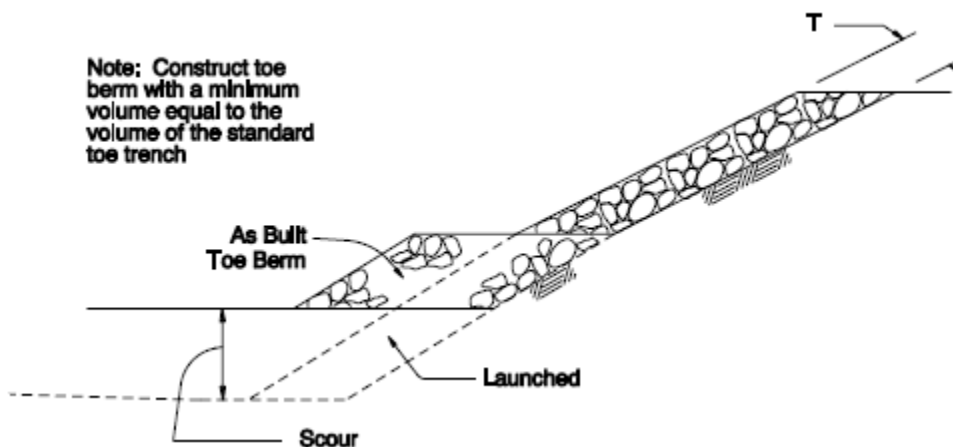
Figure 11 - Section View of Scour Protection Method No.5 from ODOT

Yet another alternative is employ the concept of “launched stone” which is placed in excess as a toe berm. The launch stone would naturally drop into the scoured hole as shown.
