MEMORANDUM FOR THE RECORD

SUBJECT: 16BON11 MFR – Adult salmonid mortalities in the PH1 unit 8B tail log slot.

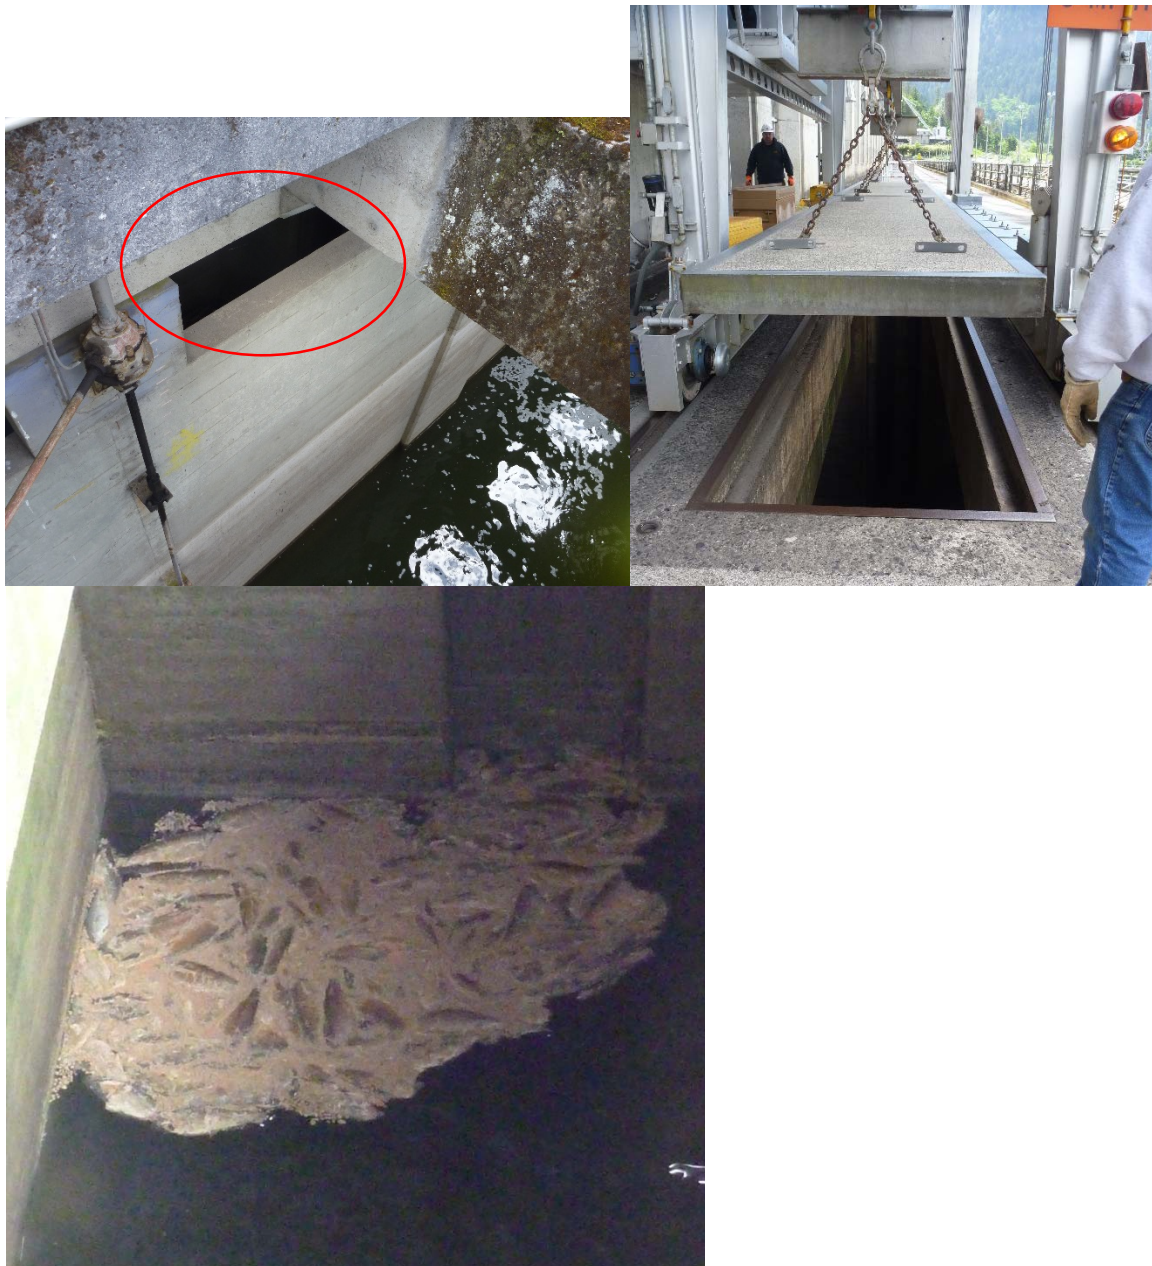
On 7 May, a Project Biologist noted dead fish floating in the PH1 tail log slot for unit 8B. A dead fish odor had been noted in the area the week prior by multiple biologists but inspections of the area had come up empty. The tail log slot is upstream of the PH1 collection channel (CC) under the roadway and only the very upstream portion of the slot area is visible from the CC walkway, from a PH1 diffuser bridge. Water in the tail log slot can only be seen when tailwater is high enough. A schematic of the area is shown in Figure 1. Generalized water levels are shown in blue, with the location of the dead fish indicated by the red circle and anticipated trajectory of the fish as the red arrow. It's unknown when the fish moved into the tail log slot. Unit 8 has been out of service since 22 February 2016 with no tail logs installed (open to the tailrace with no water flow).

On 9 May, the first available work day, the structural crew removed the roadway deck plates located above the tail log slot at the request of Project Fisheries in order to allow a clear visual inspection of the area. Project Biologists estimated ~70 dead adult salmonids were floating in the unit 8B tail log slot. The slot for 8A was also investigated; no mortalities were found but at least two salmonids were noted swimming in the slot. No means of entry to the area was noted other than the tail log slot itself (red arrow in Figure 1).

- B. Origin – Unknown
- C. Lengths – Unknown
- D. Tags – Unknown
- E. Marks and Injuries found on carcass – Unknown
- F. Cause and Time of Death – Unknown. Dead fish odor was present one week prior.
- G. Future and Preventative Measures – Under investigation. The mechanism causing this incident to occur is currently unknown. The HVAC cooling water for PH1 discharges a small amount of water into tail log slots 8B and 9A. This could potentially have provided attraction water. The cooling water is now only being discharged into unit 9, which is running. Other measures are actively being pursued.

Salmonid mortalities in the PH1 unit 8B tail log slot. Hausmann said 7 and 8 have been out for breaker work. 5&6 went down a couple weeks ago. Chilling water was switched to unit 9. Smell was noticed a week and a half ago. Fish went into the draft tube and up in to the tail log slot. About 70 adult salmonids

died. This hasn't happened before. They weren't trapped but would have had to dive 40feet down to get out. There are two slots that chiller water could be emptied into. Tail logs will get installed. Hausmann asked if we want anything added to the FPP.
