Subject: Bonneville Adult Collection and Monitoring Facility (Bonn AFF):
Proposed Improvements for Small Project work in the Fiscal Year (FY) 13 In-Water Work Period

From: Stephen Schlenker, EC-HD
Jon Rerecich, PM-E
Steve Sipe, EC-DM

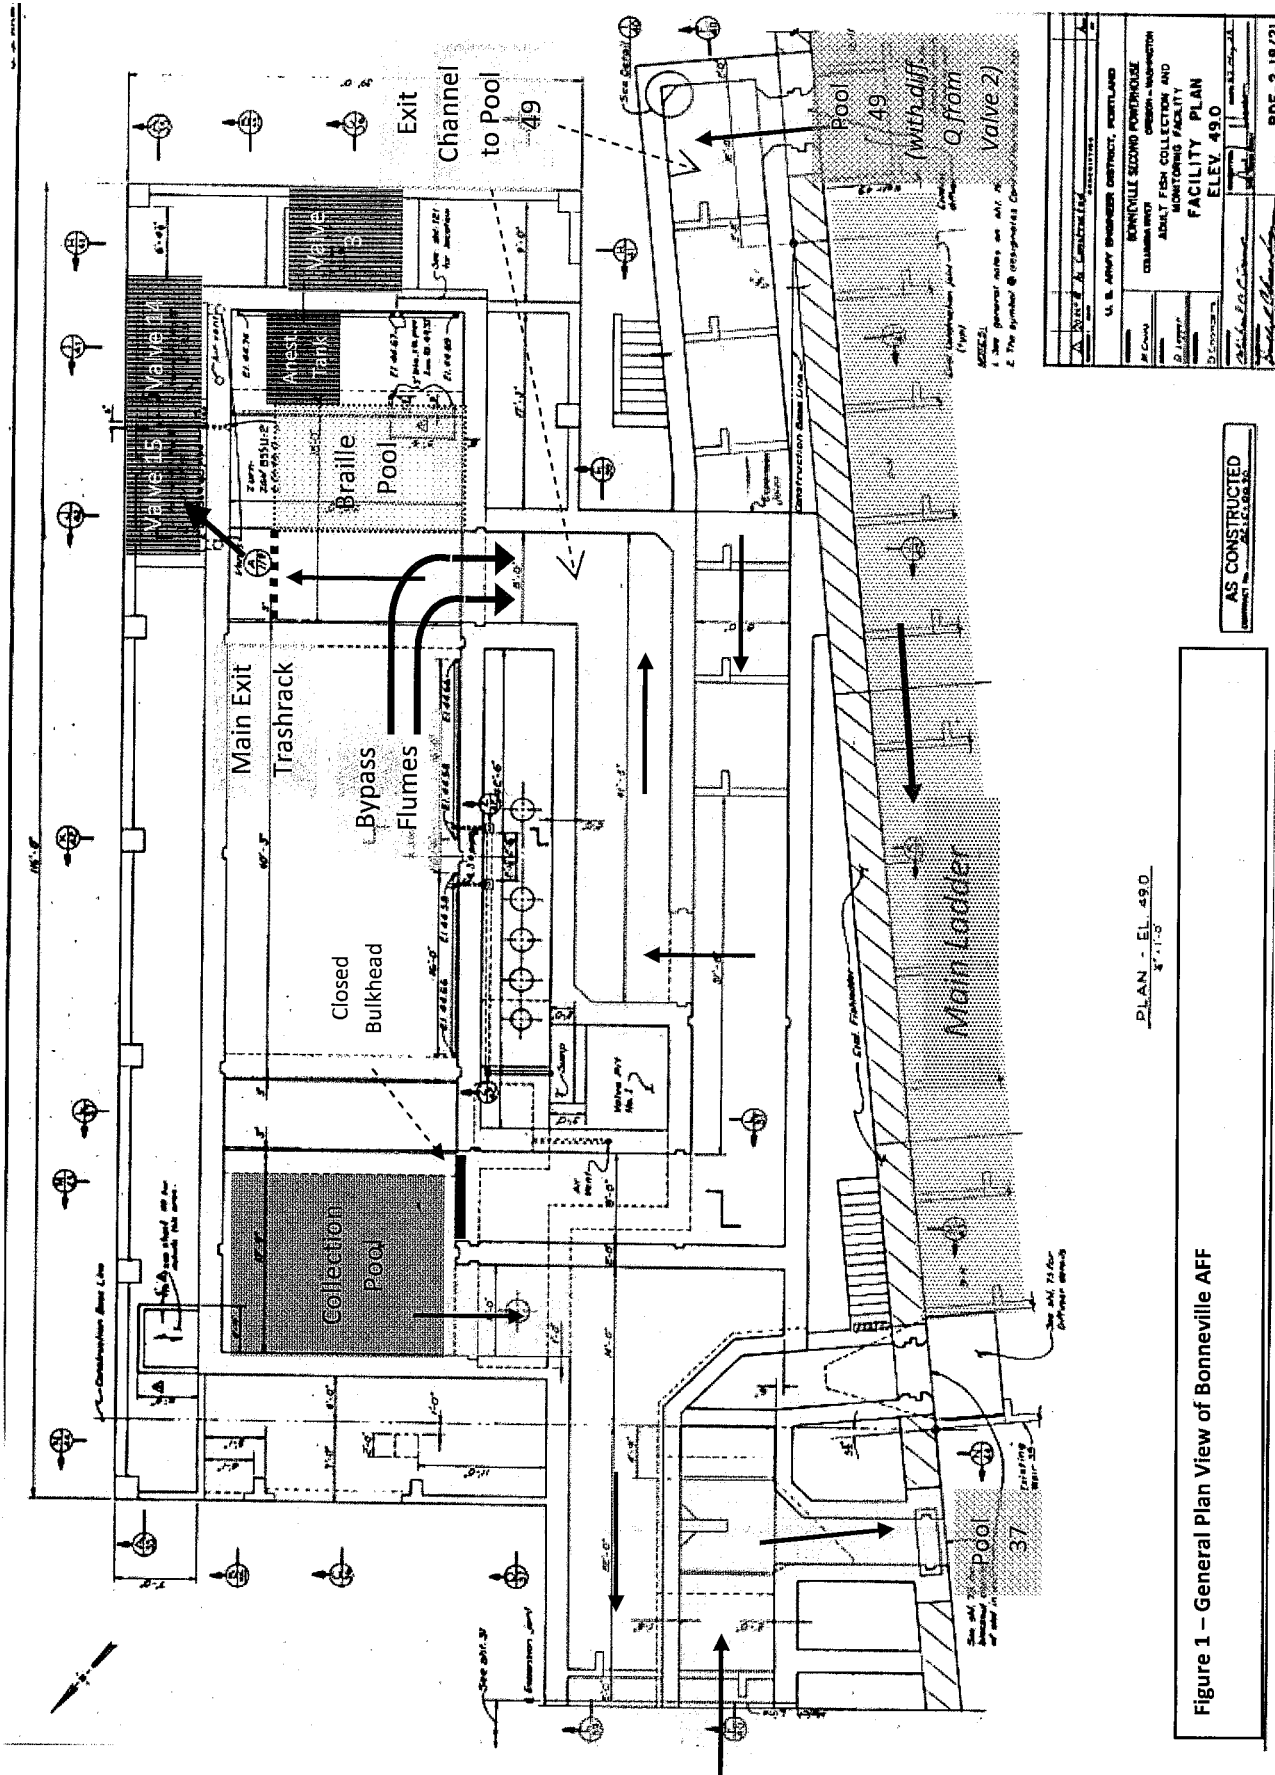
Figure 1 - General Plan View of Bonneville AFF

A general plan view of the Bonn AFF is shown in Figure 1.

All exit channel flow is currently discharged through both an 8-foot long terminating trashrack and an adjacent 5-foot long vertical side wall trashrack. All outflow then discharges over a system of stoplog weirs surrounding the drainage pit for Valve 15. The sum (clear) opening length of the weirs is 12.5 feet and the stoplogs are about 4 feet above the invert. The stoplogs consist of 4 x 4-inch wood members and there is noticeable leakage through them. The weirs tend to control the discharge and maintain water surface elevation in the exit channel and brail pool. Valve 15 is set at 75% open to assure drainage behind the weirs and prevent them from becoming submerged. In the previous years, the valve was set at 55% to maintain essentially the same water level elevation. This indicates there is more outflow going through valve 15 than in previous years (unless there is some new impedance in the drainage system).

There is also Valve 14 located off to the side in the NE corner of the sump area, which could be used to augment drainage capacity. It is currently kept closed.

- Replace 4.5 feet of stop log weirs (out of 12.5 feet total) with low porosity perforation plate, replace existing stoplog weirs with new members and add u/s blockage plywood to reduce leakage.
 - Add two recovery tanks to hold up to 4 fish for duration of 20-30 minutes, as a transition for fish between the anesthesia tank and the brail pool.
 - Extend the existing bypass flumes approximately 30 feet at 5% to bend around corner in exit channel and reduce drop between invert and water level in exit channel to about 6 inches.
- a) Replace 4.5 feet of Stoplog weir with porosity plate and improve sealing around remainder of weirs.

The old stoplogs will need to be replaced and an additional section of plywood should be placed upstream of each weir section to further reduce leakage in the remaining weirs.
