# MCNARY SPILLWAY STATUS

FPOM  
22 August 2024

# MCNARY SPILLWAY

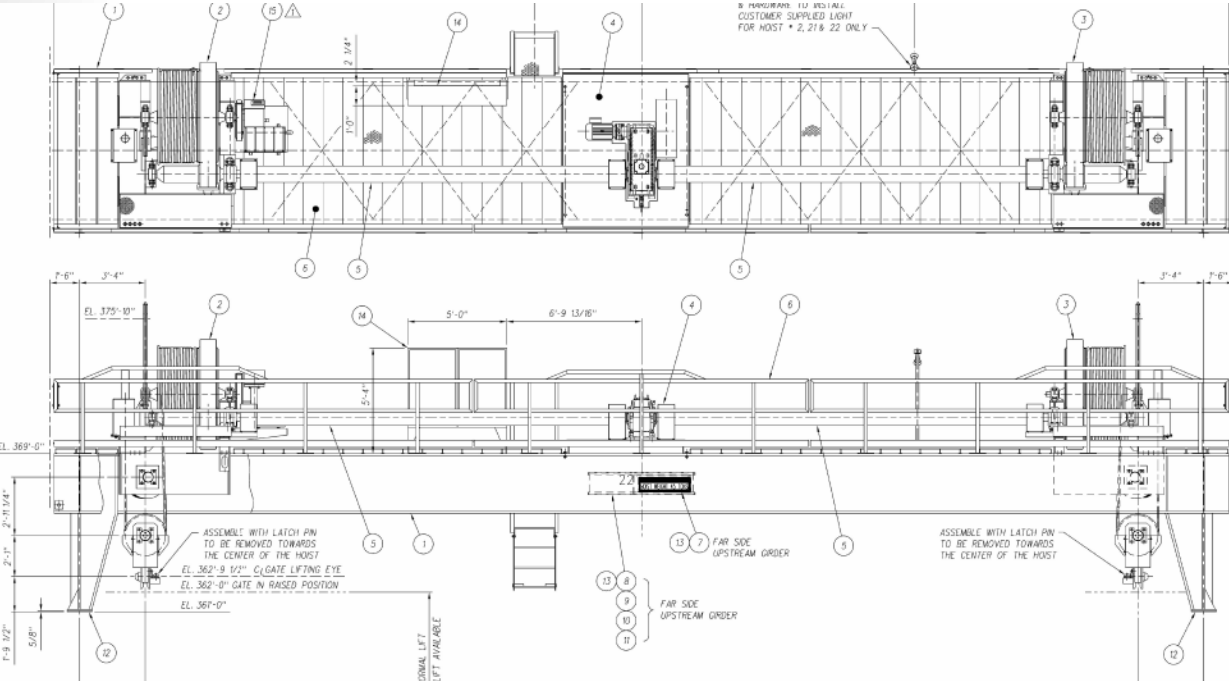
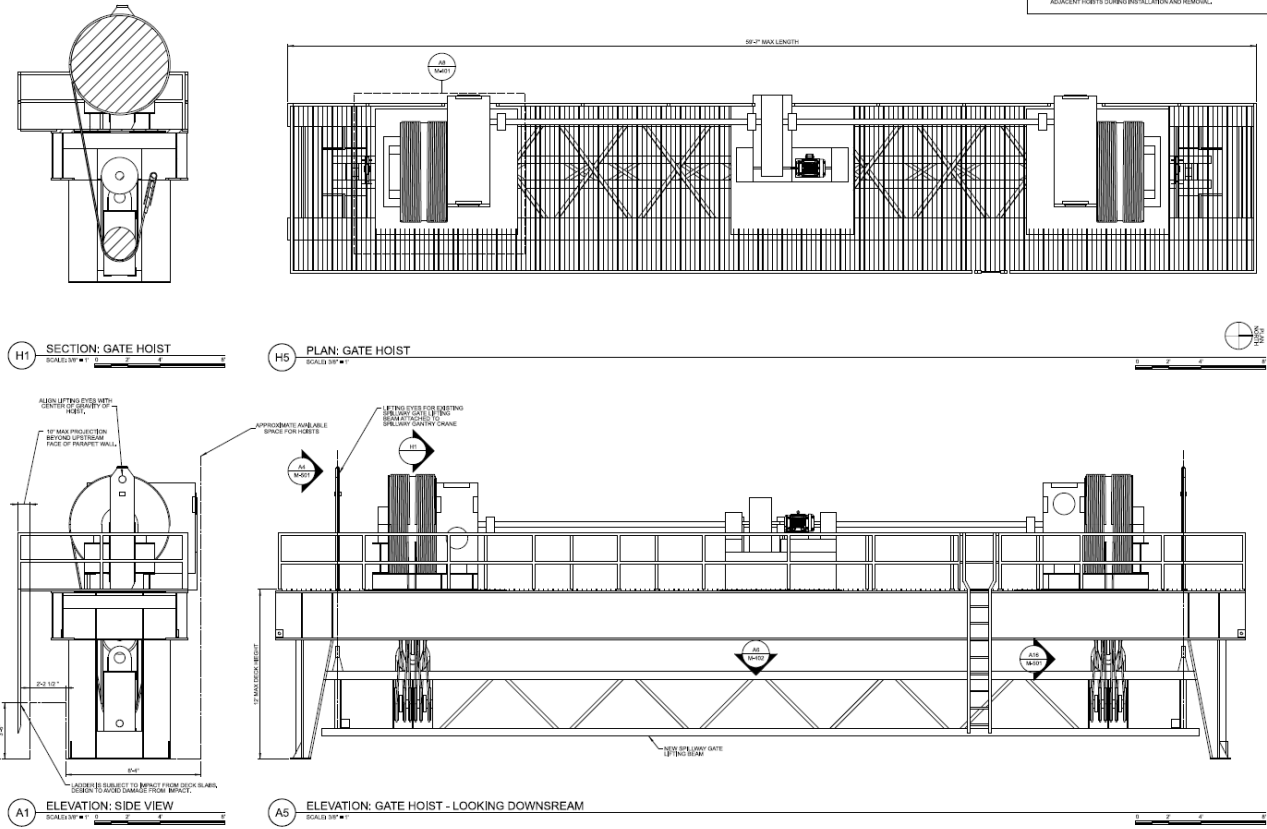
SEE PLAN FOR HOIST AND RAIL POSITIONING, WITH LIFTING EYE. DIMENSIONED TO CENTER OF HOIST TO BE REMOVED FROM HOISTING UP ON THE ADJACENT HOISTS DURING INSTALLATION AND REMOVAL.

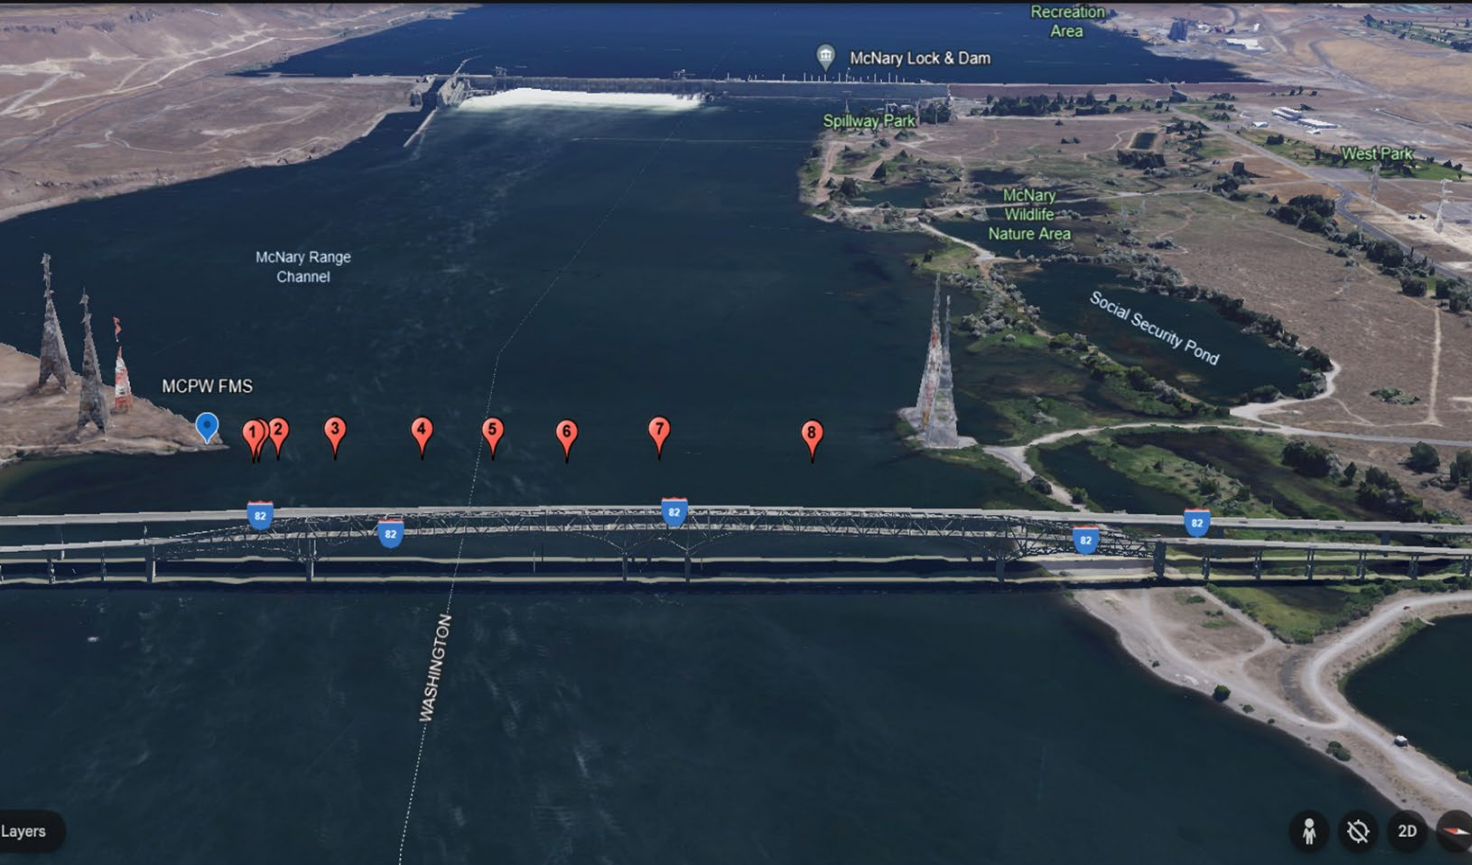
Percent TDG at 2m Depth vs. Data Collection Point

TDG Results Table						
Date	Time UTC	Air Pressure	TDG	Depth	TDG	Location Notes
MM/dd/yyyy	hh:mm:ss	mmHg	mmHg	ft	%	
6/10/2024	18:49:00	755	925	6.3	122.6%	Point 1 (same location as MCPW but at shallower depth)
6/10/2024	19:06:00	755	926	6.4	122.7%	Point 2
6/10/2024	19:25:00	754	930	6.3	123.2%	Point 3
6/10/2024	19:43:00	754	933	6.6	123.7%	Point 4
6/10/2024	20:19:00	754	927	5.9	123.0%	Point 5
6/10/2024	20:43:00	754	921	5.6	122.1%	Point 6
6/10/2024	21:04:00	754	910	6.3	120.8%	Point 7
6/10/2024	21:53:00	753	909	6.0	118.8%	Point 8
						<b>Flow 219 k</b>
						<b>Spill 159 k</b>

TDG was measured and observed for each of the red numbered pinpoints spanning the Columbia River below McNary Dam and upstream of the I-82 bridge. Points 1 through 8 represent the TDG measurements taken at approximately 6-ft (2m) depths.

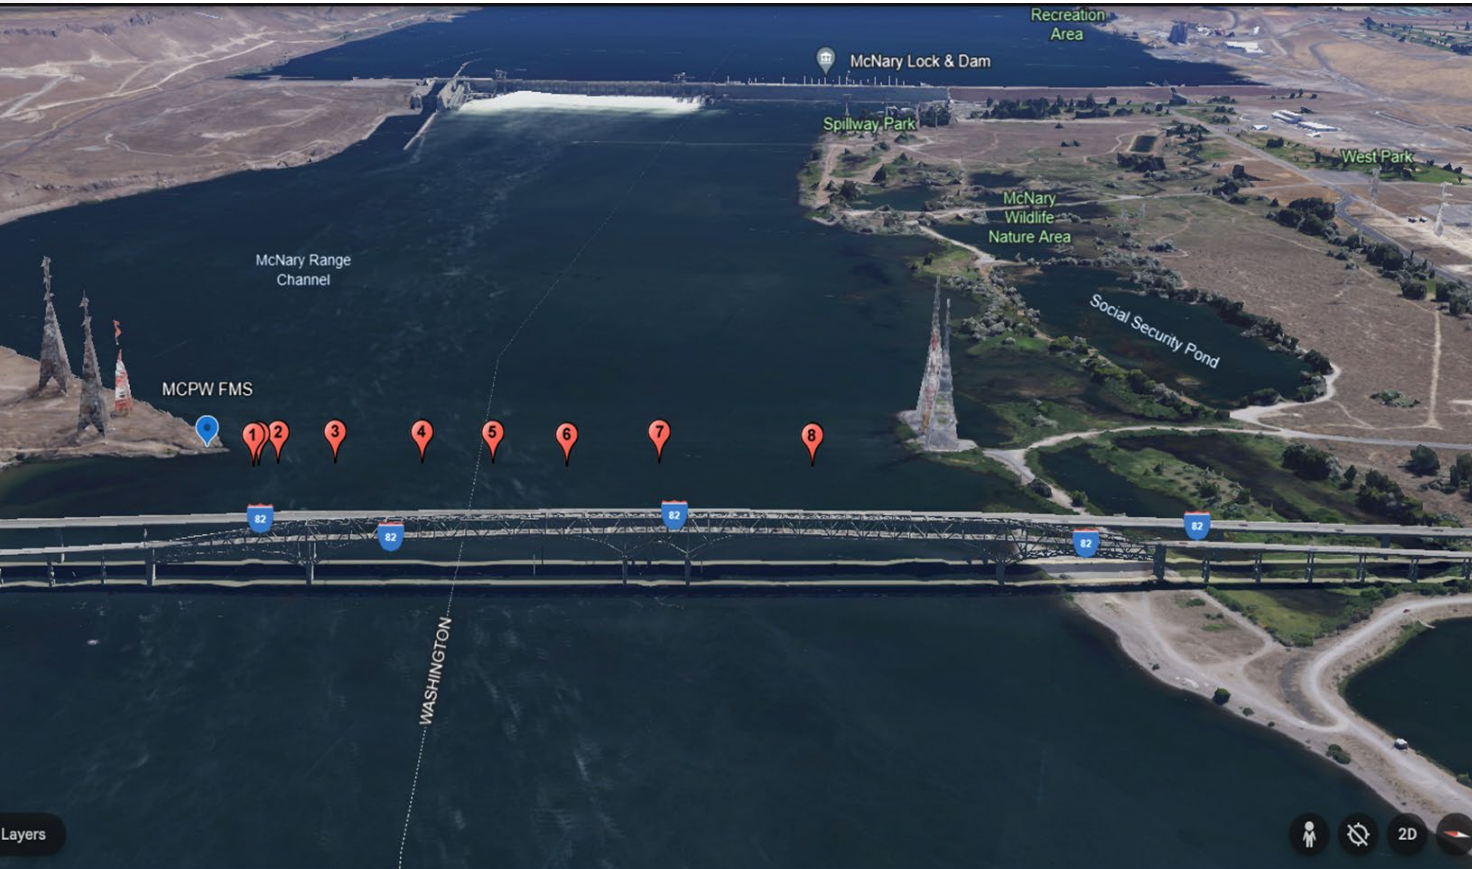
Percent TDG at 2m Depth vs. Data Collection Point

Date	Time UTC	Air Pressure	TDG	Depth	TDG	Location Notes
MM/dd/yyyy	hh:mm:ss	mmHg	mmHg	ft	%	
5/30/2024	17:08:00	762.6	919	18.2	120.5%	Correlation to MCPW. FMS readings: TDG = 120.7%, Depth = 19.0 ft
5/30/2024	17:46:00	762.4	919	6.8	120.5%	Point 1
5/30/2024	18:10:00	762.2	922	6.0	120.9%	Point 2
5/30/2024	18:36:00	761.9	923	5.7	121.1%	Point 3
5/30/2024	19:50:00	761.2	925	6.1	121.5%	Point 4
5/30/2024	20:16:00	761	920	5.8	120.9%	Point 5
5/30/2024	20:36:00	760.8	917	6.0	120.5%	Point 6
5/30/2024	21:18:00	760.4	905	5.4	119.0%	Point 7
5/30/2024	21:50:00	760	889	6.0	116.9%	Point 8

TDG was measured and observed for each of the red pinpoints spanning the Columbia River below McNary Dam and upstream of the I-82 bridge. Points 1 through 8 represent the TDG measurements taken at approximately 6-ft (2m) depths. The red star pin represents the correlation measurement with the Fixed Monitoring Station (FMS) MCPW, taken at approximately 19-ft depth.

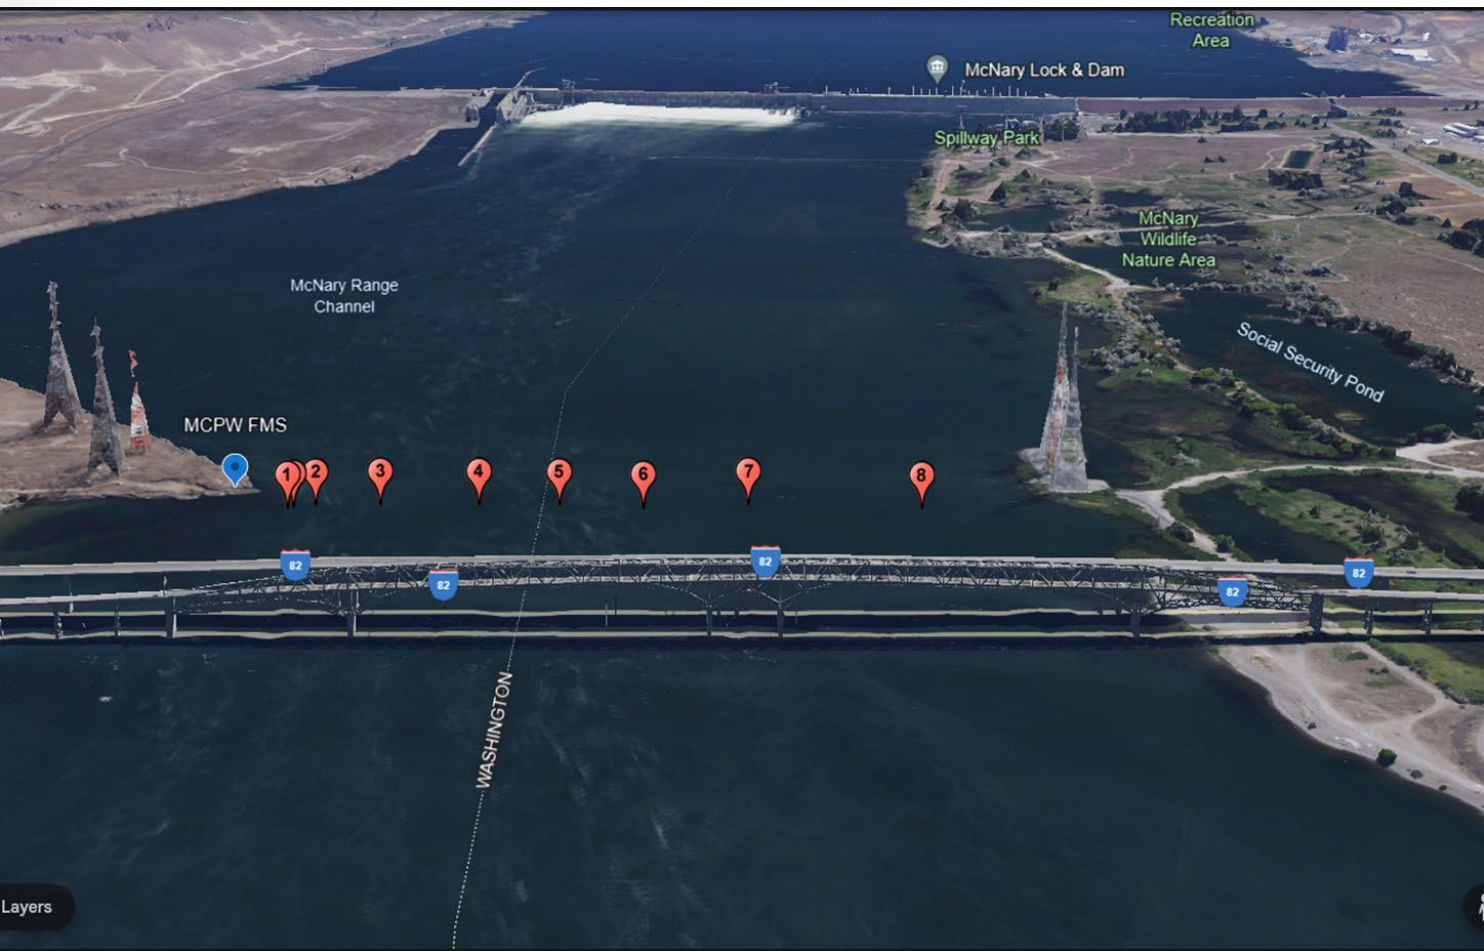
TDG Results Table							
Date	Time UTC	Air Pressure	TDG	Depth	TDG	Field Notes	
MM/dd/yyyy	hh:mm:ss	mmHg	mmHg	ft	%		
4/16/2024	18:00:00	761.0	894	21.3	117.5	MCPW FMS reading: TDG = 117.4%, Depth = 19.0 ft	
4/16/2024	18:08:00	761.0	893	5.6	117.3	Point 1	
4/16/2024	18:22:00	761.0	899	6.1	118.1	Point 2	
4/16/2024	18:38:00	760.9	902	7.6	118.5	Point 3	
4/16/2024	19:50:00	760.3	902	6.1	118.6	Point 4	
4/16/2024	20:20:00	760.0	900	6.1	118.4	Point 5	
4/16/2024	20:48:00	759.9	896	6.6	117.8	Point 6	
4/16/2024	21:25:00	760.6	885	6.8	116.4	Point 7	<b>Flow 174 kcfs</b>
4/16/2024	21:52:00	759.3	880	6.5	115.8	Point 8	<b>Spill 115 kcfs</b>

TDG was measured and observed for each of the red pinpoints spanning the Columbia River below McNary Dam and upstream of the I-82 bridge. Points 1 through 8 represent the TDG measurements taken at approximately 6-ft depths. The red star pin represents the correlation measurement with the Fixed Monitoring Station (FMS) MCPW, taken at approximately 20-ft depth.
