# The Dalles Dam Fishway Status Report

Inspection Period: 03/13/2016-03/19/2016

## THE DALLES DAM

US Army Corps  
of Engineers  
Portland District

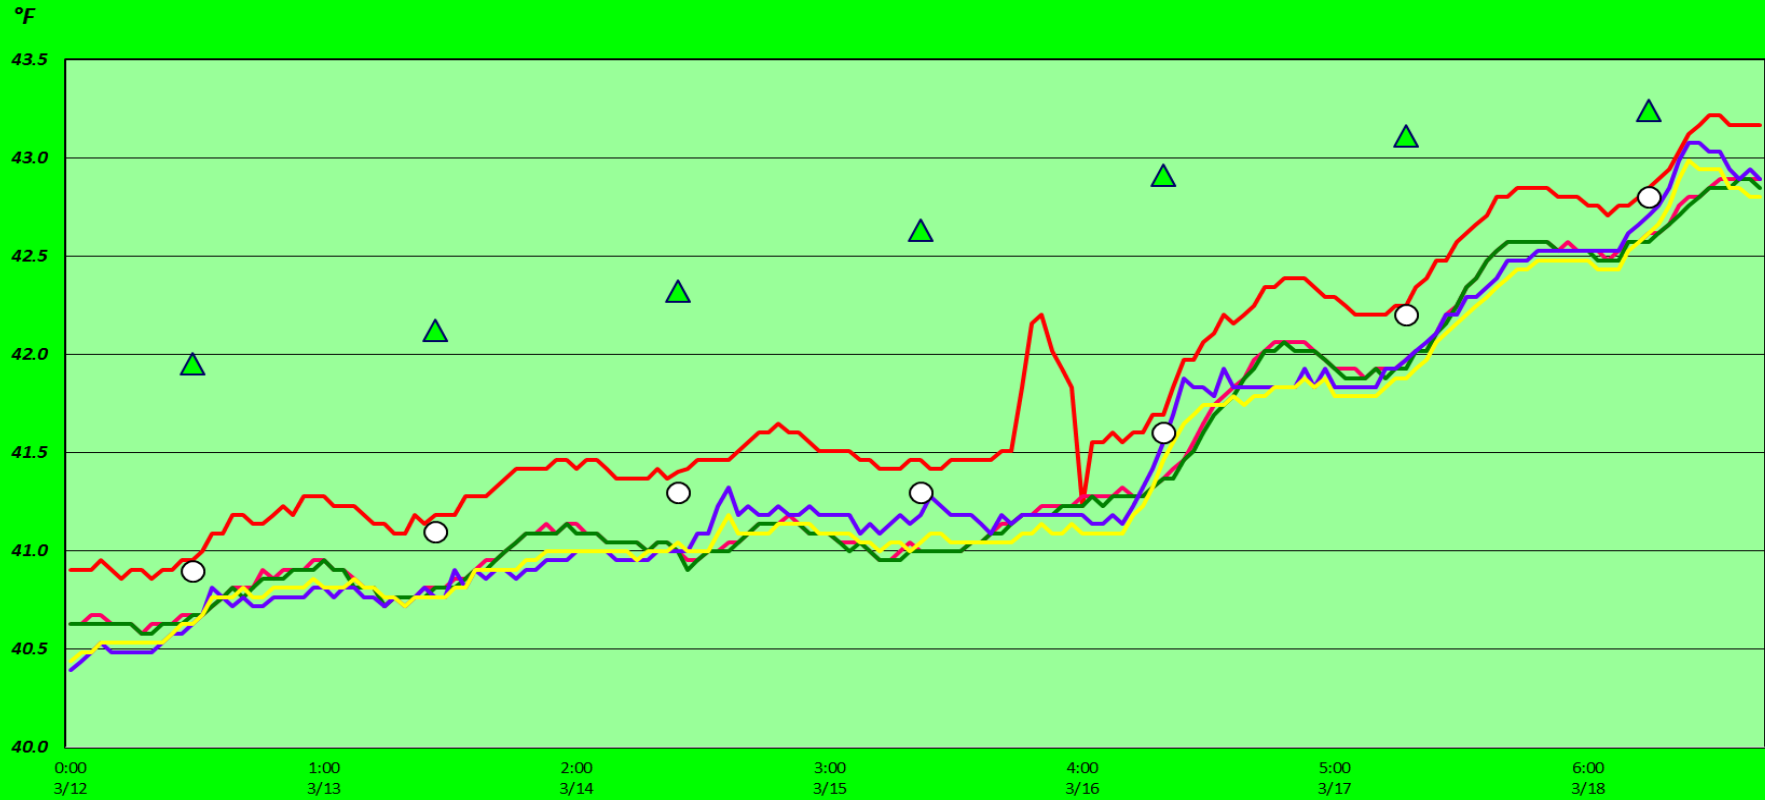
## The Dalles Dam Adult Fish Ladder/River Temperatures

Secchi:		Temperatures
4.0	Sun	40.9
3.0	Mon	41.1
3.0	Tue	41.3
3.0	Wed	41.3
3.0	Thurs	41.6
3.0	Fri	42.2
2.5	Sat	42.8
3.1	AVG	41.7
