The Dalles Dam Fishway Status Report

12/22/18

Inspection Period: Dec. 16 - Dec. 22, 2018

US Army Corps
of Engineers
Portland District

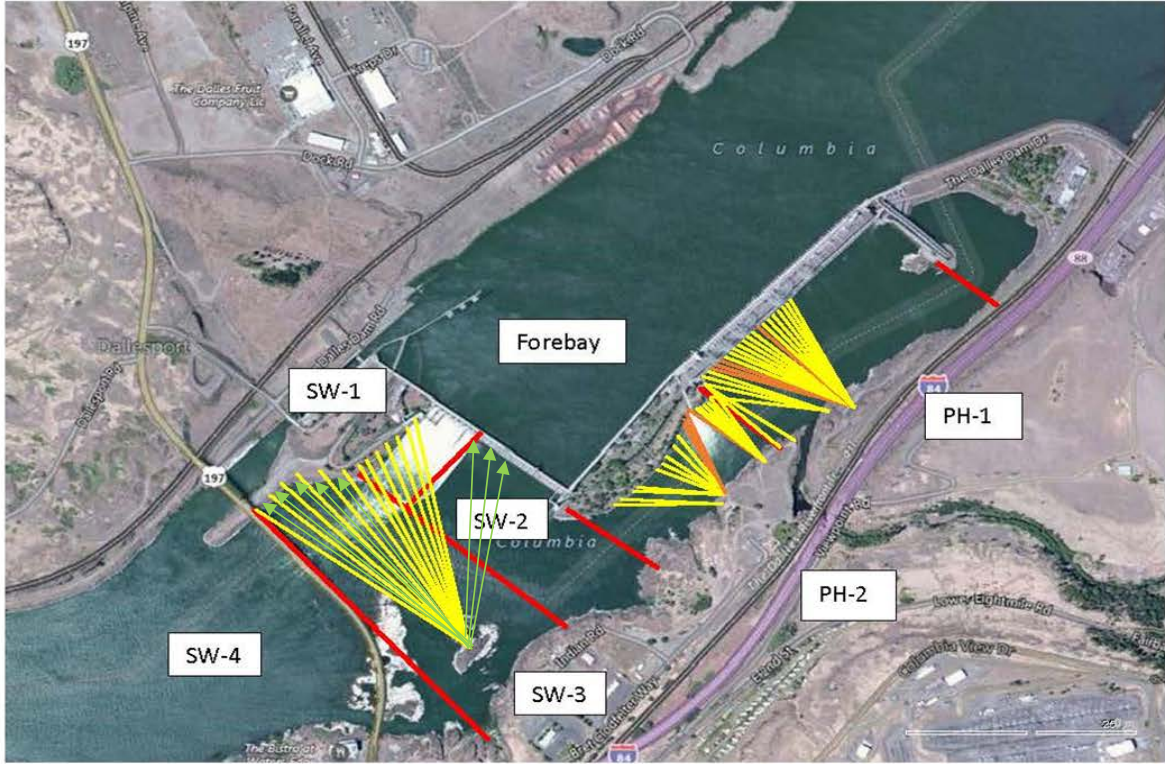
Red lines = avian zones

Yellow lines = current wires

Orange lines = down or missing wires

→ Additional avian lines installed 9/2018
