The Dalles Dam Fishway Status Report

Date: 02/09/2014
 Inspection Period: 02/02/2014-02/08/2014

THE DALLES DAM

US Army Corps
 of Engineers
 Portland District

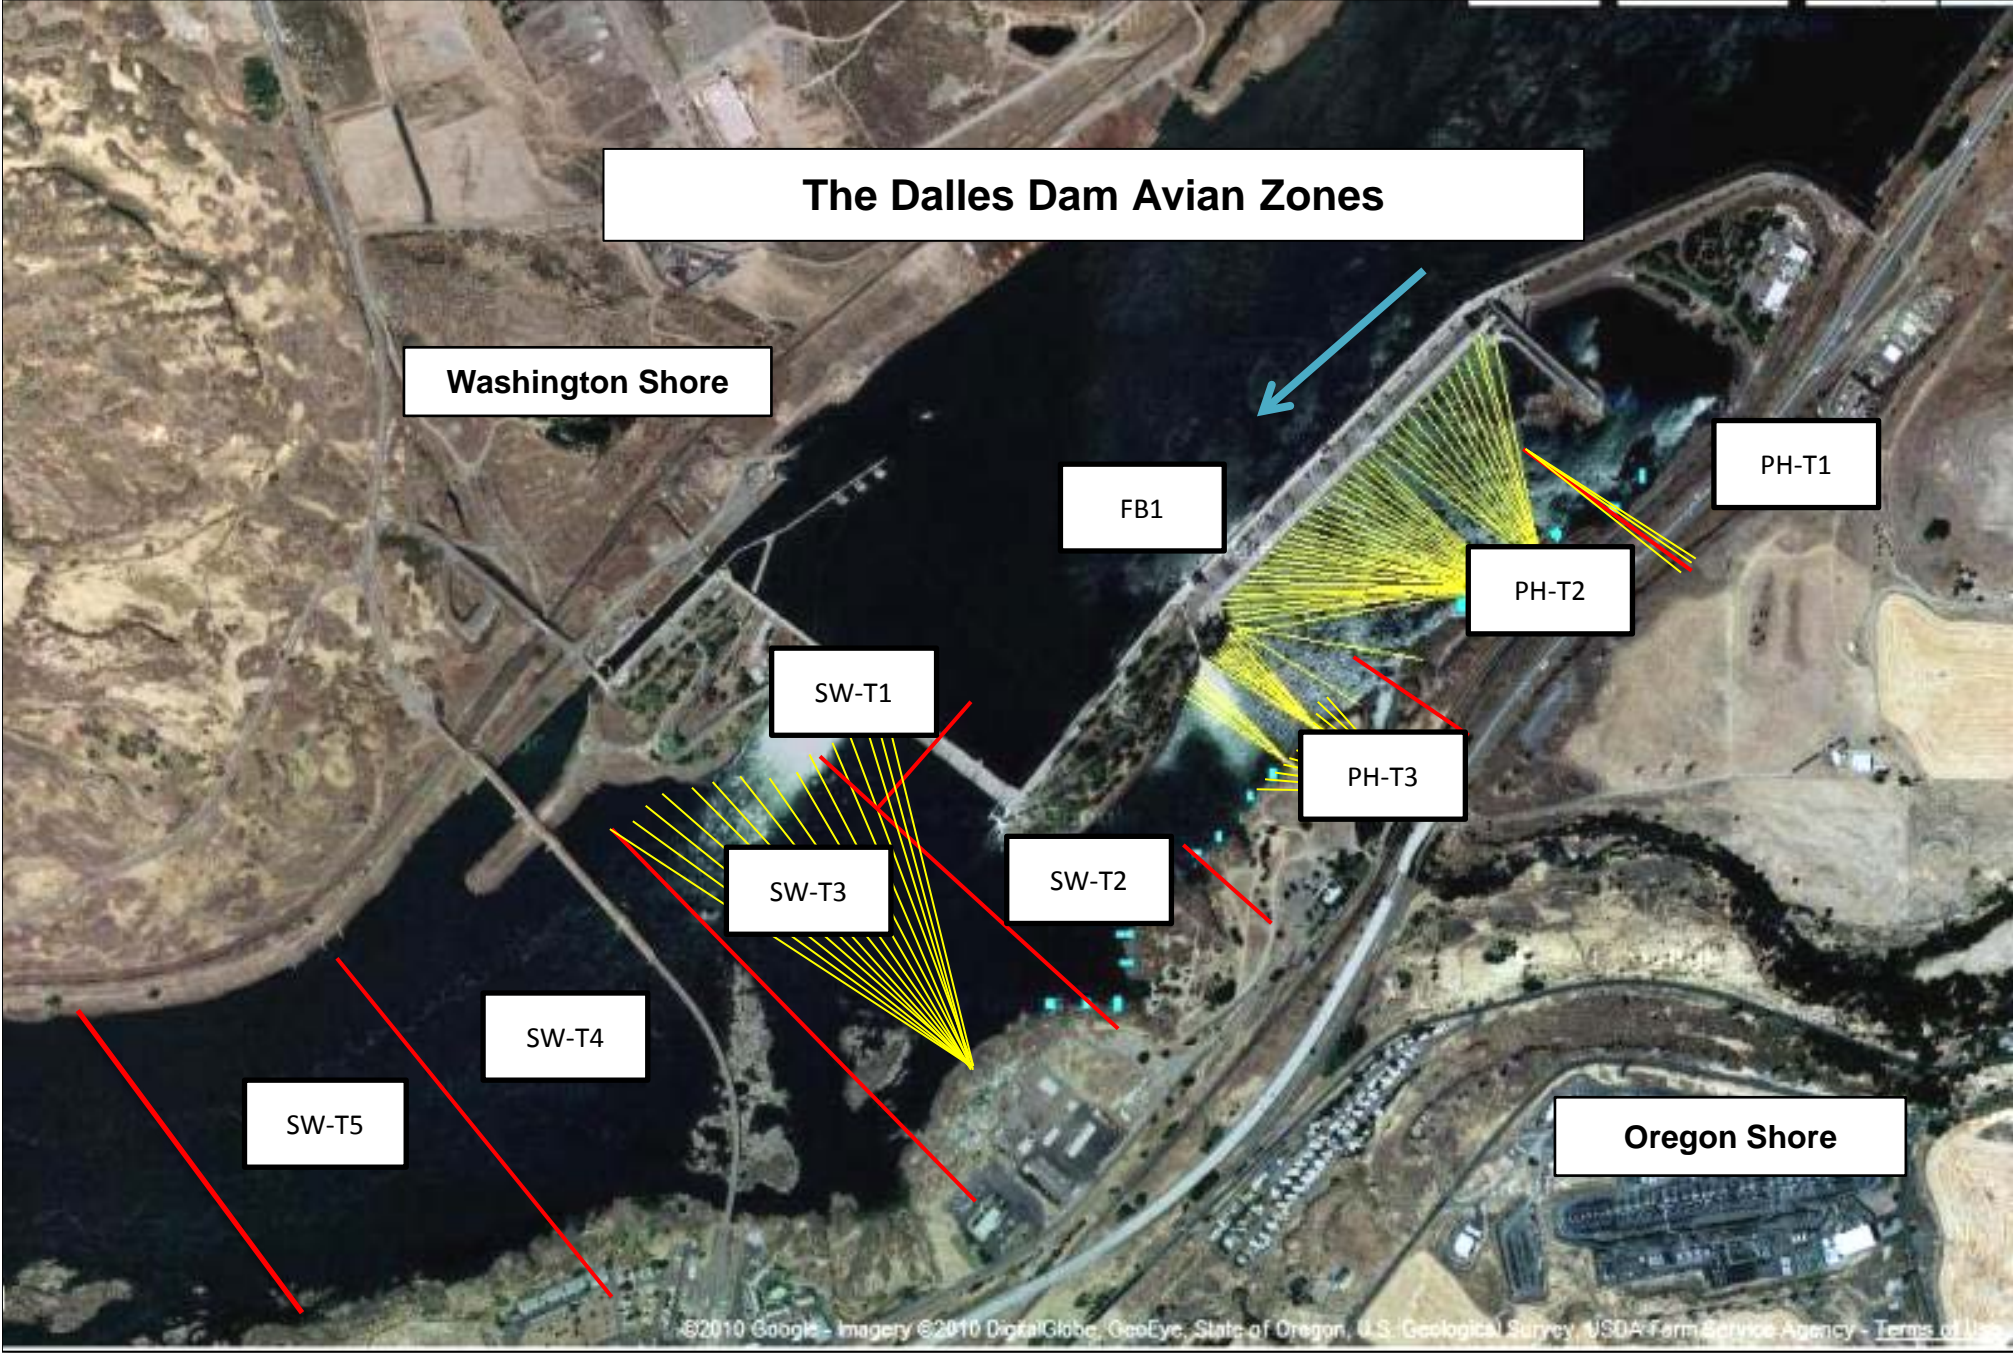
Bird observation data collected once daily. Fewer eagles foraging/roosting at Westick park. Great blue herons scavenging on shad carcasses below roosting trees. See avian zones map and distribution details.

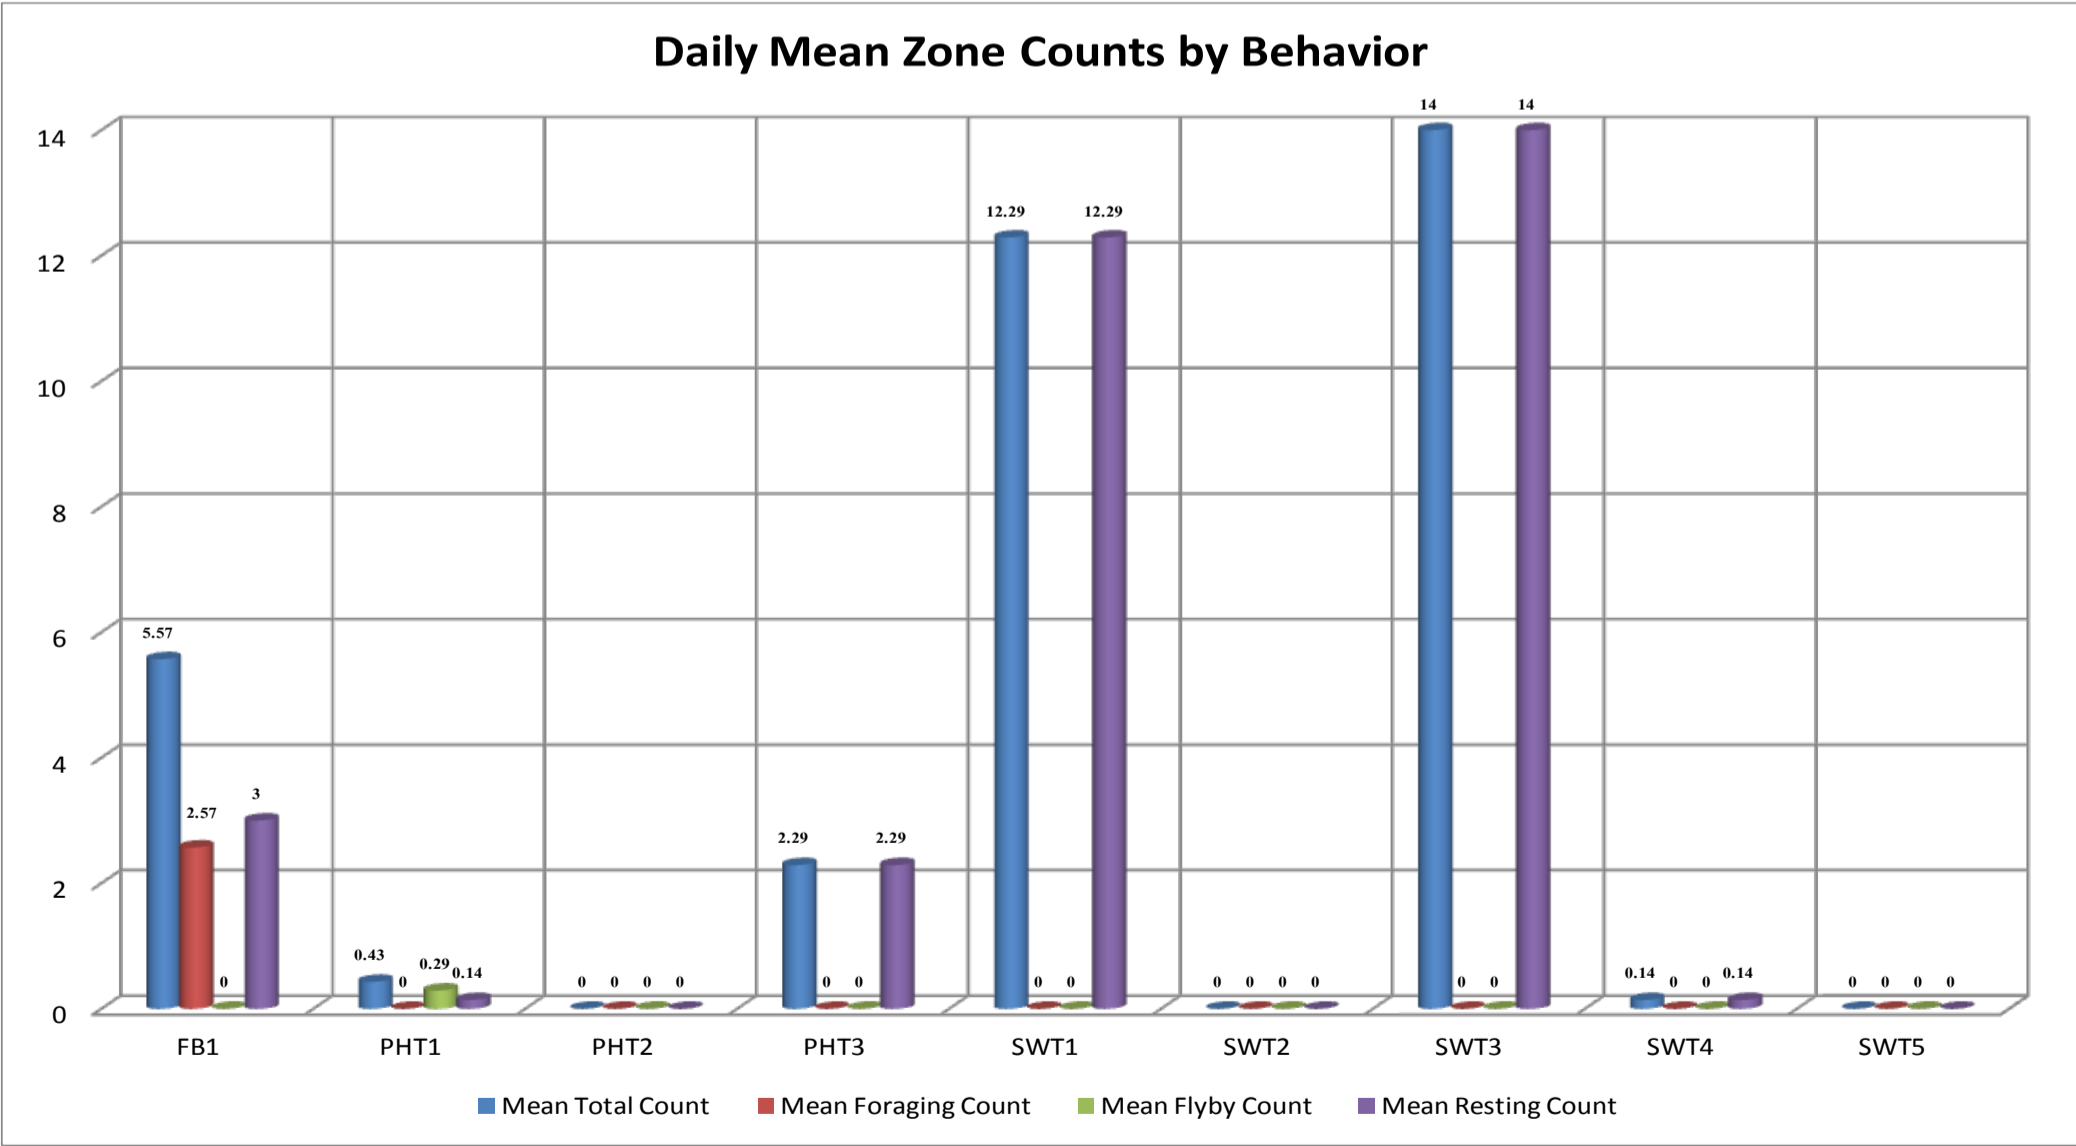
BAEA - Bald Eagle; COME - Common Merganser; DCCO - double crested cormorant; GBHE - Great Blue Heron; GREBE - Grebe; Gull- Gull (all species)

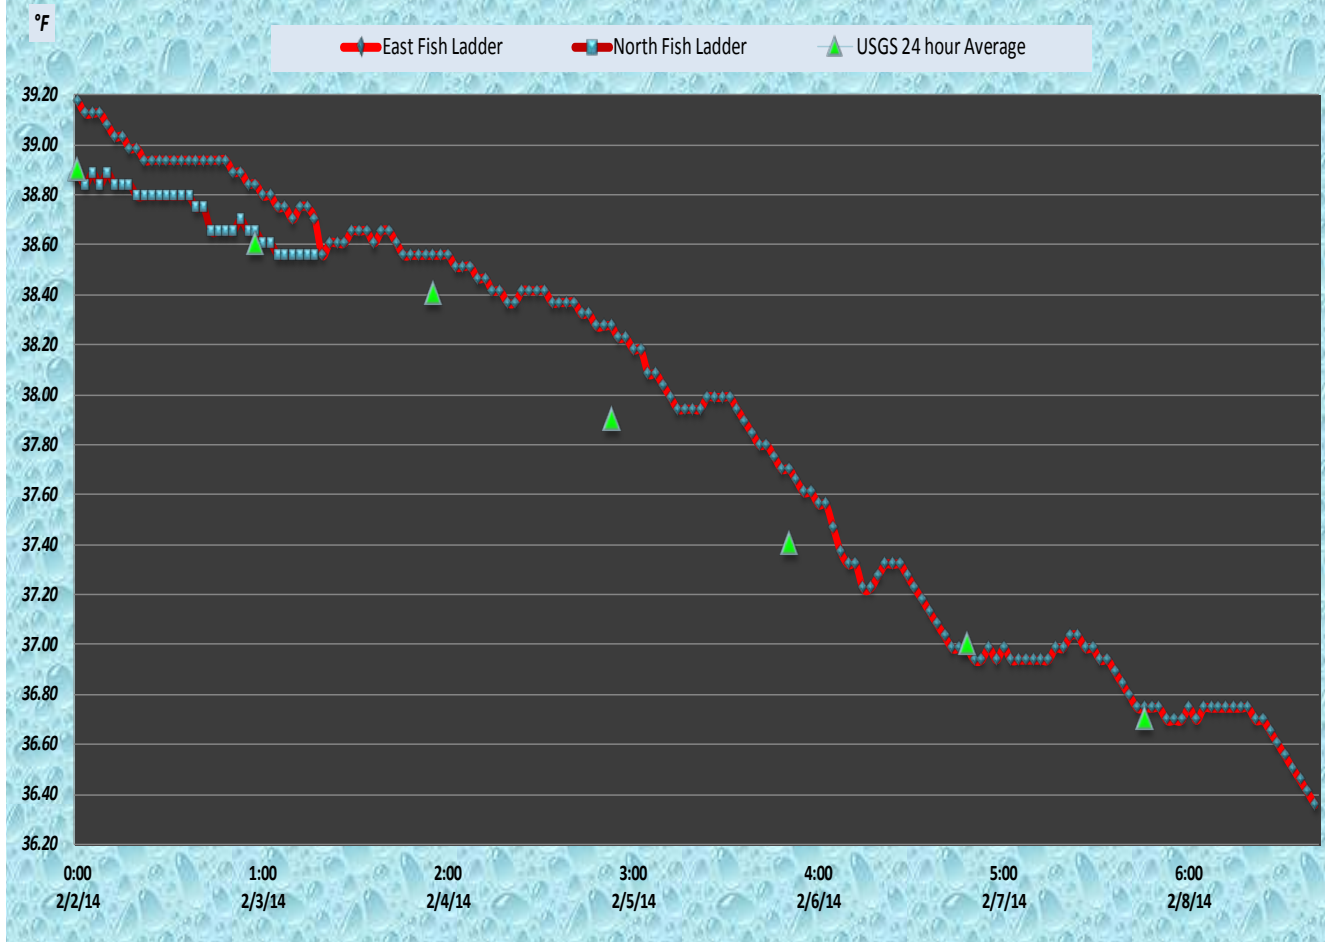
The Dalles Dam Adult Fish Ladder River/Water Temperatures

Temp:		Secchi:	
	38.9	SUN	5.5
	38.6	MON	5.5
	38.4	TUES	5.5
	37.9	WED	5.5
	37.4	THUR	5.5
	37.0	FRI	5.5
	36.7	SAT	5.5
AVG:	37.8	AVG:	5.5
