# The Dalles Dam Fishway Status Report

1/31/2015  
 Inspection Period: 1/25/2014 to 1/31/2015

## THE DALLES DAM

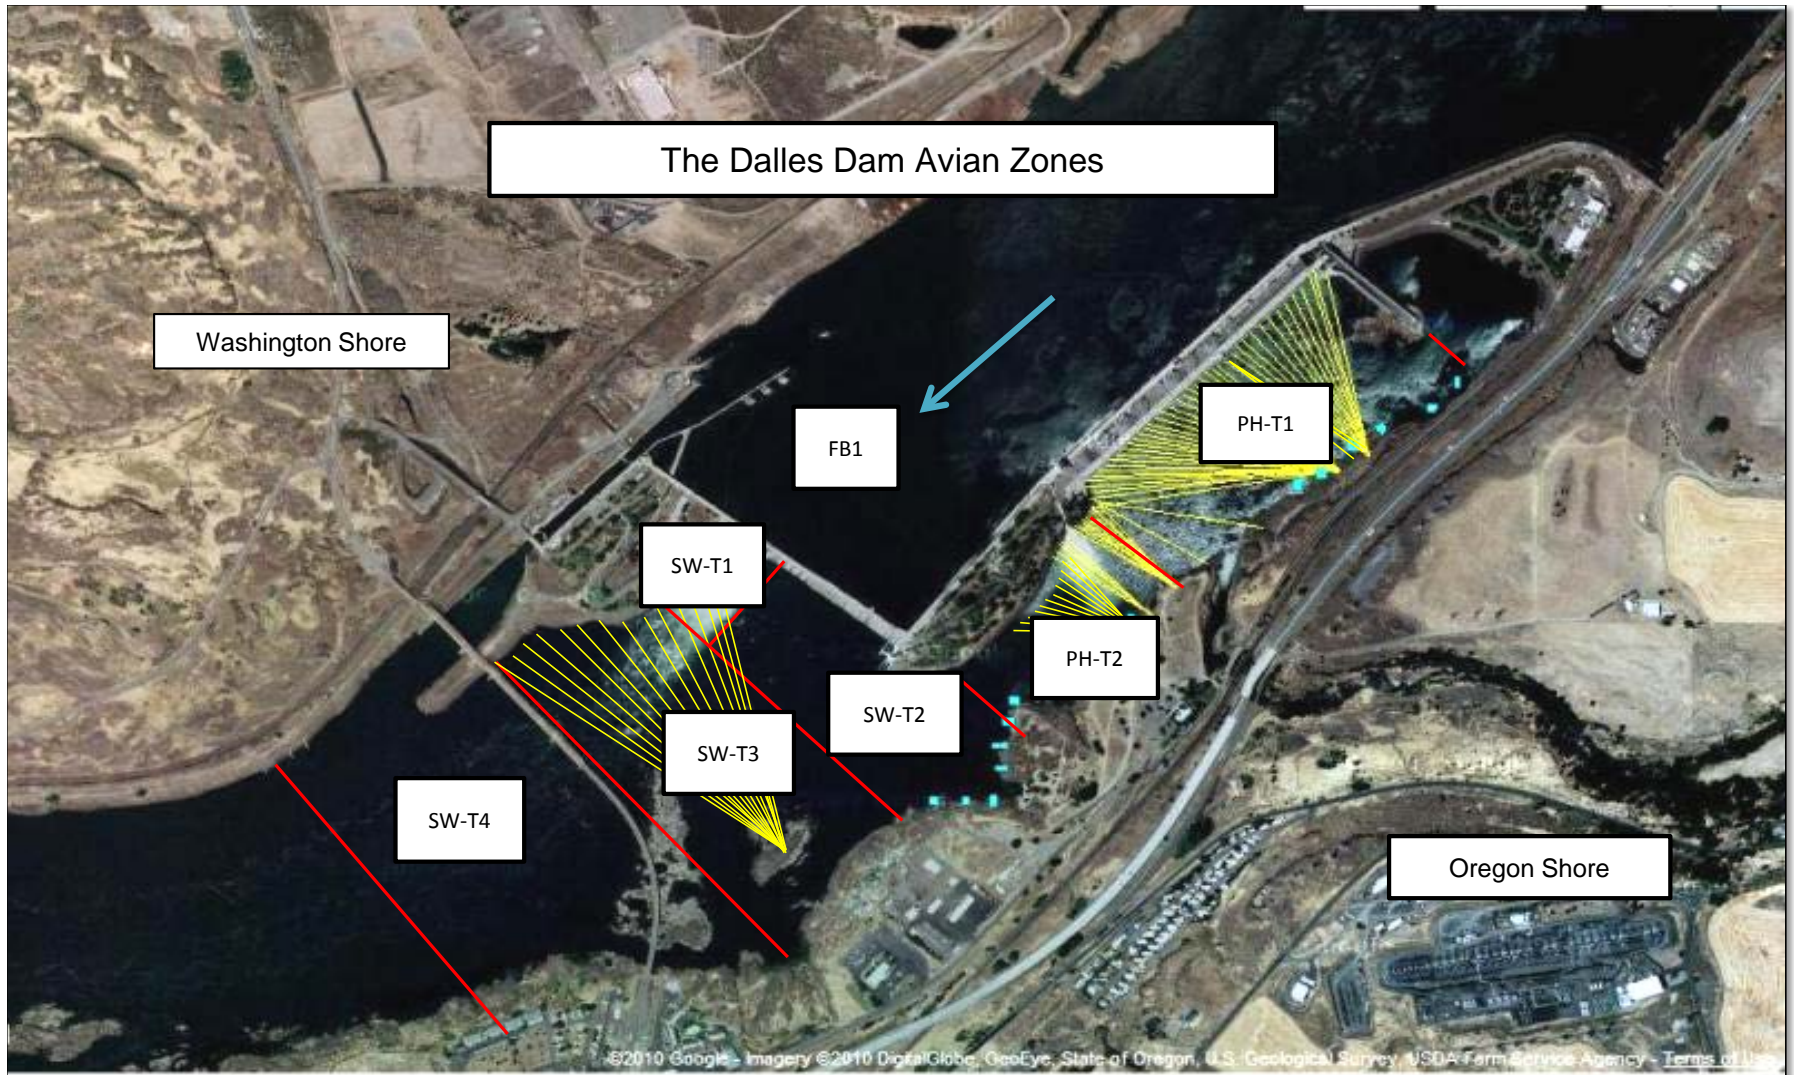
Bird observation data collected once daily. Eagle numbers appear decreasing. Refer to Avian Zone Map.

Avian lines in yellow, zones in red, river flow in blue.
