The Dalles Dam Fishway Status Report

Inspection Period:9/20-9/25/2021

THE DALLES DAM

US Army Corps
of Engineers
Portland District

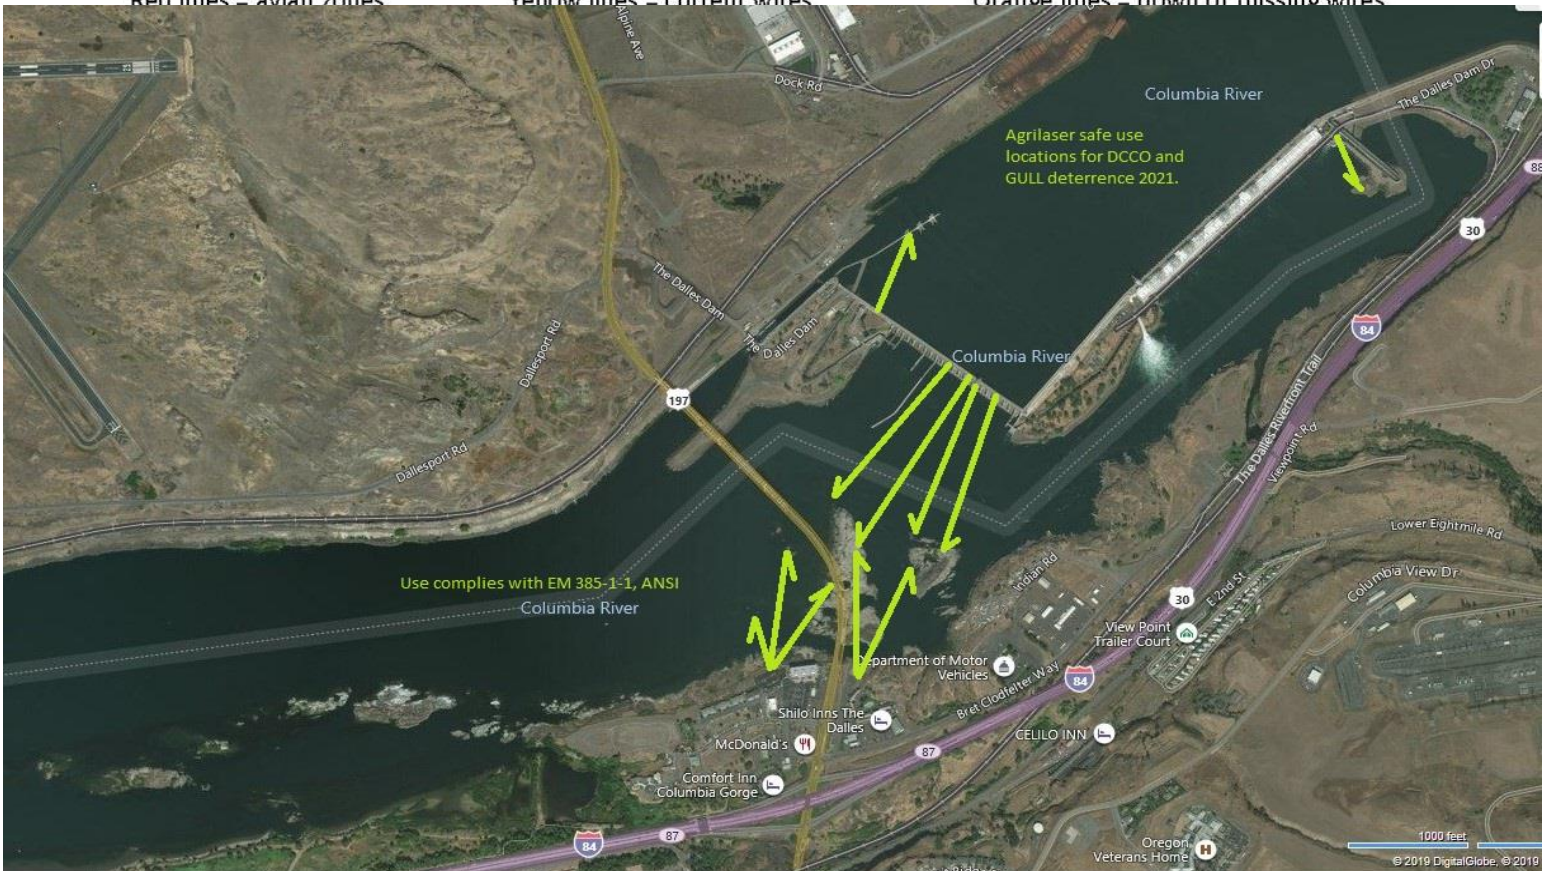
Yellow lines = current wires

Orange lines = down or missing wires

Agrilaser safe use locations for DCCO and GULL deterrence 2021.
