The Dalles Dam Fishway Status Report

Inspection Period: 11/7 - 11/13/2021

THE DALLES DAM

US Army Corps
of Engineers
Portland District

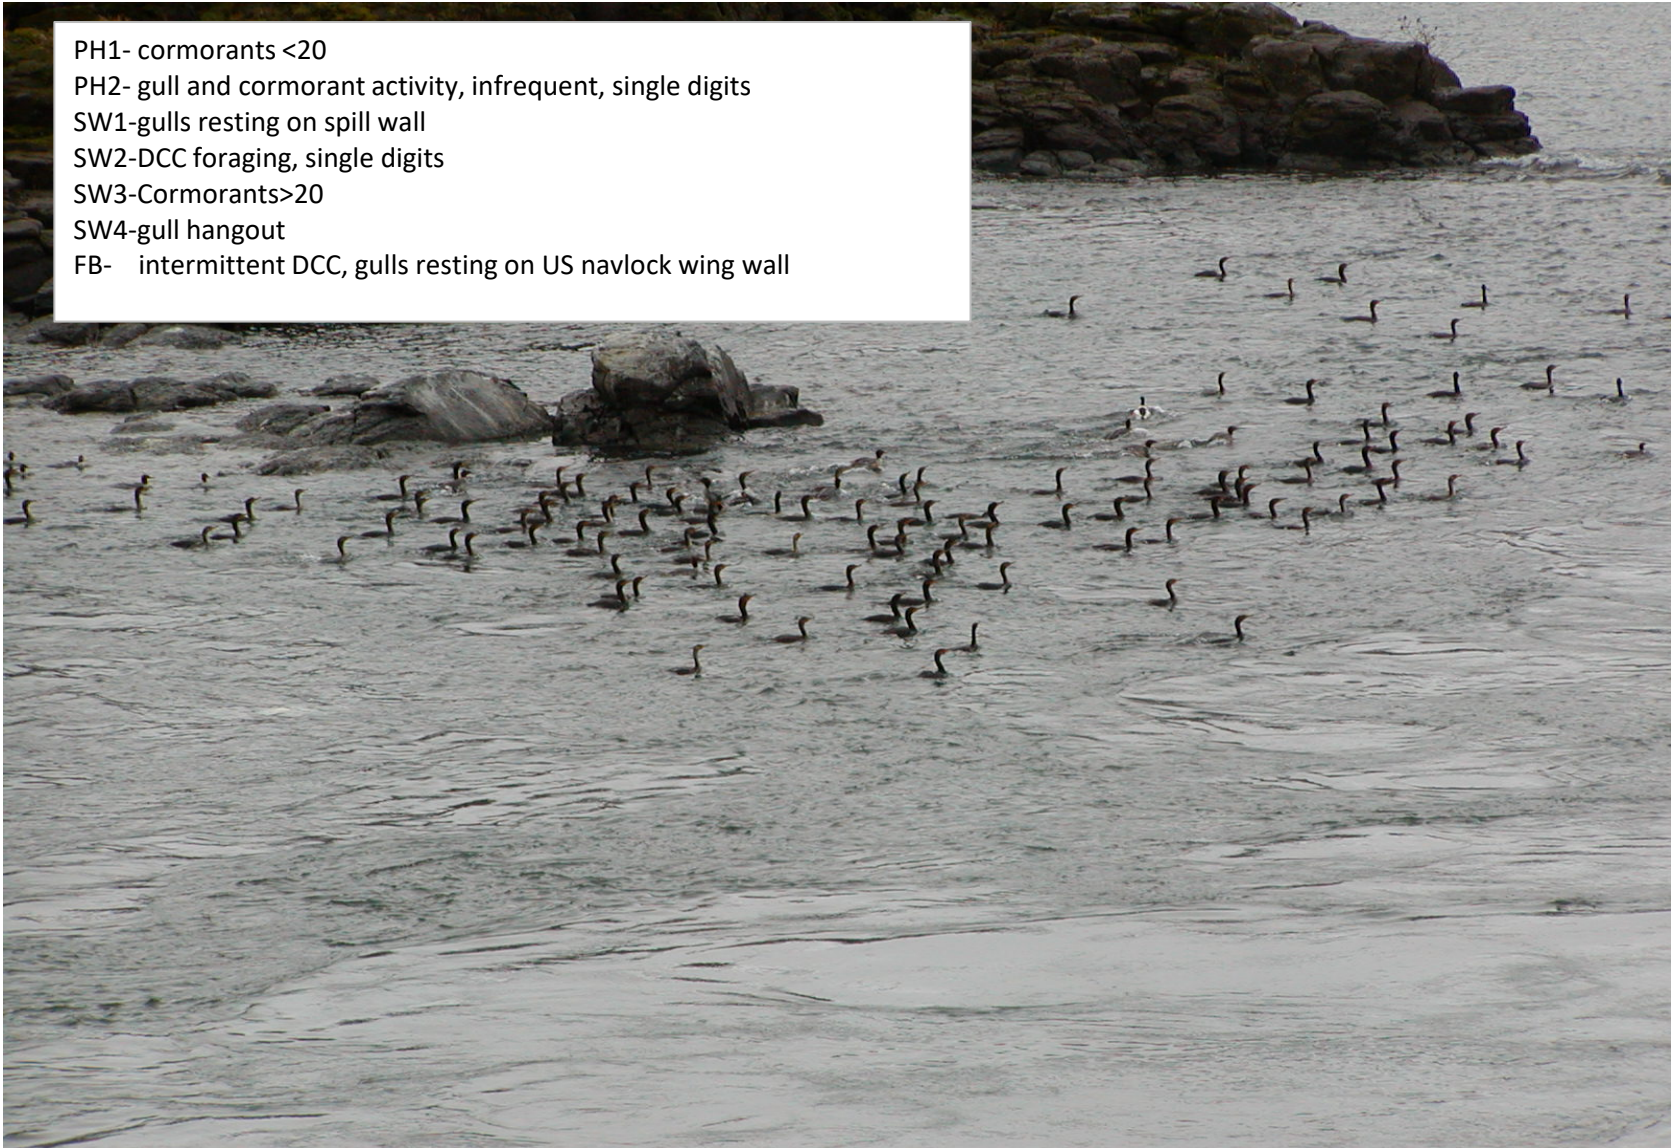
Agrilaser safe use locations for DCCO and GULL deterrence 2021.

PH1- cormorants <20
PH2- gull and cormorant activity, infrequent, single digits
SW1-gulls resting on spill wall
SW2-DCC foraging, single digits
SW3-Cormorants>20
SW4-gull hangout
FB- intermittent DCC, gulls resting on US navlock wing wall
