The Dalles Dam Fishway Status Report

Inspection Period: 1/30 - 2/5/2022

THE DALLES DAM

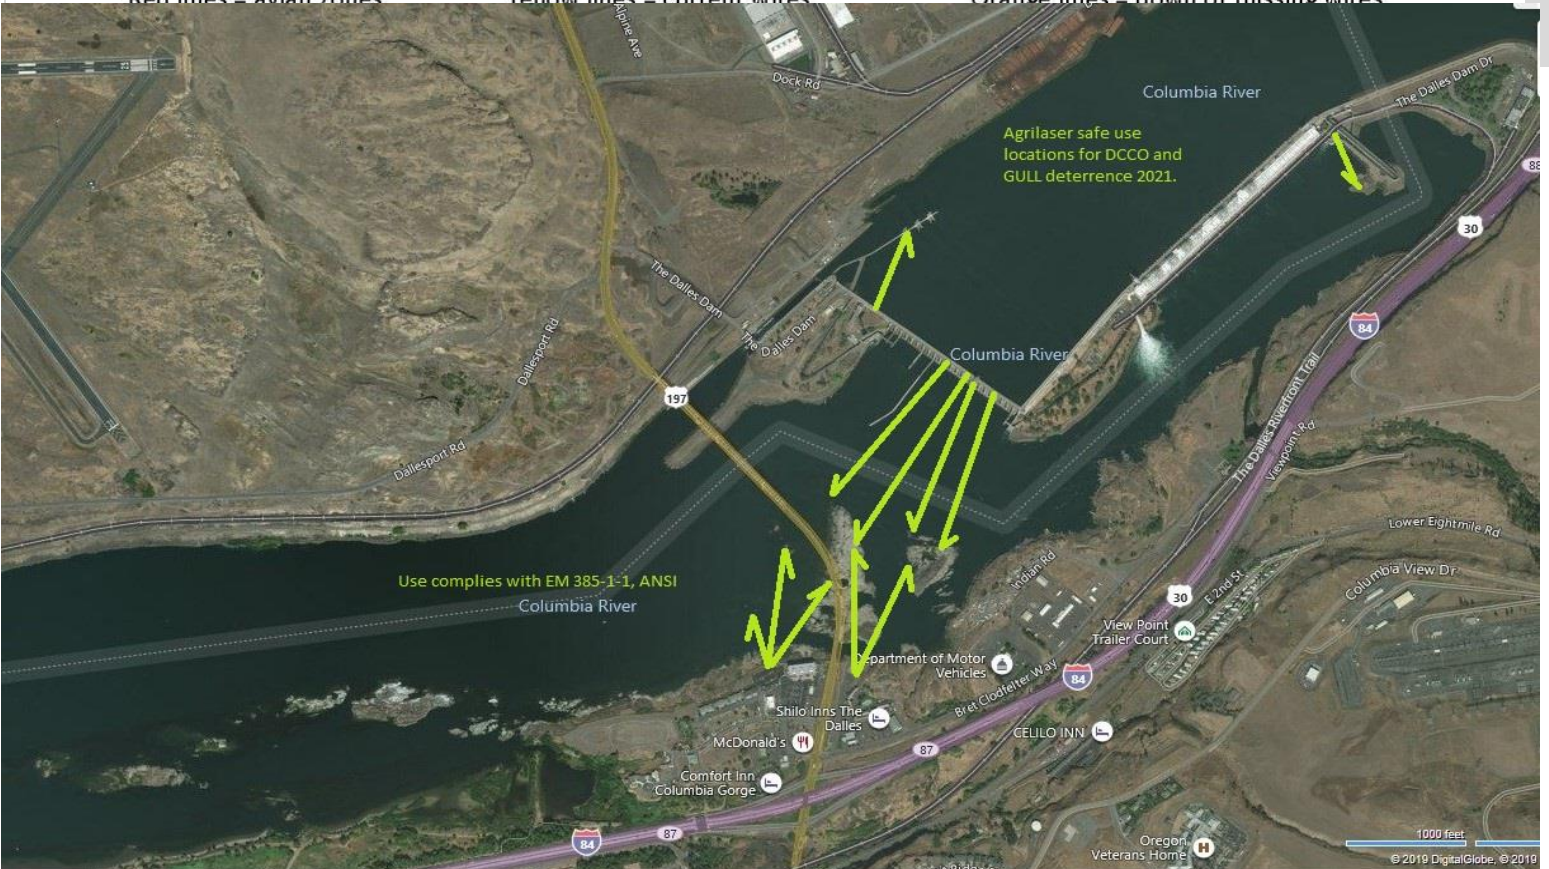
Yellow lines = current wires

Orange lines = down or missing wires

Agrilaser safe use locations for DCCO and GULL deterrence 2021.
