# The Dalles Dam Fishway Status Report

## 1/8/2017

Inspection Period: 01/07/2017 - 01/07/2017

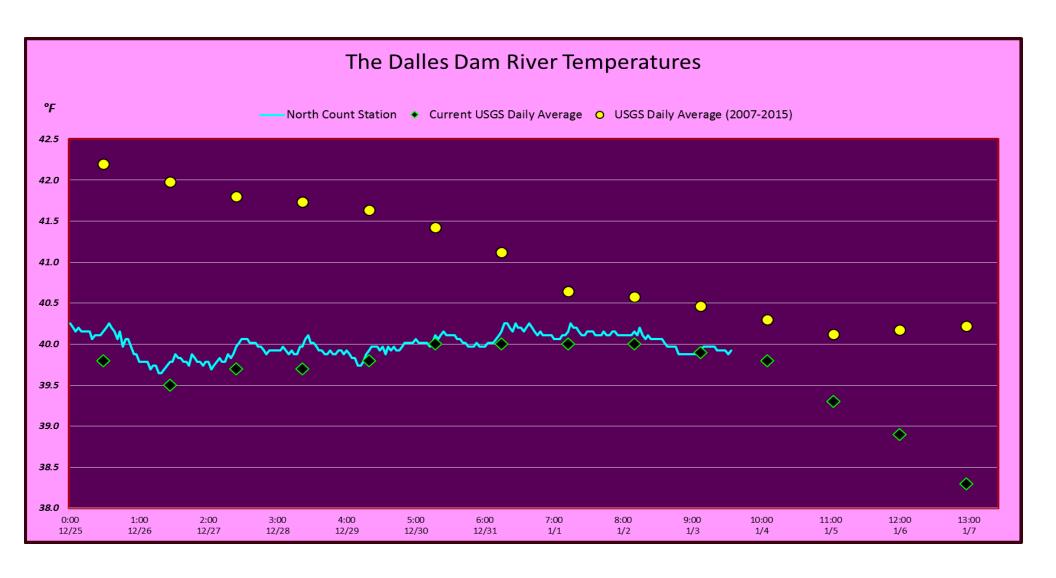
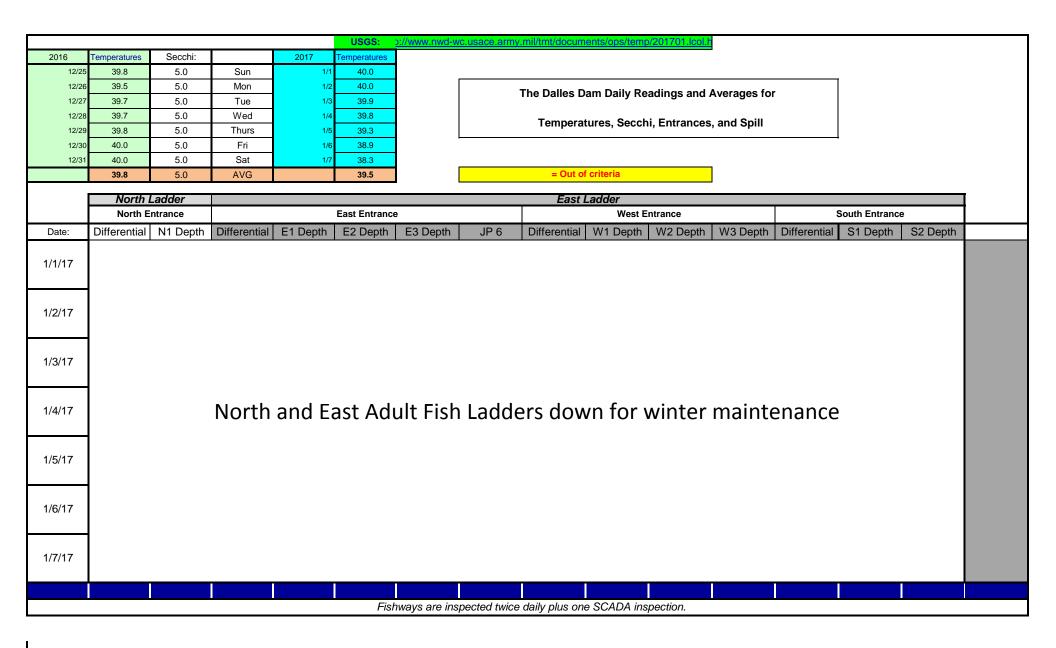
Too much ice coverage to dewater north fishway entrance below tailwater. Postponed. Would require ice fishing tactics for fish salvage.
