The Dalles Dam Fishway Status Report

Inspection Period: 02/26/2017 - 03/04/2017

THE DALLES DAM

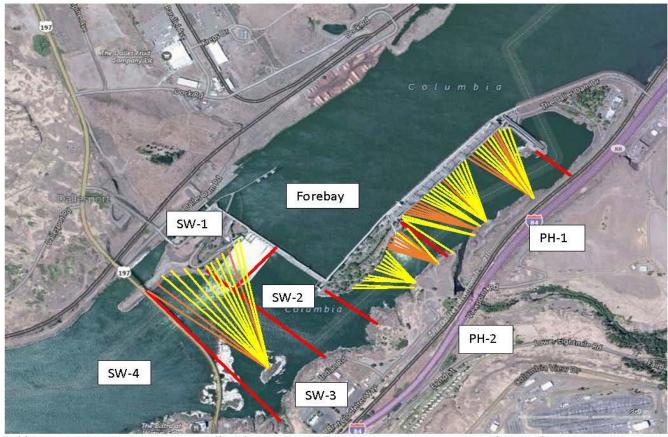
Spillway avian lines repair planned. Awaiting USDA signatures for work plan. USDA prework site tour occurred Mar1.

Red lines = avian zones

Yellow lines = current wires

Orange lines = down or missing wires
