The Dalles Dam Fishway Status Report

Date: 5/18/2014
Inspection Period: 5/11/2014 to 5/17/2014

THE DALLES DAM

US Army Corps of Engineers
Portland District

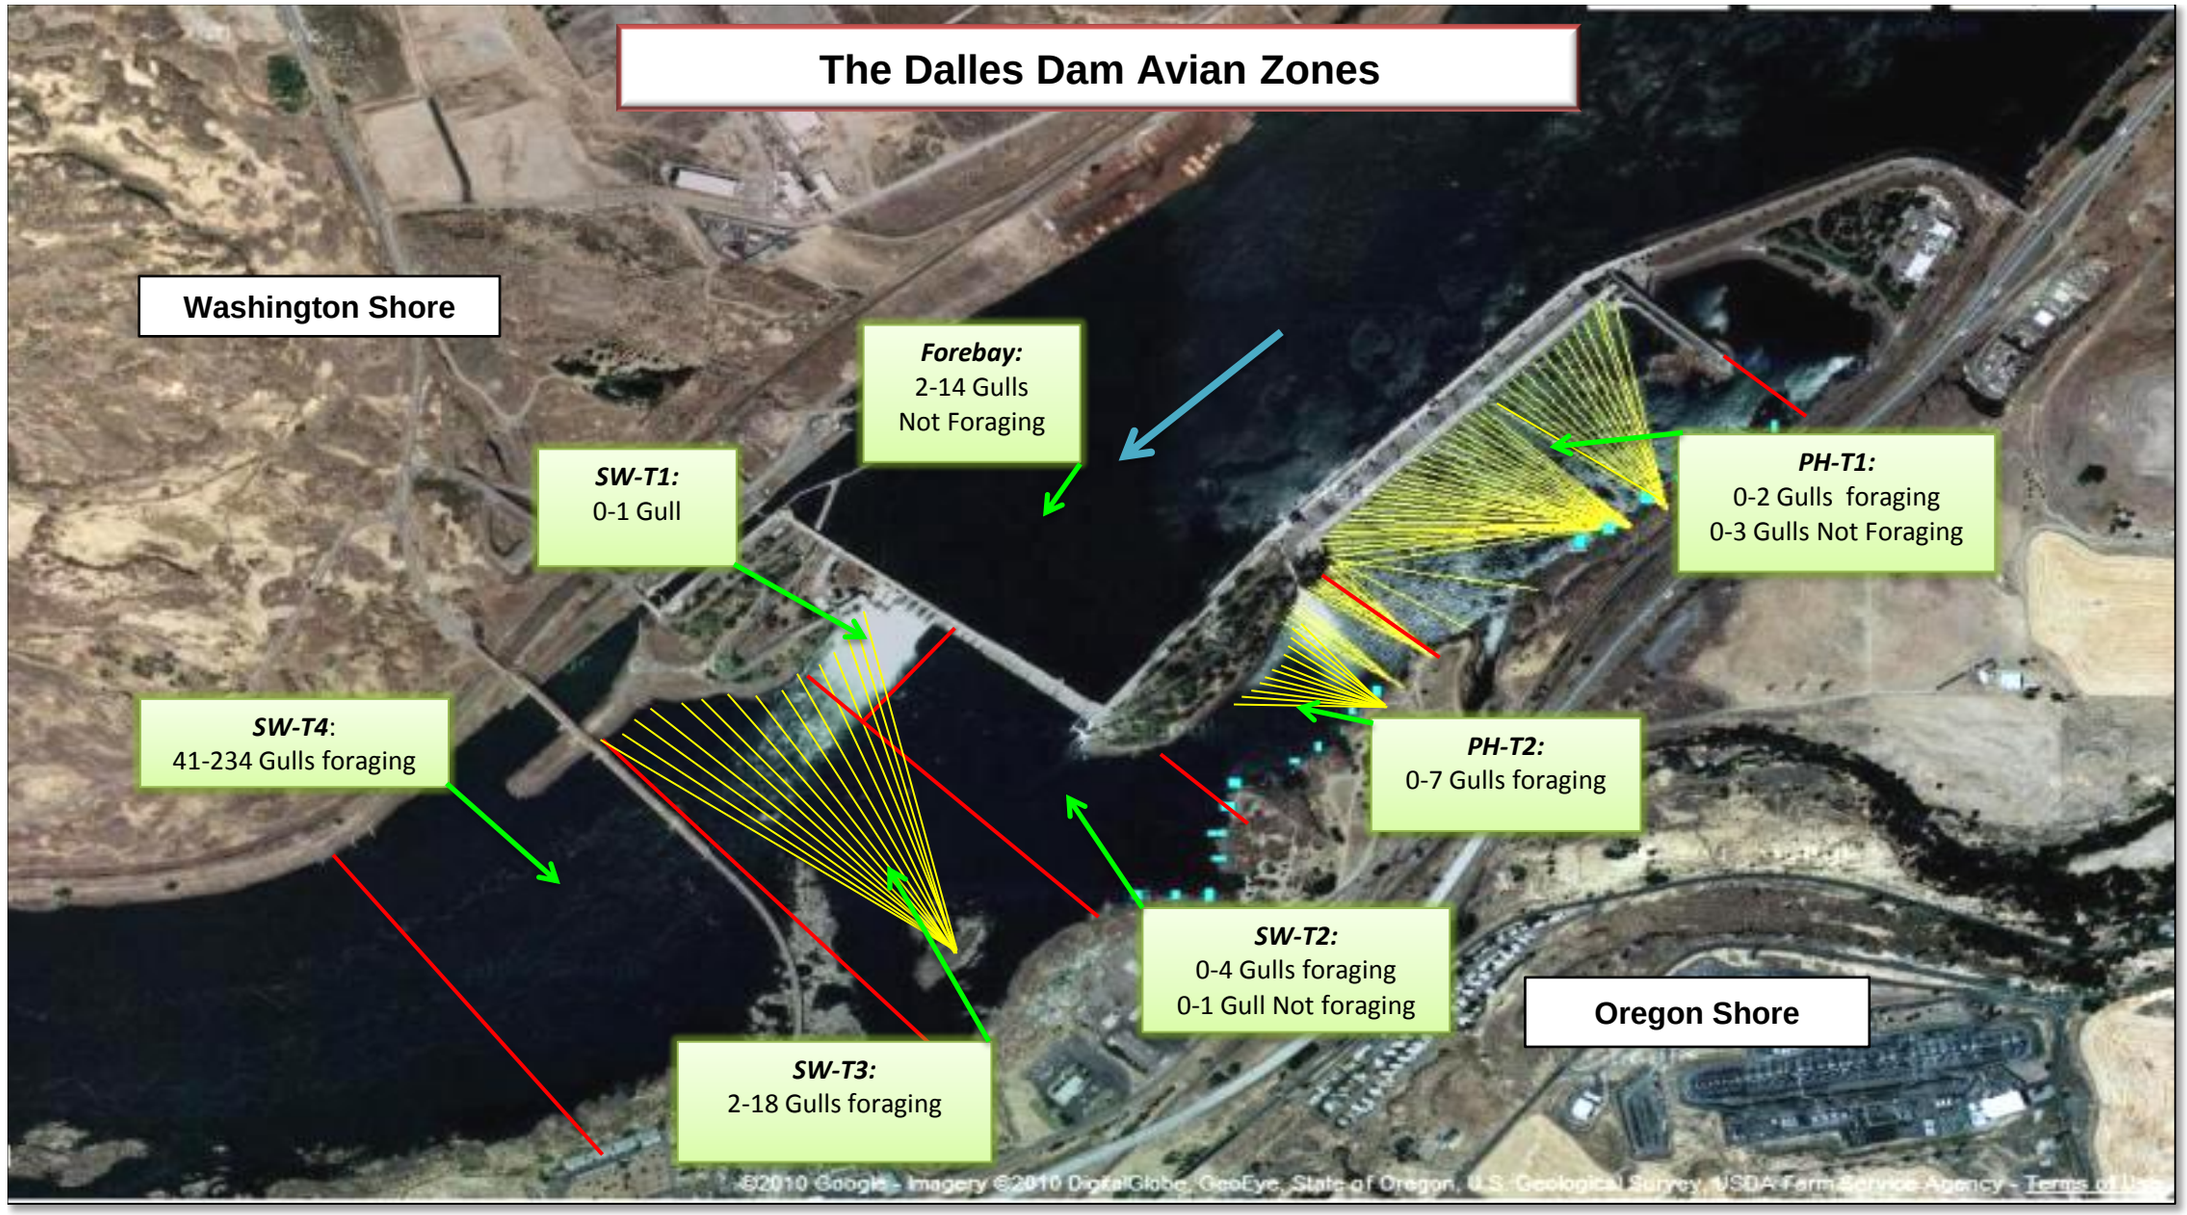
Birds/Sea lions:
Bird observation data collected once daily. Gull numbers are increasing down stream of the bridge. See avian zones map for details.
Hazing appears temporarily effective downstream of bridge. Nearing trigger for high gull numbers, but no additional action items available.
No sea lion sightings for this week.

Hazing activity primarily in SW-T4
Numbers reflect weekly range of daily averages

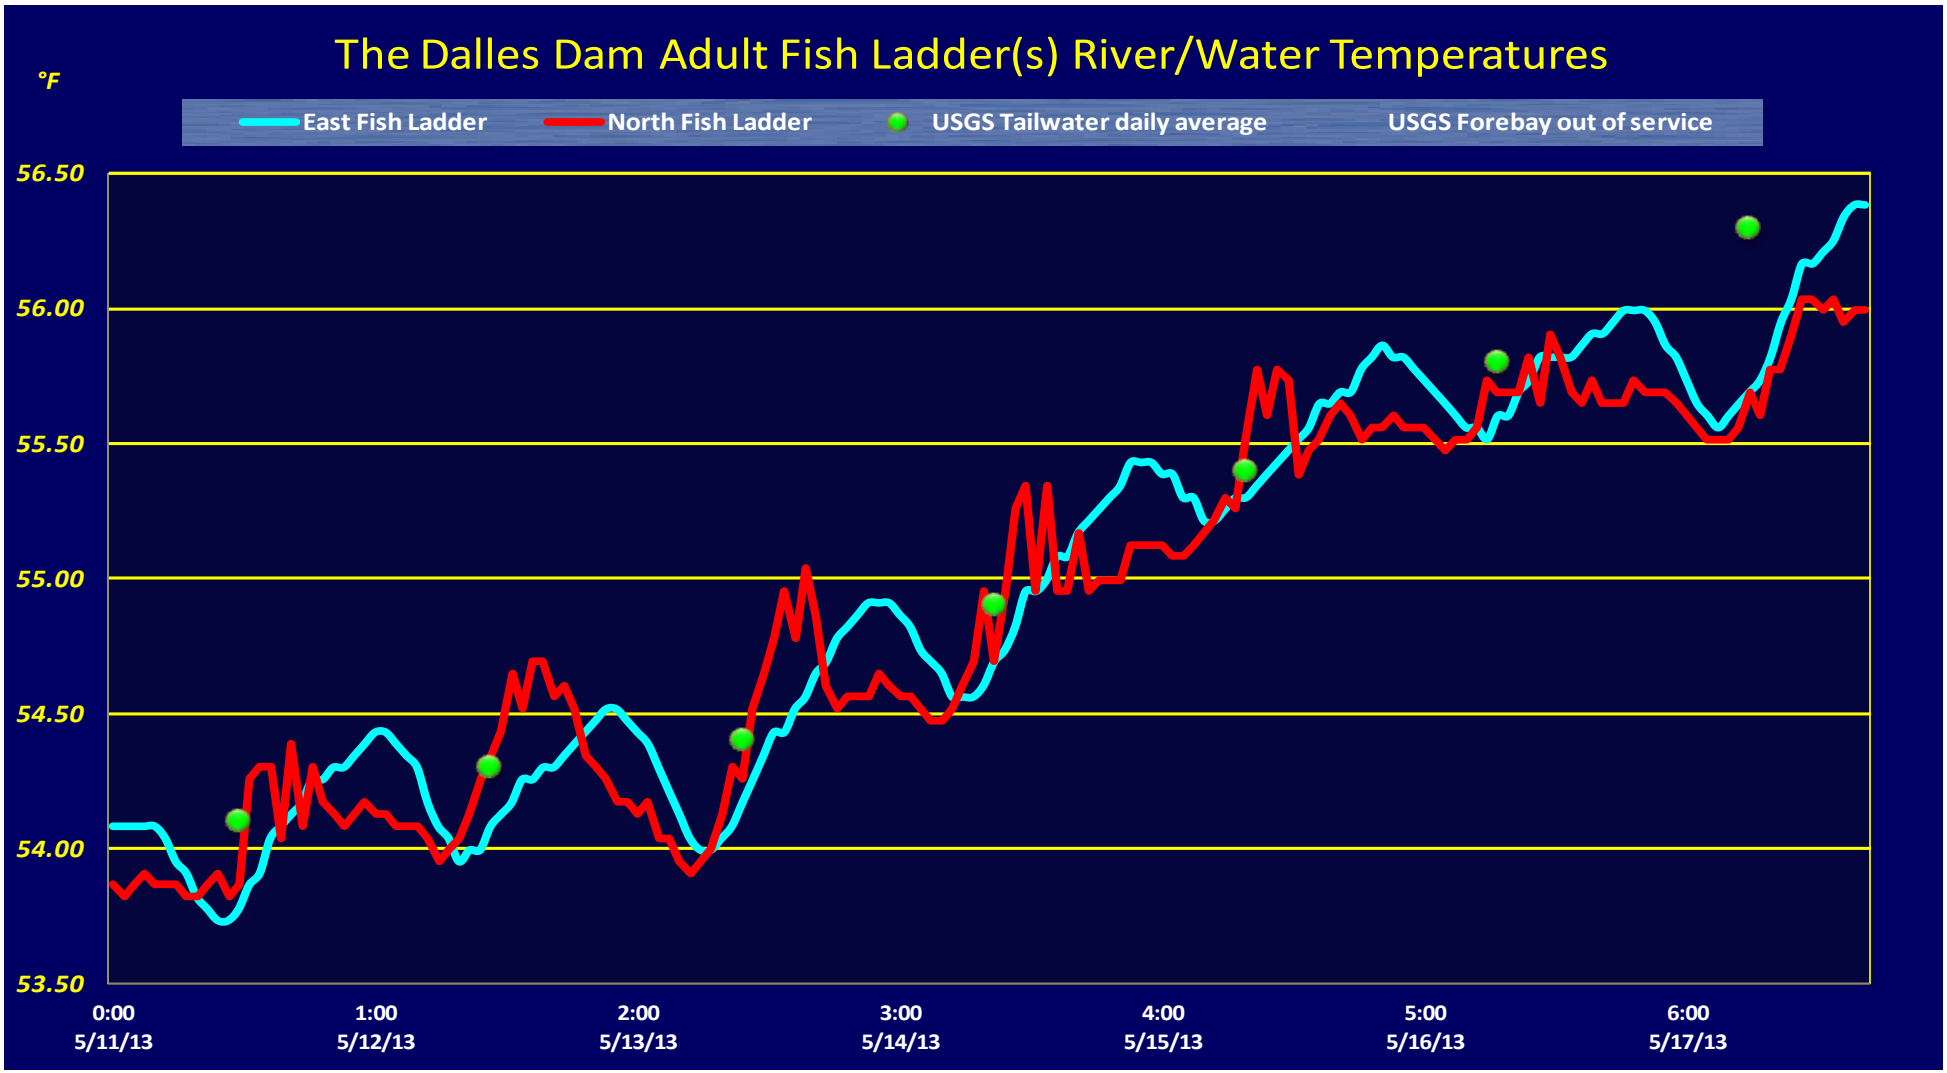
The Dalles Dam Adult Fish Ladder(s) River/Water Temperatures
°F
East Fish Ladder
North Fish Ladder
USGS Tailwater daily average
USGS Forebay out of service
56.50
56.00
55.50
55.00
54.50
54.00
53.50
0:00
5/11/13
1:00
5/12/13
2:00
5/13/13
3:00
5/14/13
4:00
5/15/13
5:00
5/16/13
6:00
5/17/13

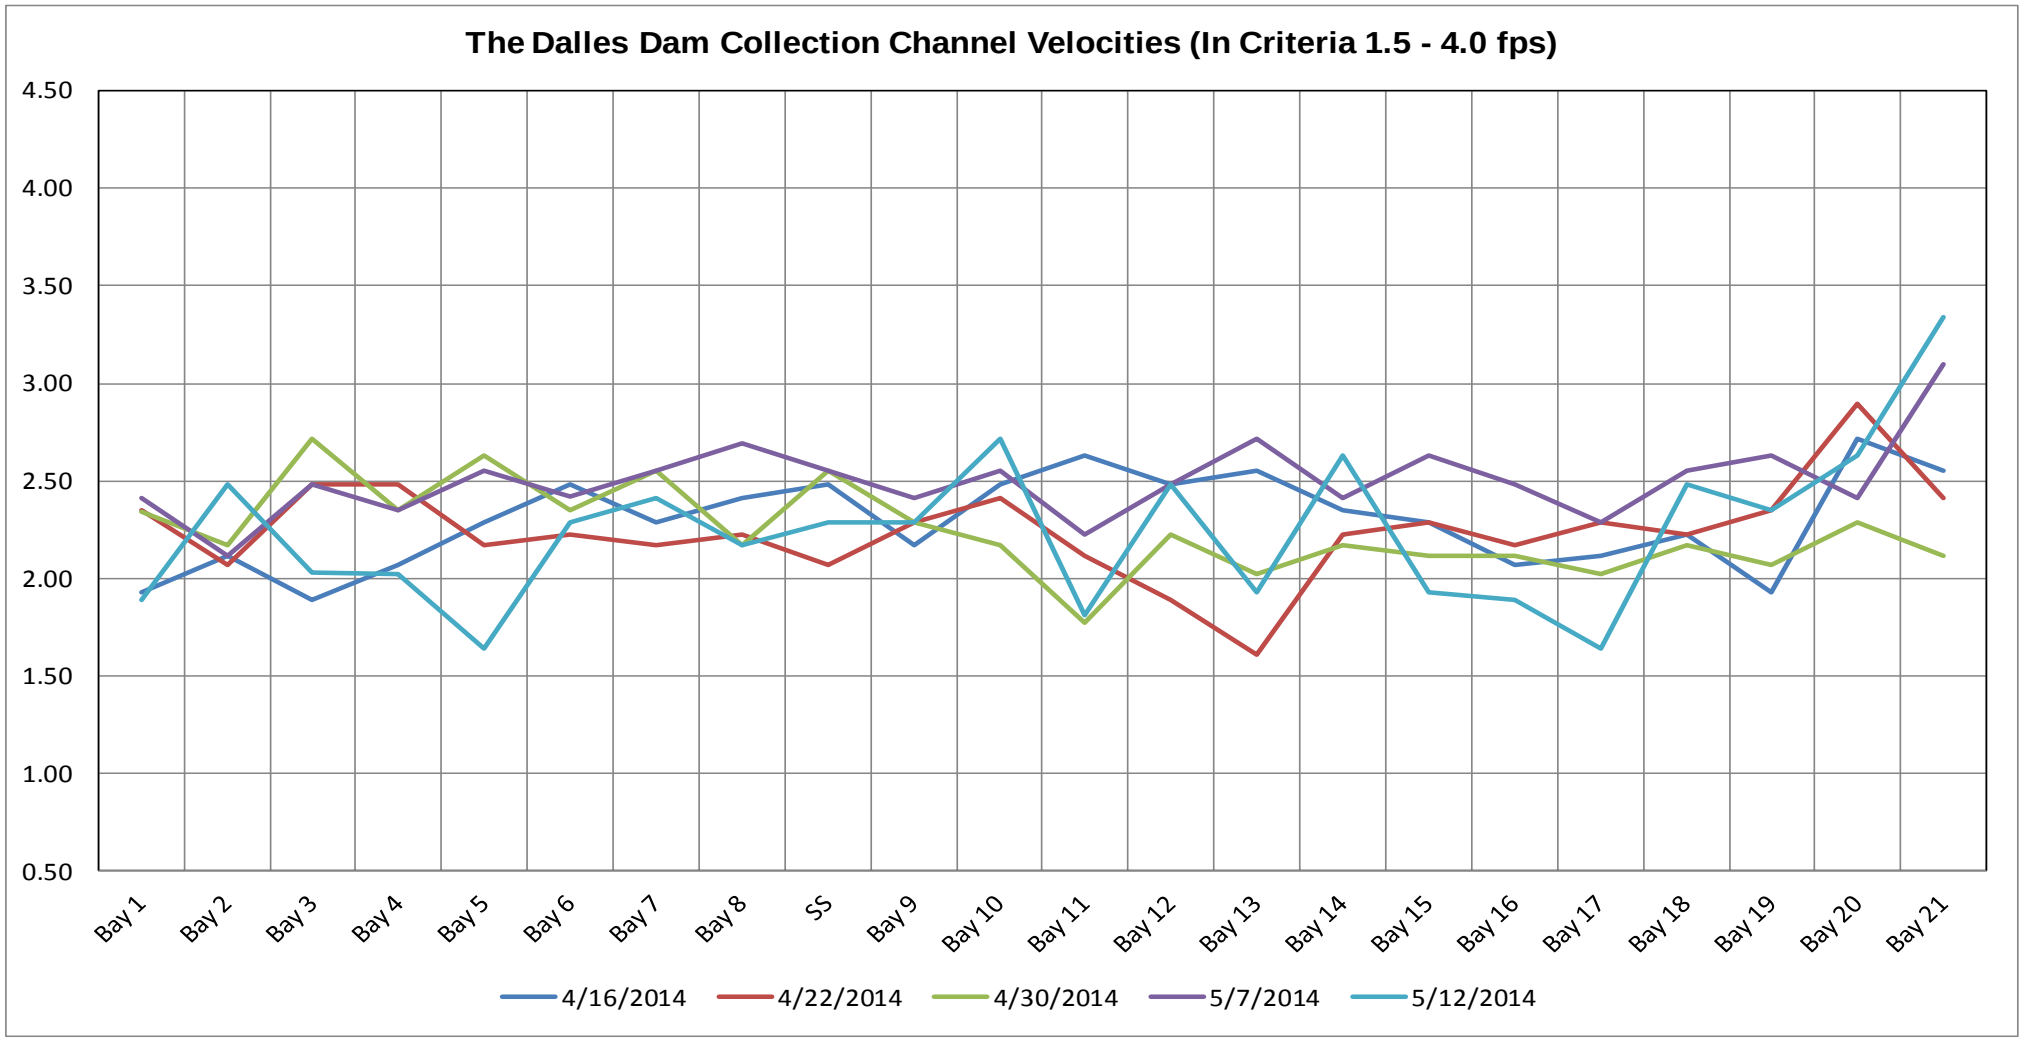
The Dalles Dam Collection Channel Velocities (In Criteria 1.5 - 4.0 fps)
4.50
4.00
3.50
3.00
2.50
2.00
1.50
1.00
0.50
Bay 1
Bay 2
Bay 3
Bay 4
Bay 5
Bay 6
Bay 7
Bay 8
SS
Bay 9
Bay 10
Bay 11
Bay 12
Bay 13
Bay 14
Bay 15
Bay 16
Bay 17
Bay 18
Bay 19
Bay 20
Bay 21
4/16/2014
4/22/2014
4/30/2014
5/7/2014
5/12/2014
