LOWER SNAKE TAILWATER IMPACTS

Technical Management Team

May 10, 2023

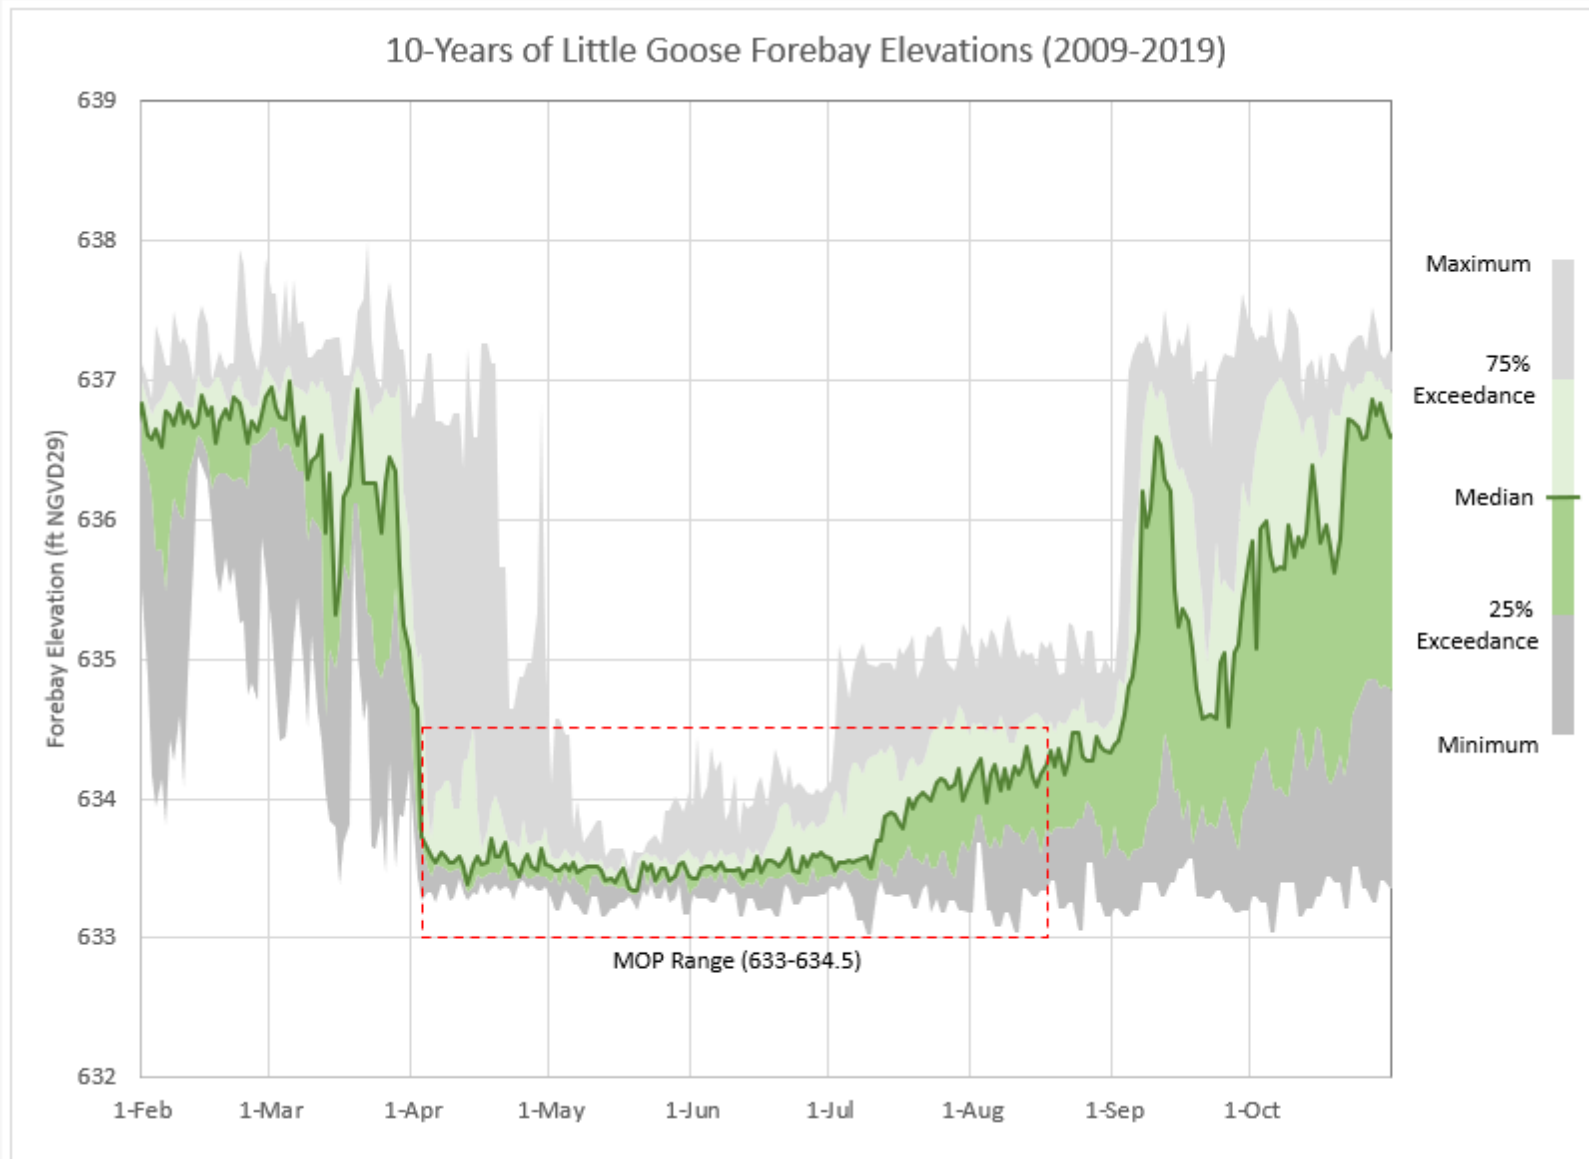
HISTORIC OPERATION (LITTLE GOOSE FOREBAY)

- The FOP included language referencing raising MOP beginning in 2009 citing navigation sill needs below Lower Granite, and later below Little Goose
- Little Goose forebay rises were common in the summer when flows decreased

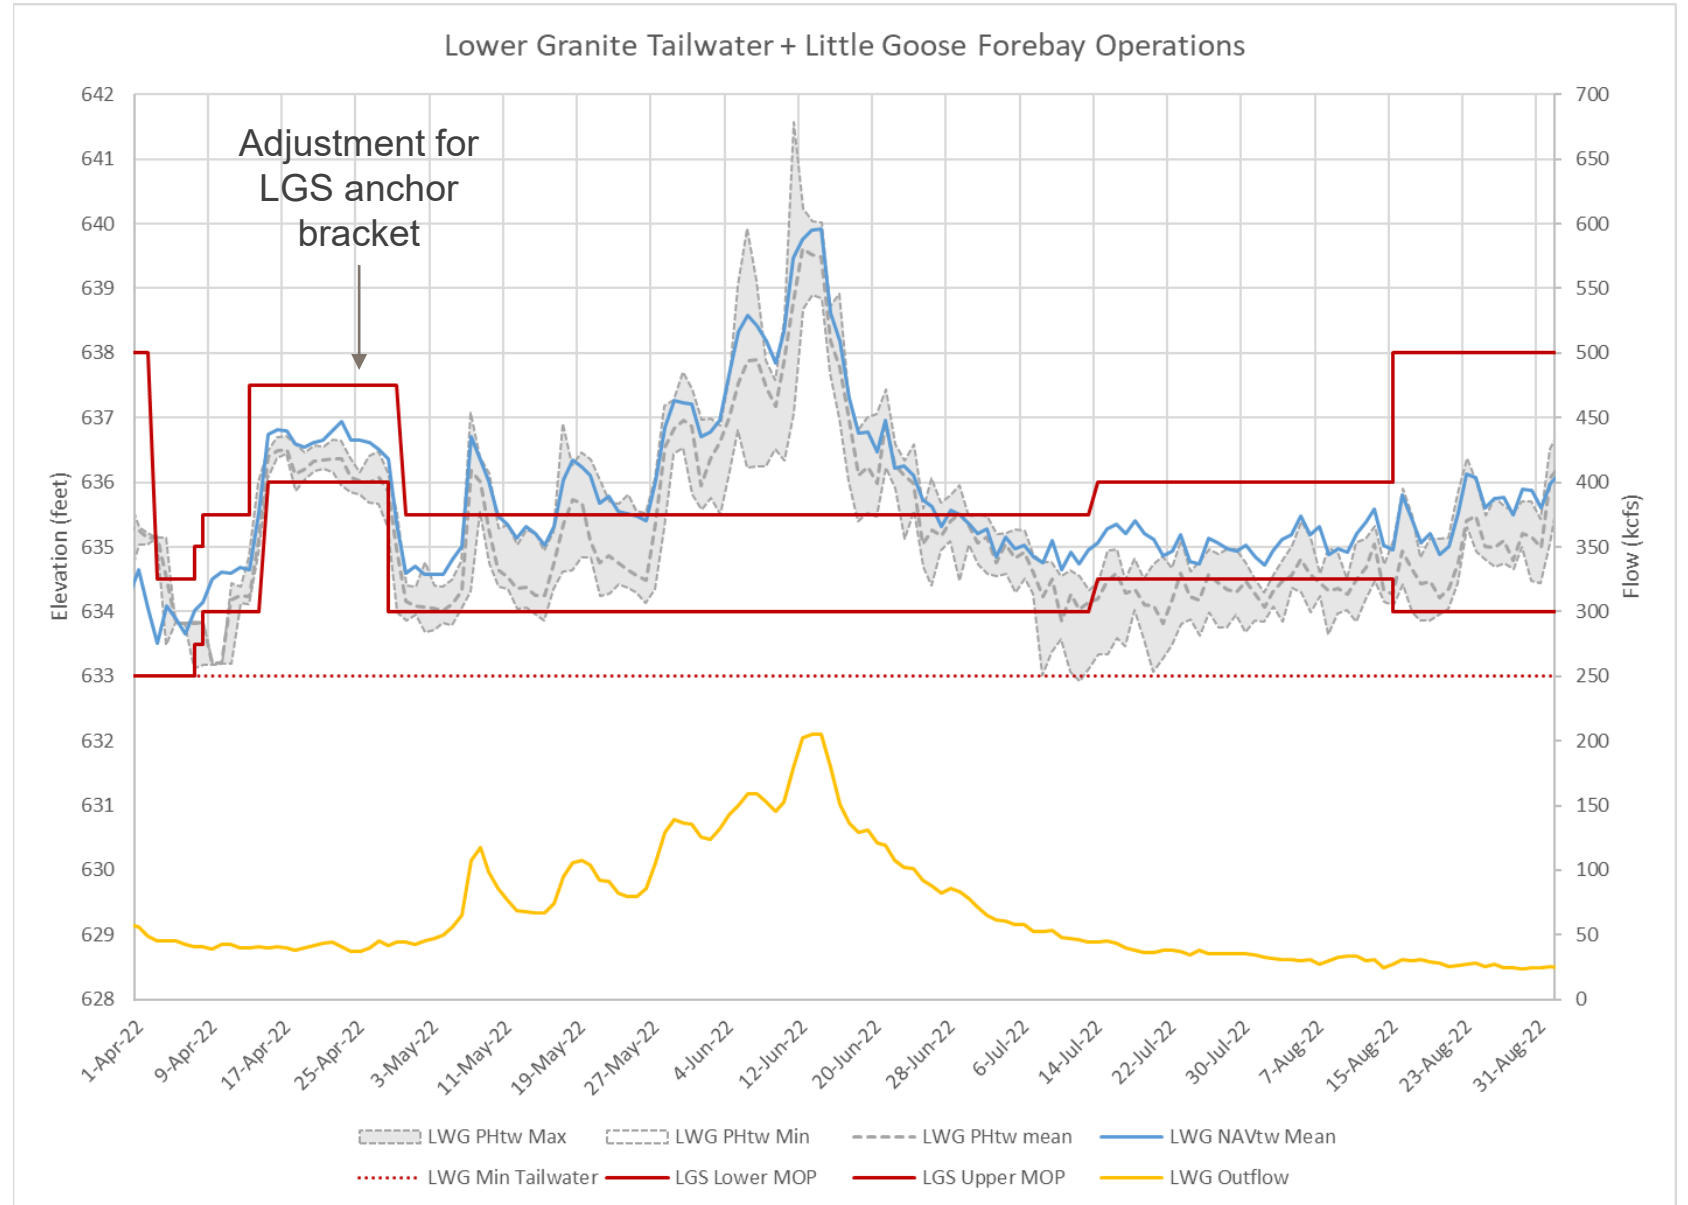
LOWER GRANITE 2022

- Spill operations change tailrace hydraulics creating more turbulence and wave action
- When outflows are less than ~75 kcfs, the nav lock gage typically reads higher than powerhouse gage and Little Goose forebay
- Under these conditions, the powerhouse tailwater gage can drop below the minimum tailwater elevation and the Corps must raise the forebay at Little Goose to help maintain the minimum tailwater at Lower Granite

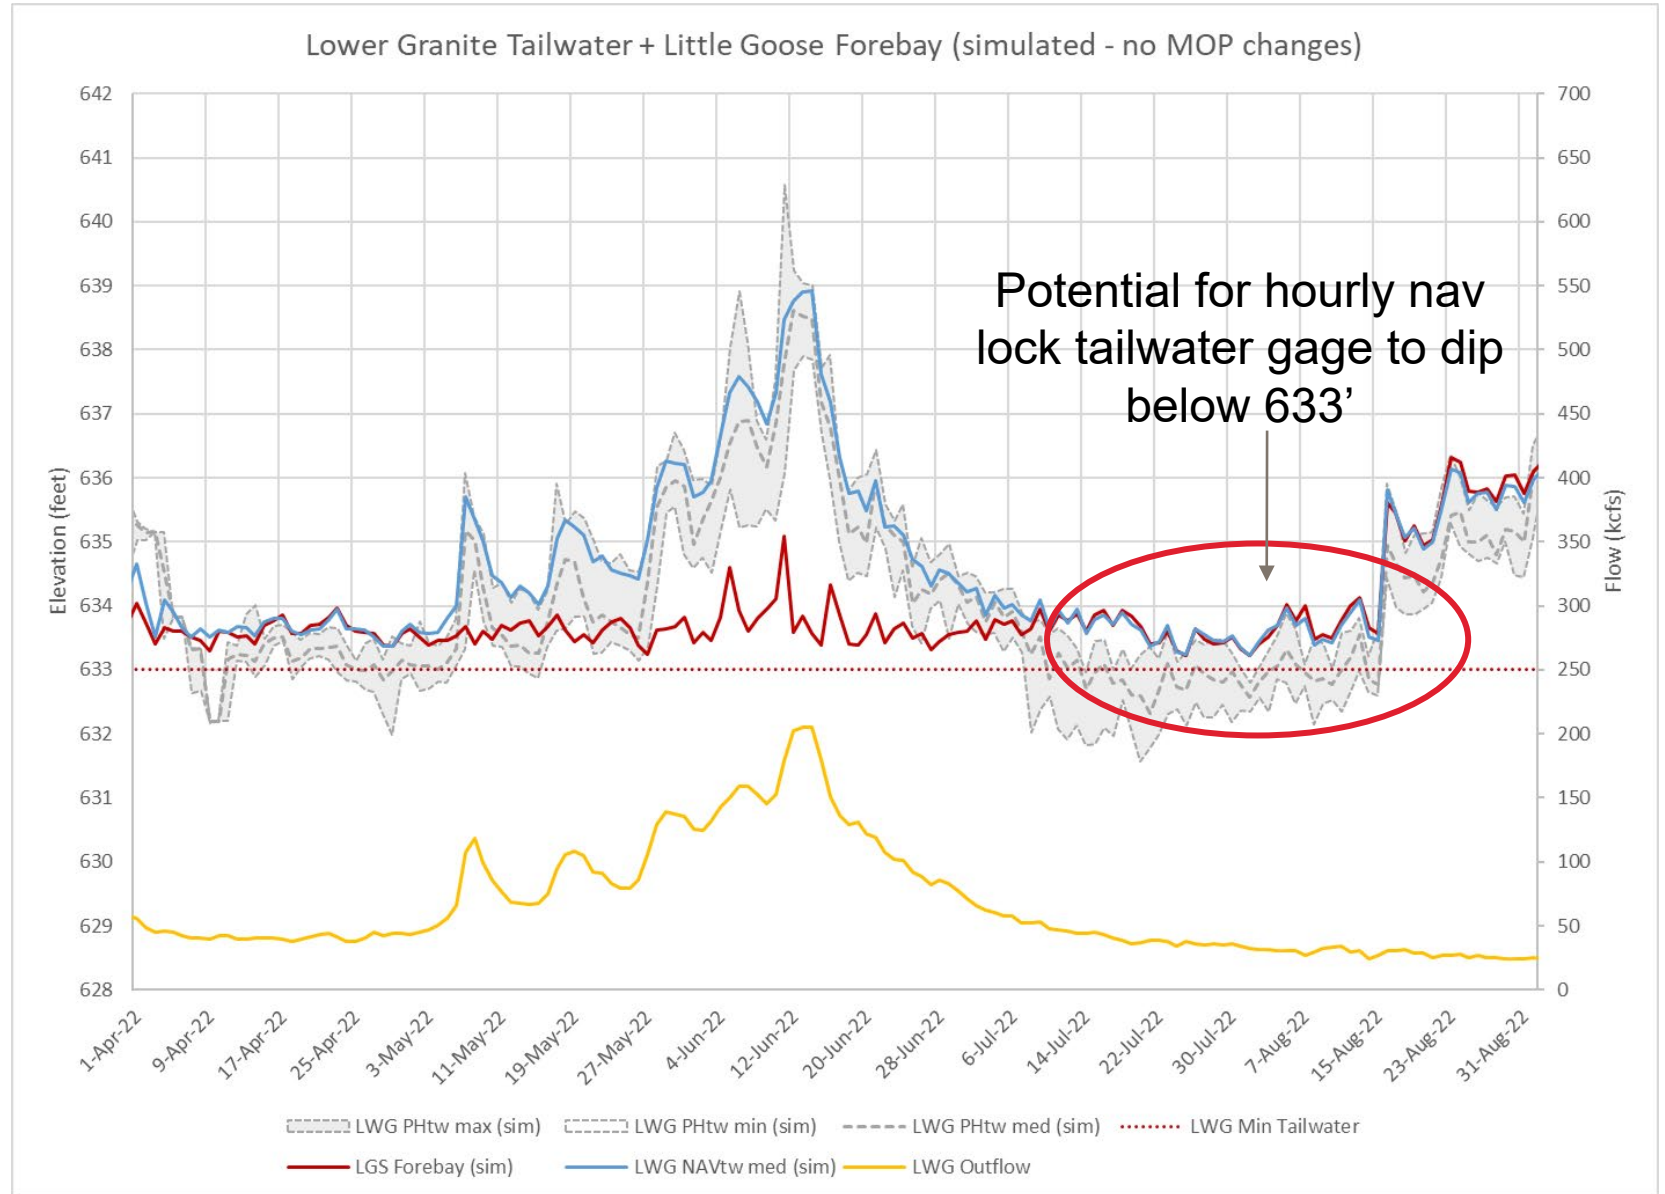
HYPOTHETICAL OPERATION – NO RAISED MOP

- Used 2022 operation
- Plot shows simulated Lower Granite tailwater and Little Goose forebay elevations
- Removed the effects of raised MOP adjustments
- Powerhouse tailwater elevations estimated to be up to 1.5 feet below the minimum tailwater requirement
- Potential for nav lock tailwater elevation to dip below 633' in summer (day average elev shown but hourly min and max range can be 1-1.5')

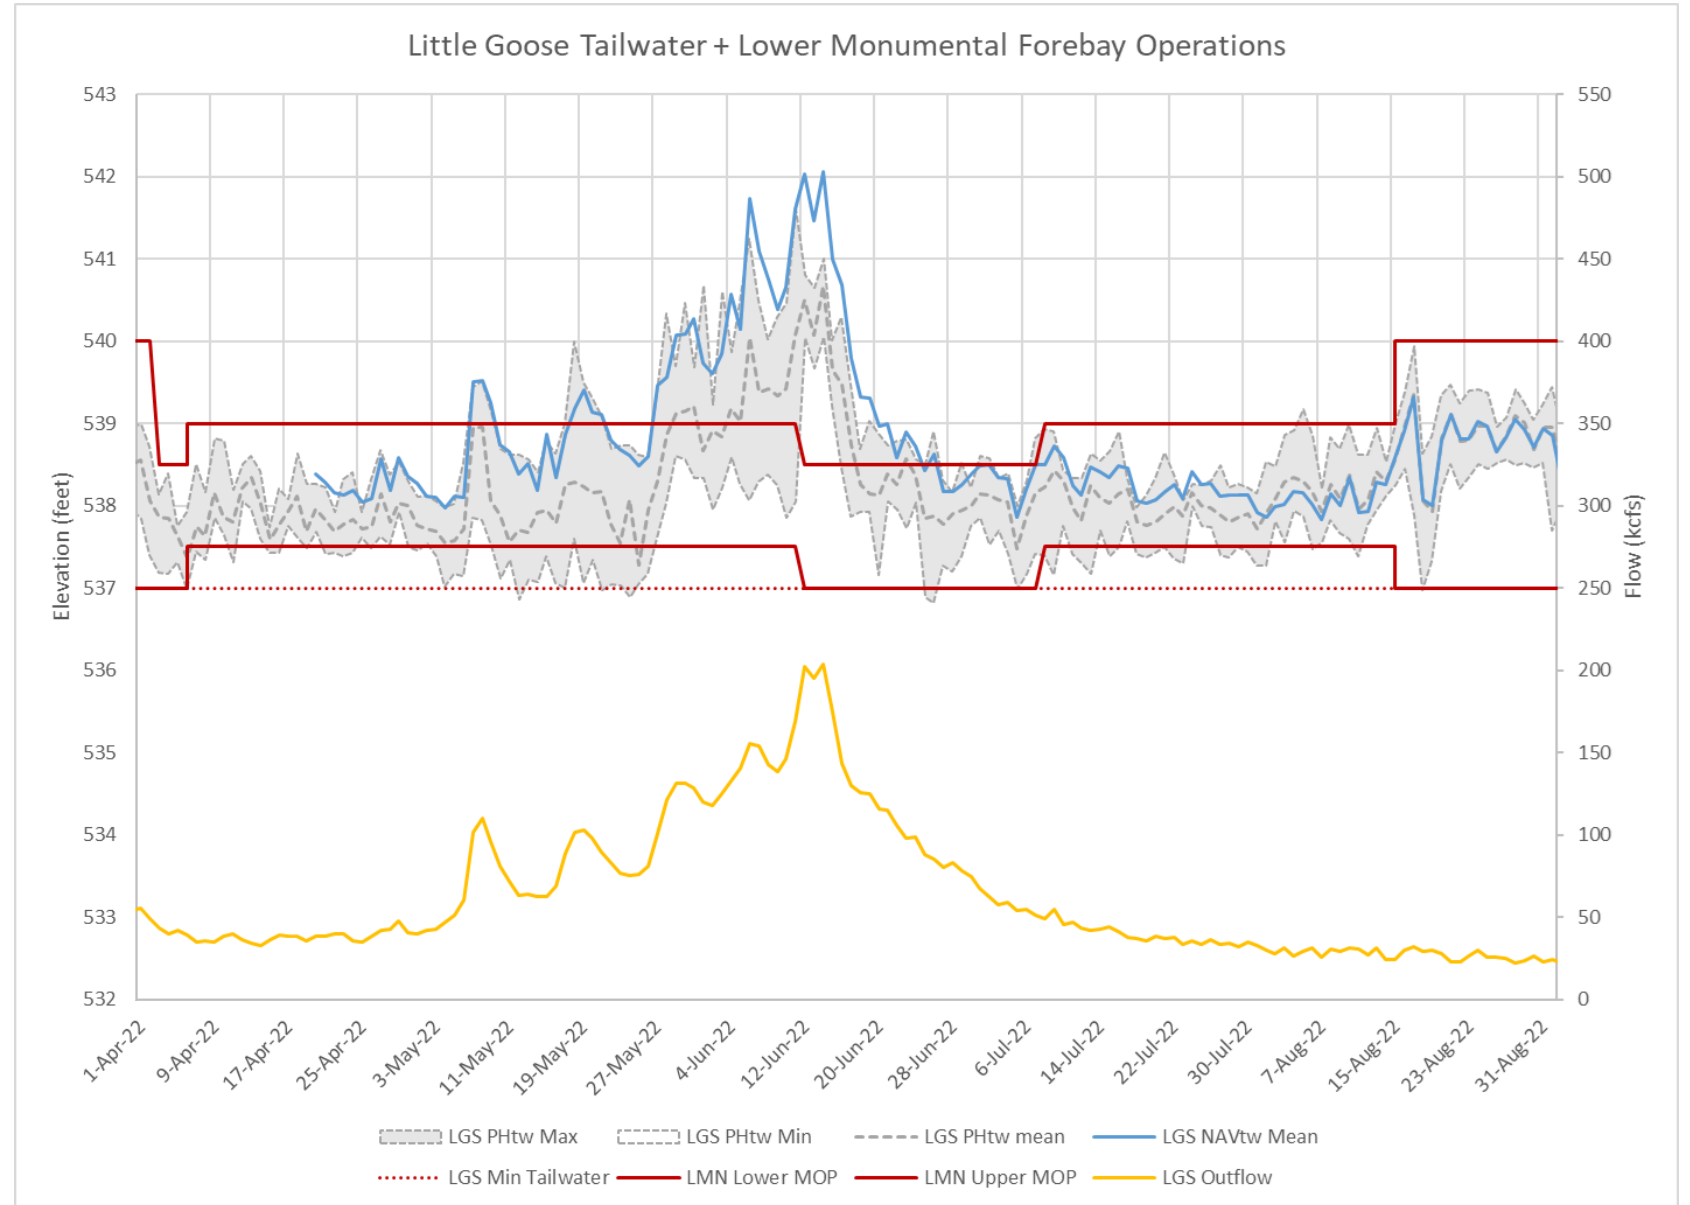
LITTLE GOOSE 2022

- During spill operations and when outflows are less than ~100 kcfs, tailwater elevations fluctuate near the project minimum and Lower Monumental usually needs a raised MOP operation
- When outflows exceed ~100 kcfs, tailwater elevations increase and Lower Monumental can usually operate in MOP

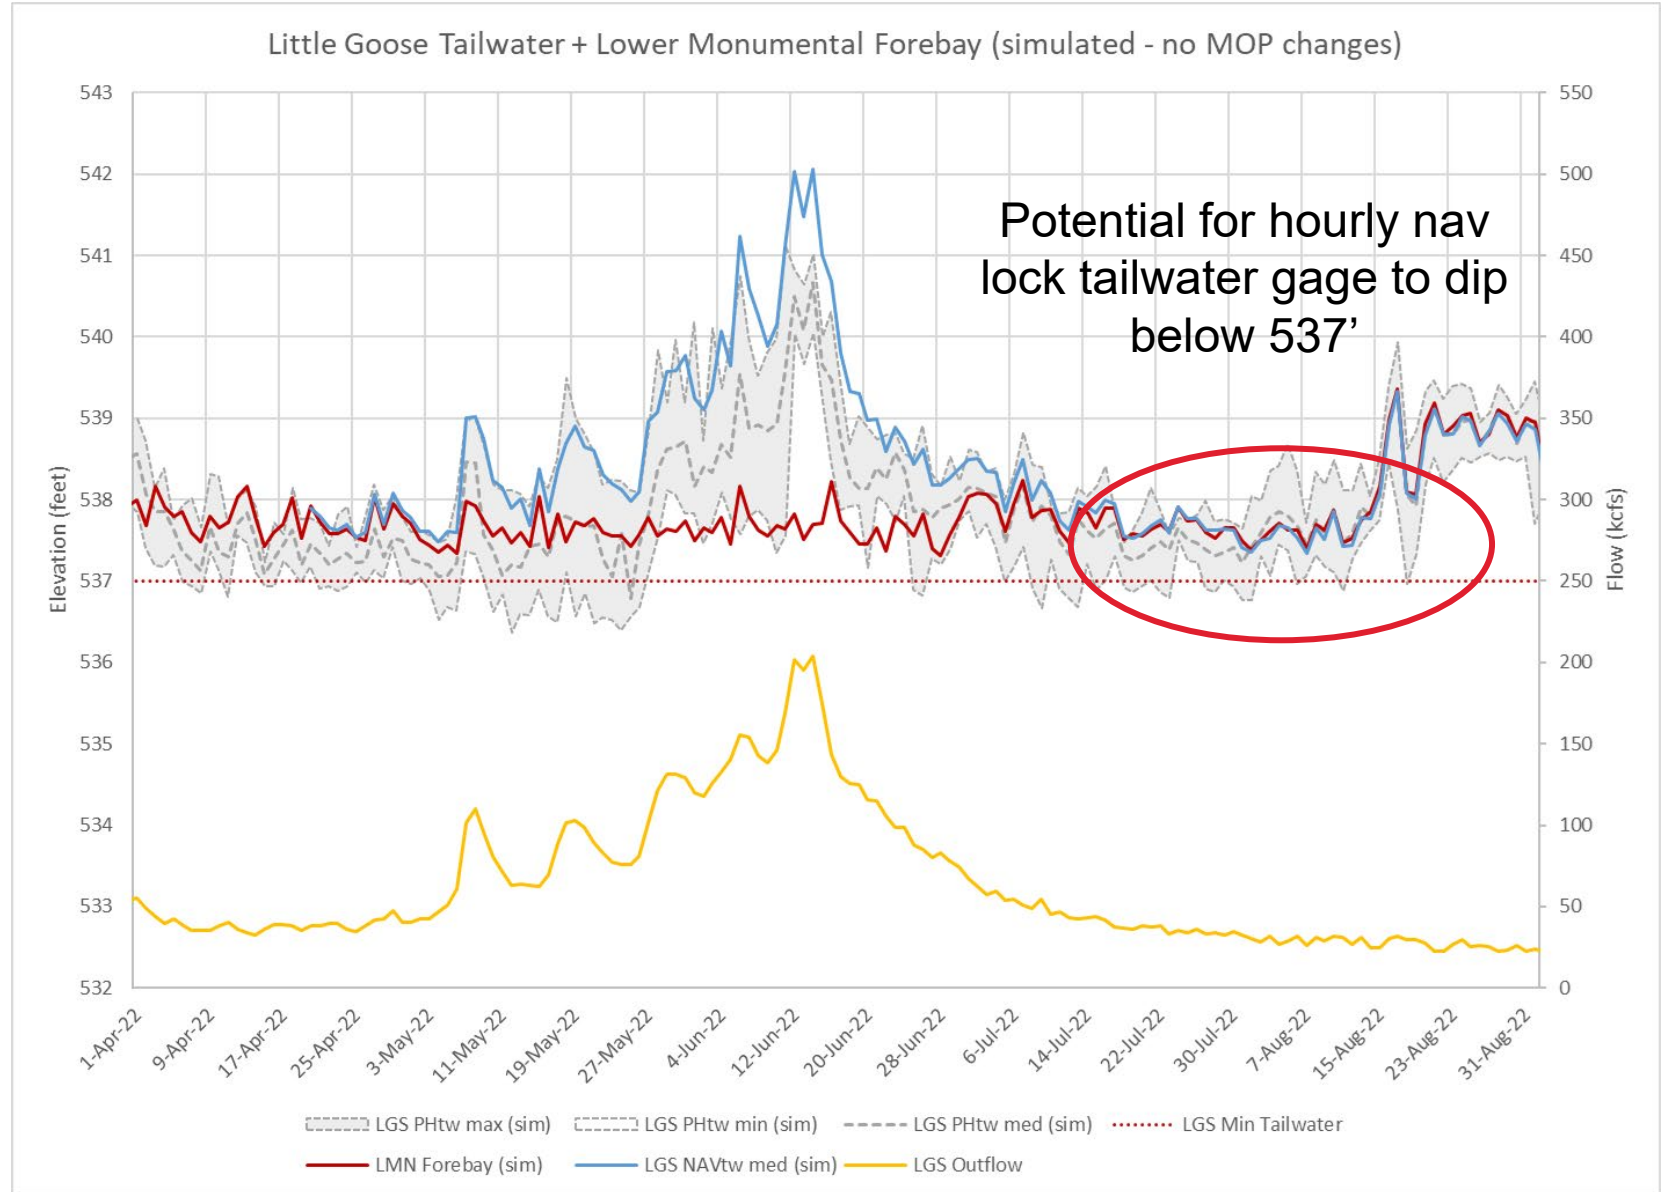
HYPOTHETICAL OPERATION – NO RAISED MOP

- Plot shows simulated Little Goose tailwater and Lower Monumental forebay elevations
- Removed the effects of raised MOP adjustments
- Powerhouse tailwater ~0.5' low in spring and late summer
- Potential for nav lock tailwater gage to dip below 537' in summer (day average elev shown but hourly min and max range can be 1-1.5')

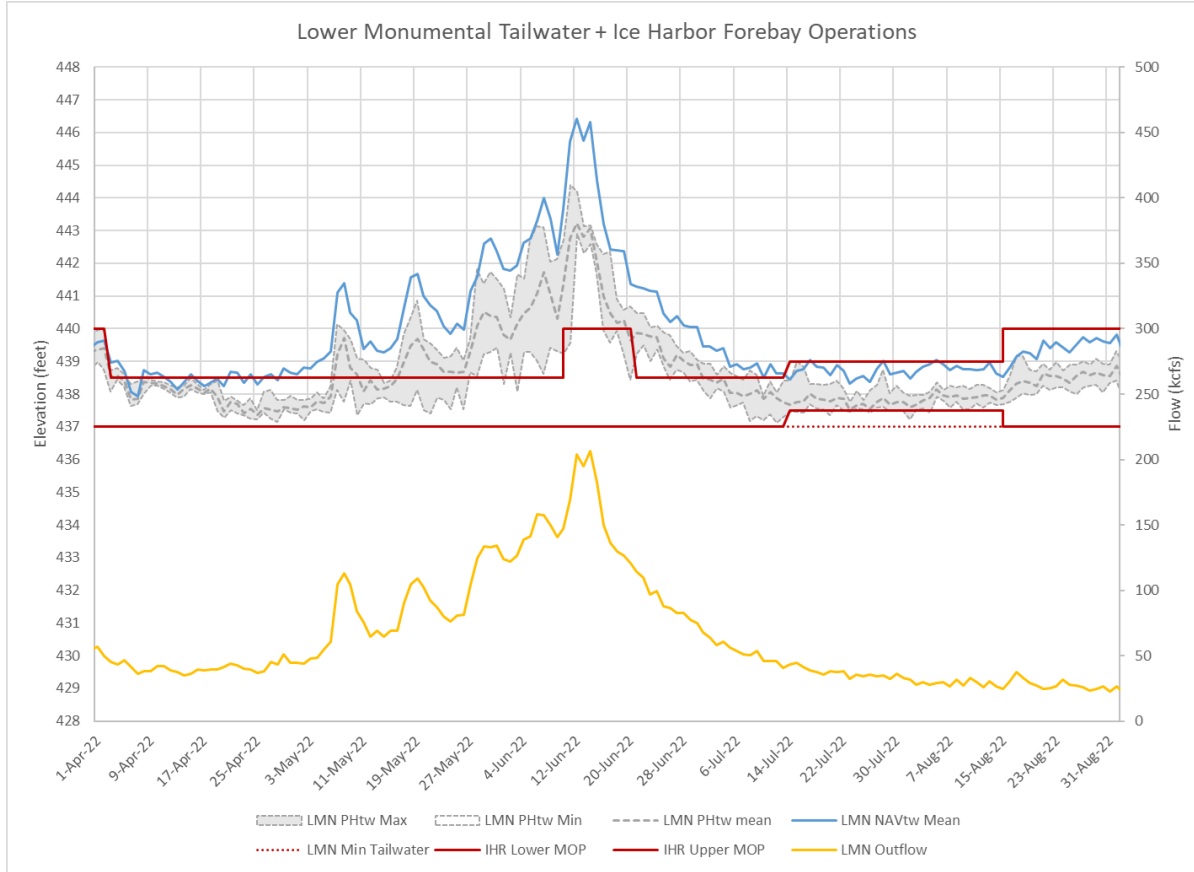
2022 OPERATIONS

During summer spill operations, when outflows were less than ~50 kcfs, tailwater elevations dropped near project minimum and the Ice Harbor forebay was raised

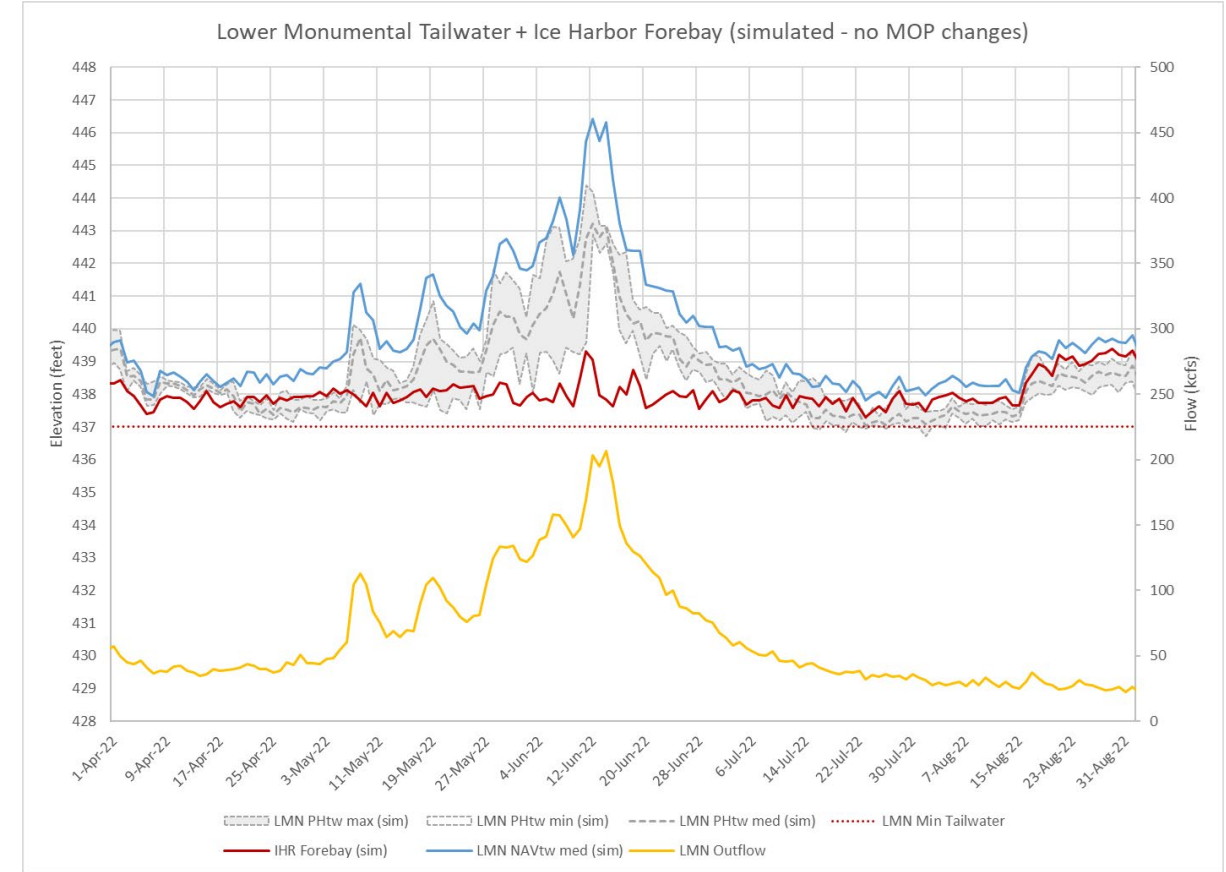
HYPOTHETICAL OPERATION – NO RAISED MOP

Small dips below minimum tailwater may occur when outflows are less than ~50 kcfs

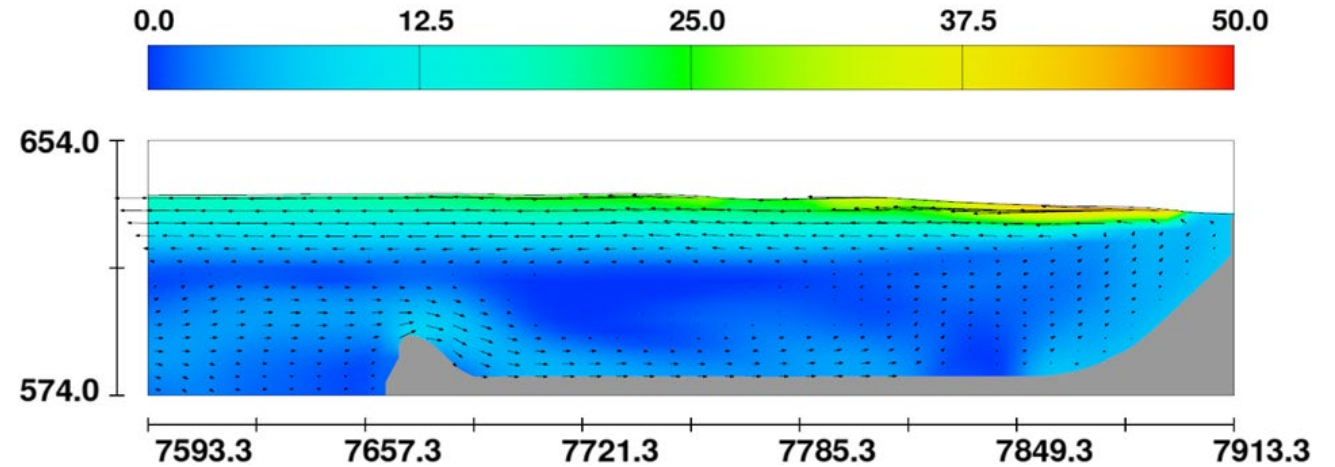
**CFD 3.8 Kcfs – 56 kcfs river at Normal Tailwater
Skimming Flow**

- Flow deflectors were designed from the 1970's to 1990's for a normal range of flows and tailwater elevations generally targeting forced spill operations during higher flows scenarios
- Skimming flow is the design flow condition to reduce downstream TDG
- Plunging flow occurs when the tailwater is too low or when the spill volume is too high
- Lowering tailwater elevation can cause spill to transition from undular/skimming to plunging
- Plunging flows can raise TDG and increase velocities at the stilling basin floor therefore increasing ball milling erosion

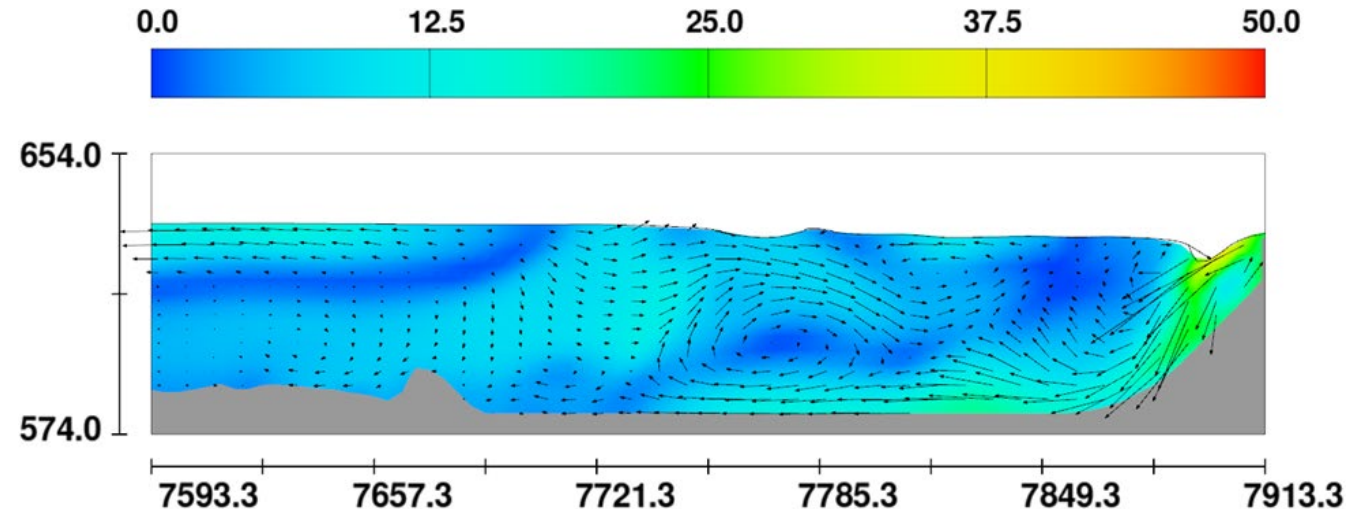
**CFD 8.2 Kcfs – 56 kcfs river at Normal Tailwater
Severe Plunging Flow**

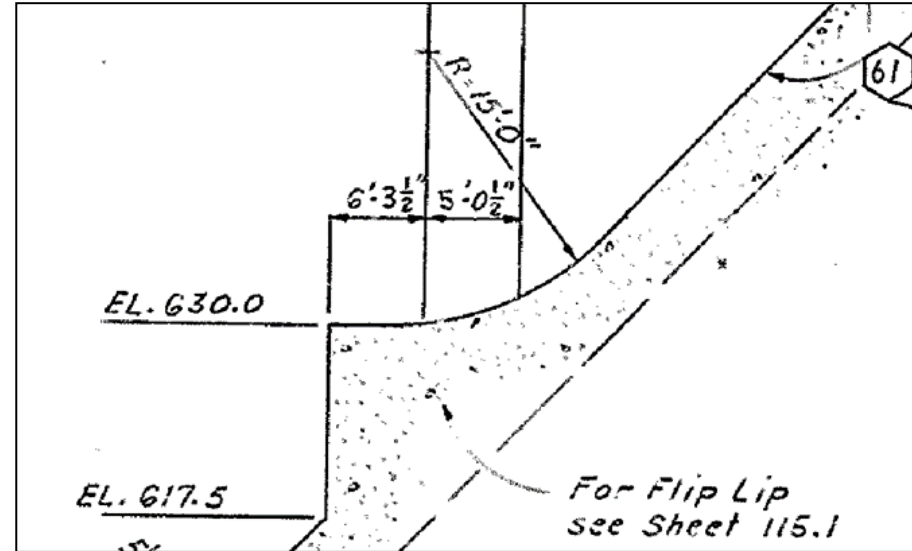
Lower Granite Interior Bay Deflector Design

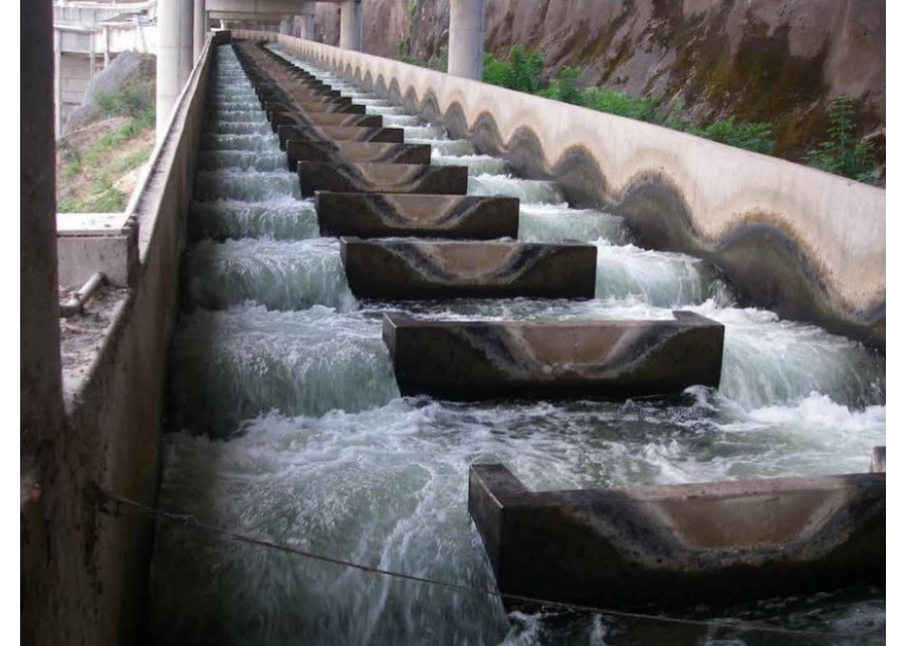
Lower Granite Fish Ladder

- At the minimum tailwater, all fishway entrances are at or near sill. Decreasing the tailwater further reduces entrance depths, decreases the head differential and thus reduces attraction velocity and discharge.
- At low tailwater elevations, fishway pumps operate at a higher pumped head, causing overheating and forced trips resulting in O&M issues and potential for failure of the pumps.
- Spill at low tailwater creates even lower local tailwater at some main entrances, adding to the challenge in meeting all fishway criteria.
