**MEMORANDUM FOR THE RECORD 19 LGS 01 Auxiliary Water Supply (AWS) Pumps****SUBJECT: Little Goose Auxiliary Water Supply Pumps Intermittently Out of Service**Background

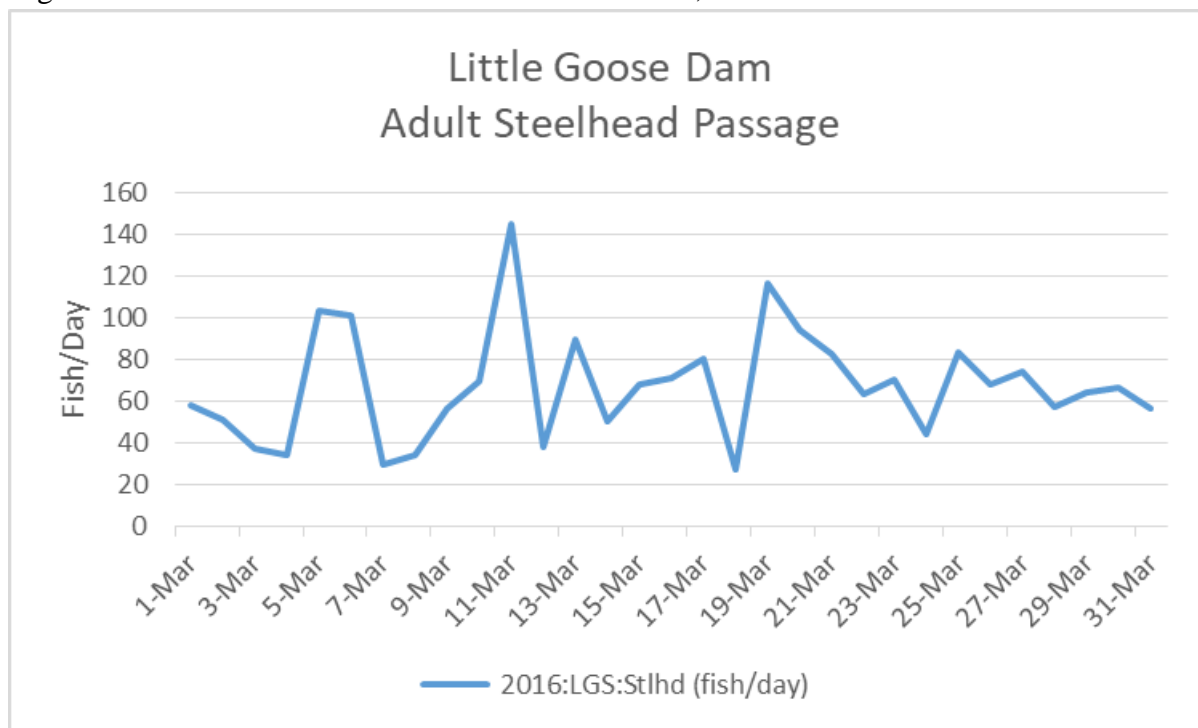
Figure 1: Adult steelhead counts at Little Goose Dam, March 2016.

Adult passage a Little Goose is typically very low during the month of March, predominately made up of adult steelhead. The most recent adult counts occurred in 2016, with the daily average adult count of 67 steelhead per day (Figure 1). Adult fish counts are not currently being conducted at Little Goose and will resume on April 01.
