Lamprey Minor Fishway Modifications: Reference Photos of BON Washington Shore Fish Ladder

(For Proposed 2014-15 IWW Period Actions)

Proposed Modifications

1. Remove existing prototype lamprey diffuser plating and replace with “mushroom” style plating upstream and downstream of weir orifices in lower section of WA Shore Ladder
2. Modify four (4) main entrance weirs at WA Shore Ladder (Powerhouse 2) to facilitate surface attachment:
 - a. Rounded caps on entrance weir crests (4-inch radius)
 - b. Skin plates on downstream faces of entrance weirs

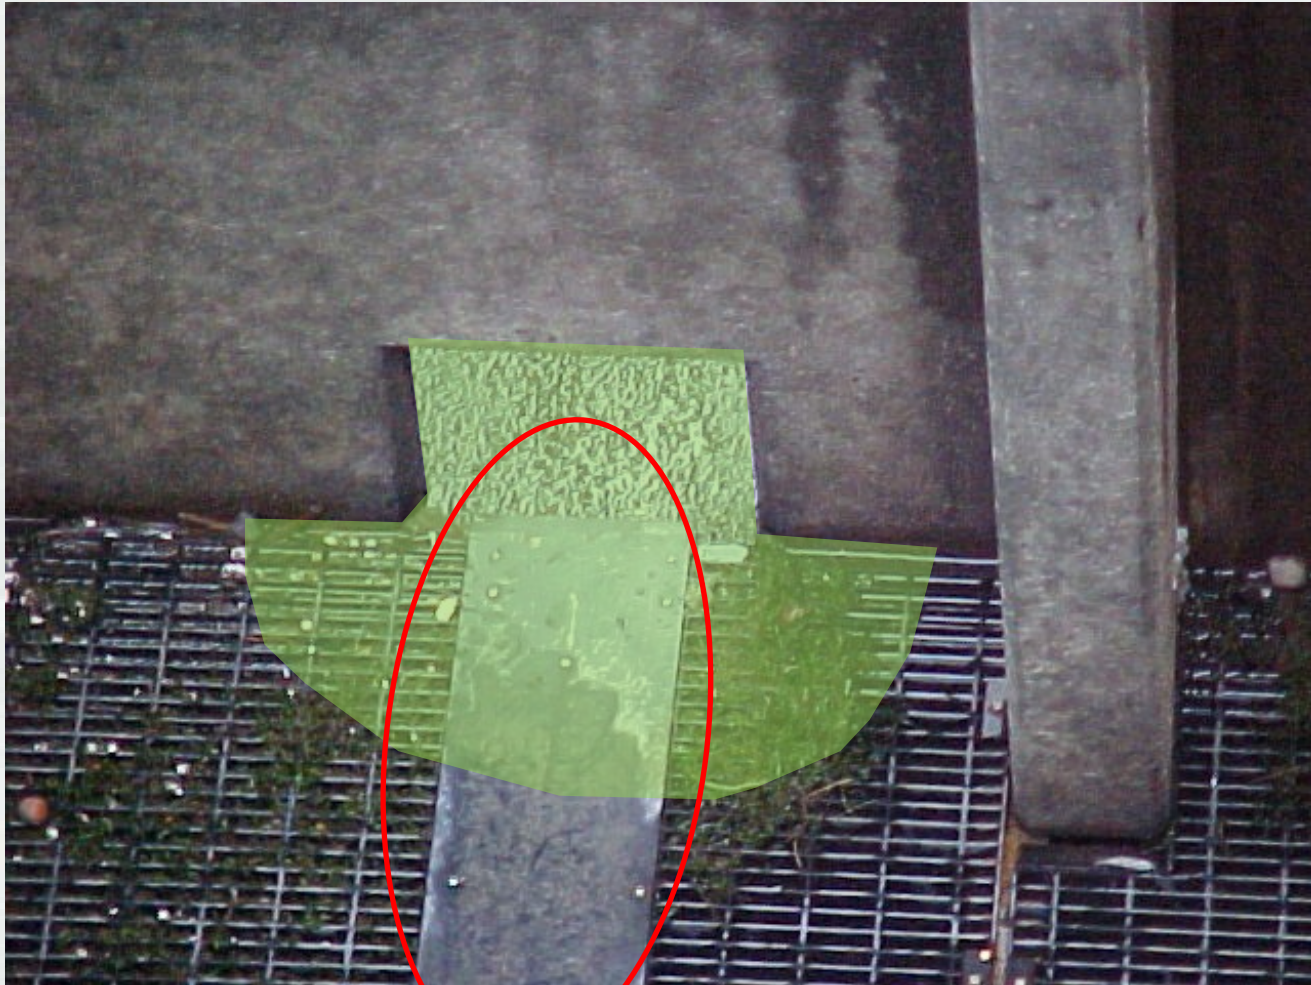
Existing plating at WA Shore Ladder transition pool overflow weirs (w/ new in green)

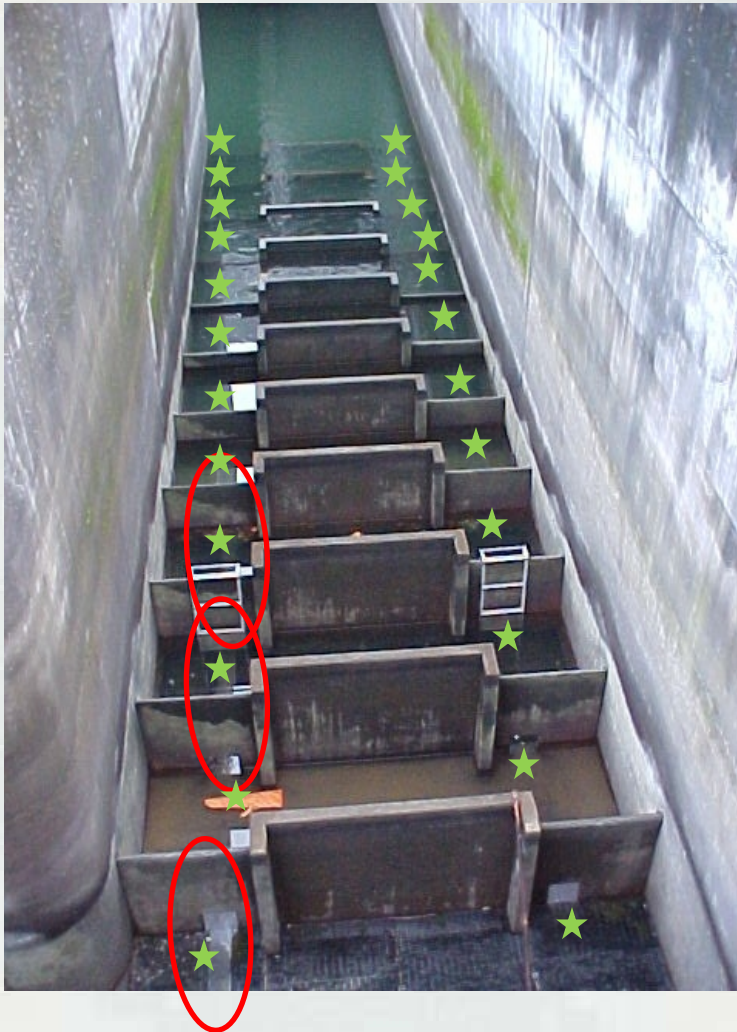
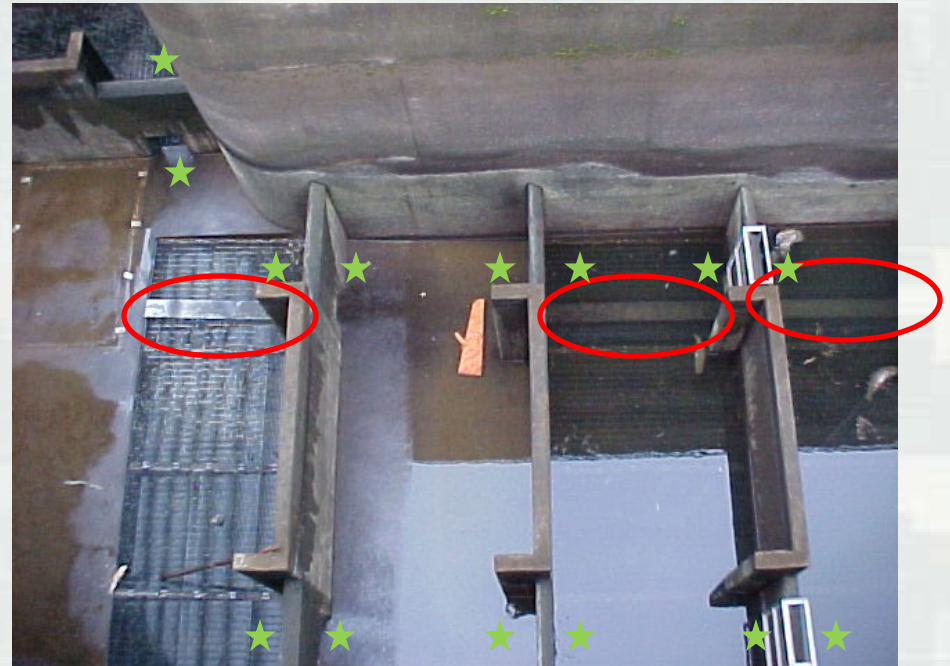
Existing plating at WA Shore Ladder transition pool overflow weirs (w/ new in green)

- Existing plating extends through junction pool. *Only* remove plating at overflow weirs in transition pool.
- Transition pool continues upstream of 90-degree bend in photo.

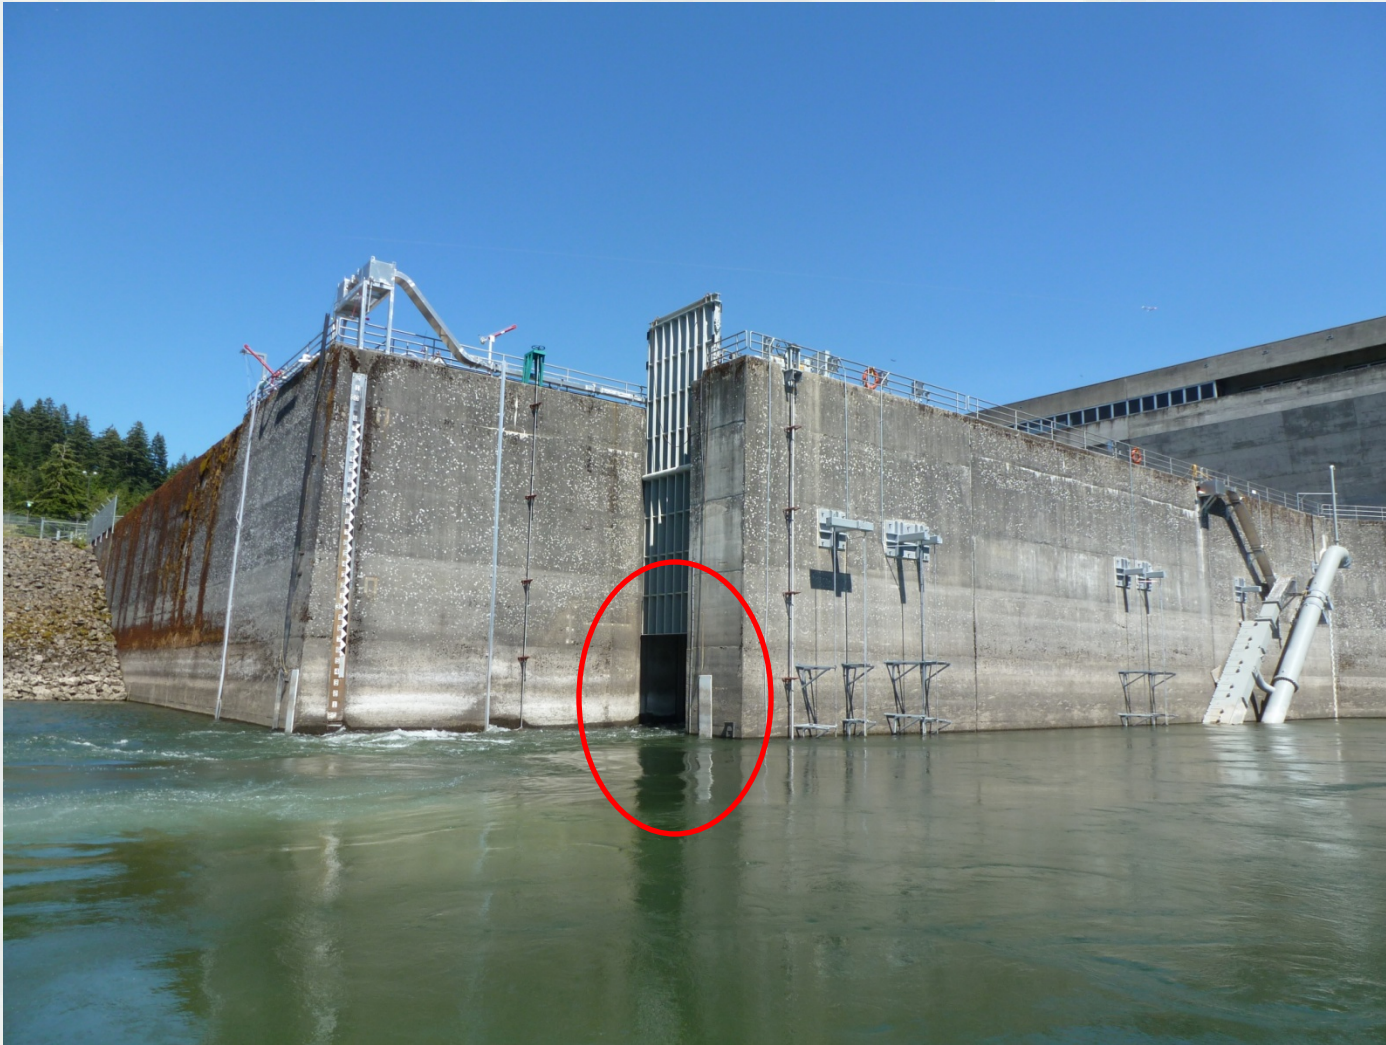
North Downstream Entrance (NDE)

NDE construction photos in the following slides are from 2012-13
construction of Lamprey Flume System
(*BDF-1.102 WA Shore Ladder Entrance Modifications* in ProjectWise)

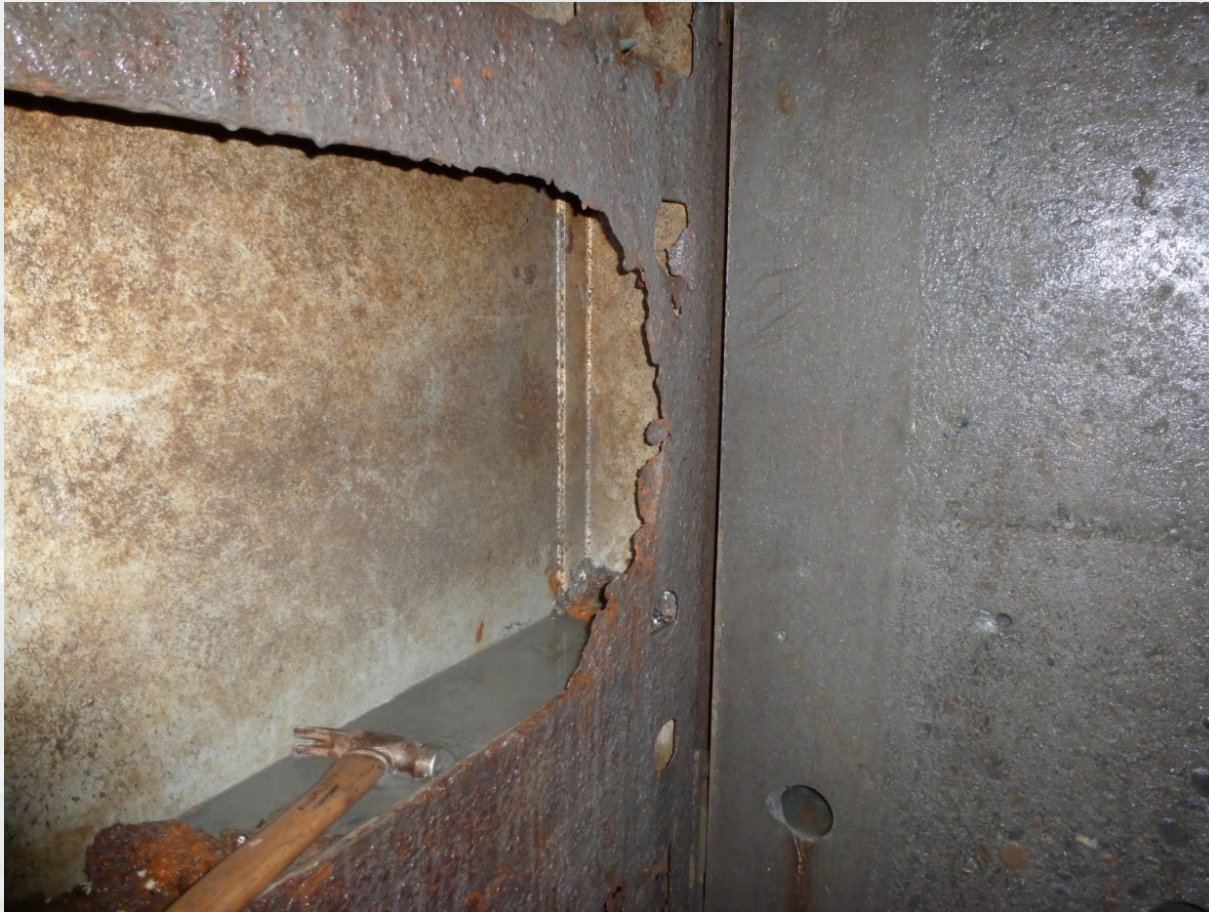
Corroded face of NDE weir? (consult w/ Brent Welton or Mike Adams)

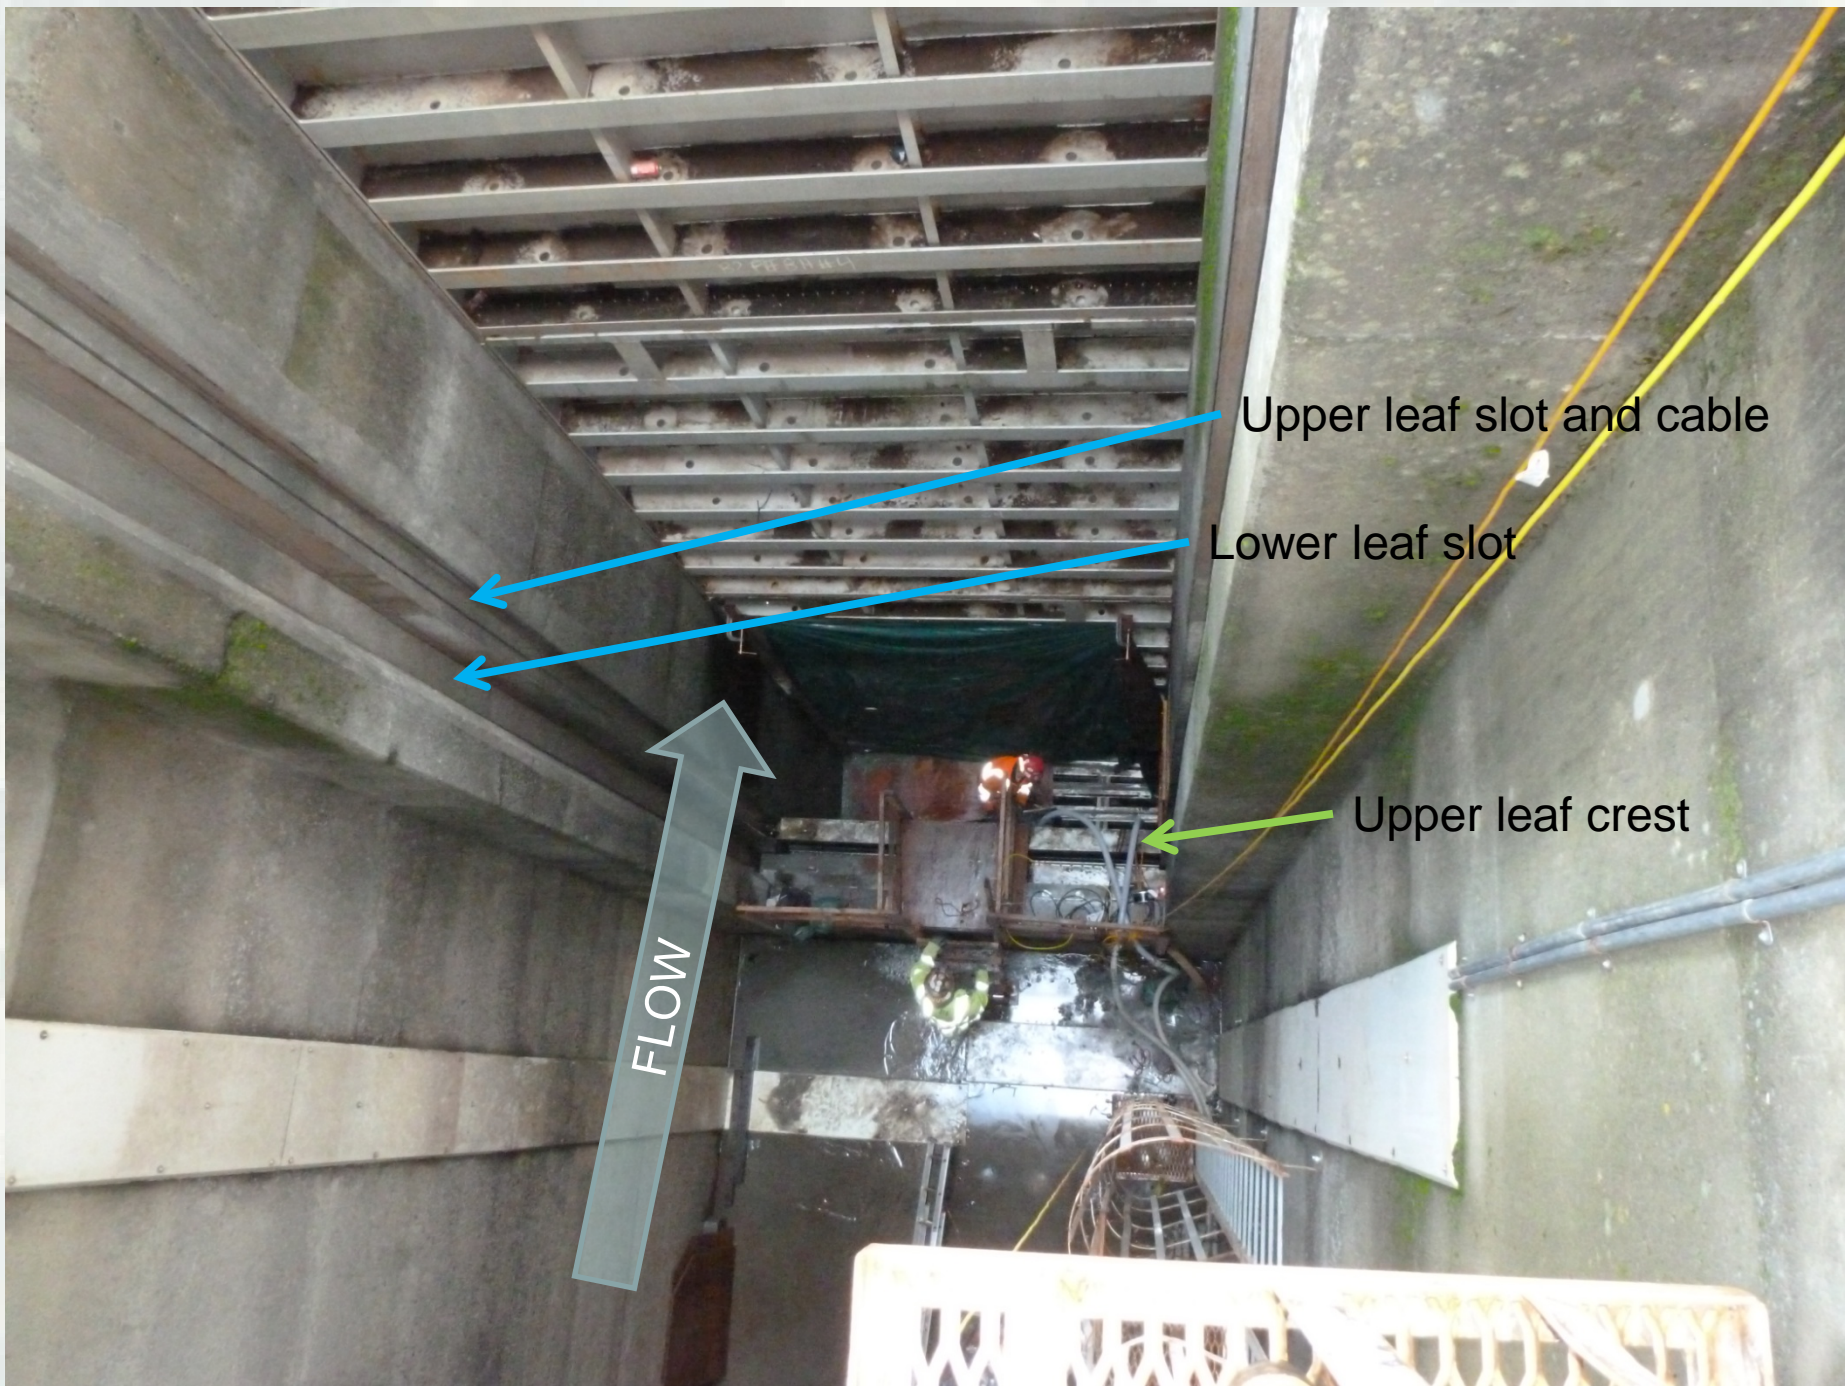
Upper leaf slot and cable

Lower leaf slot

Upper leaf crest

FLOW

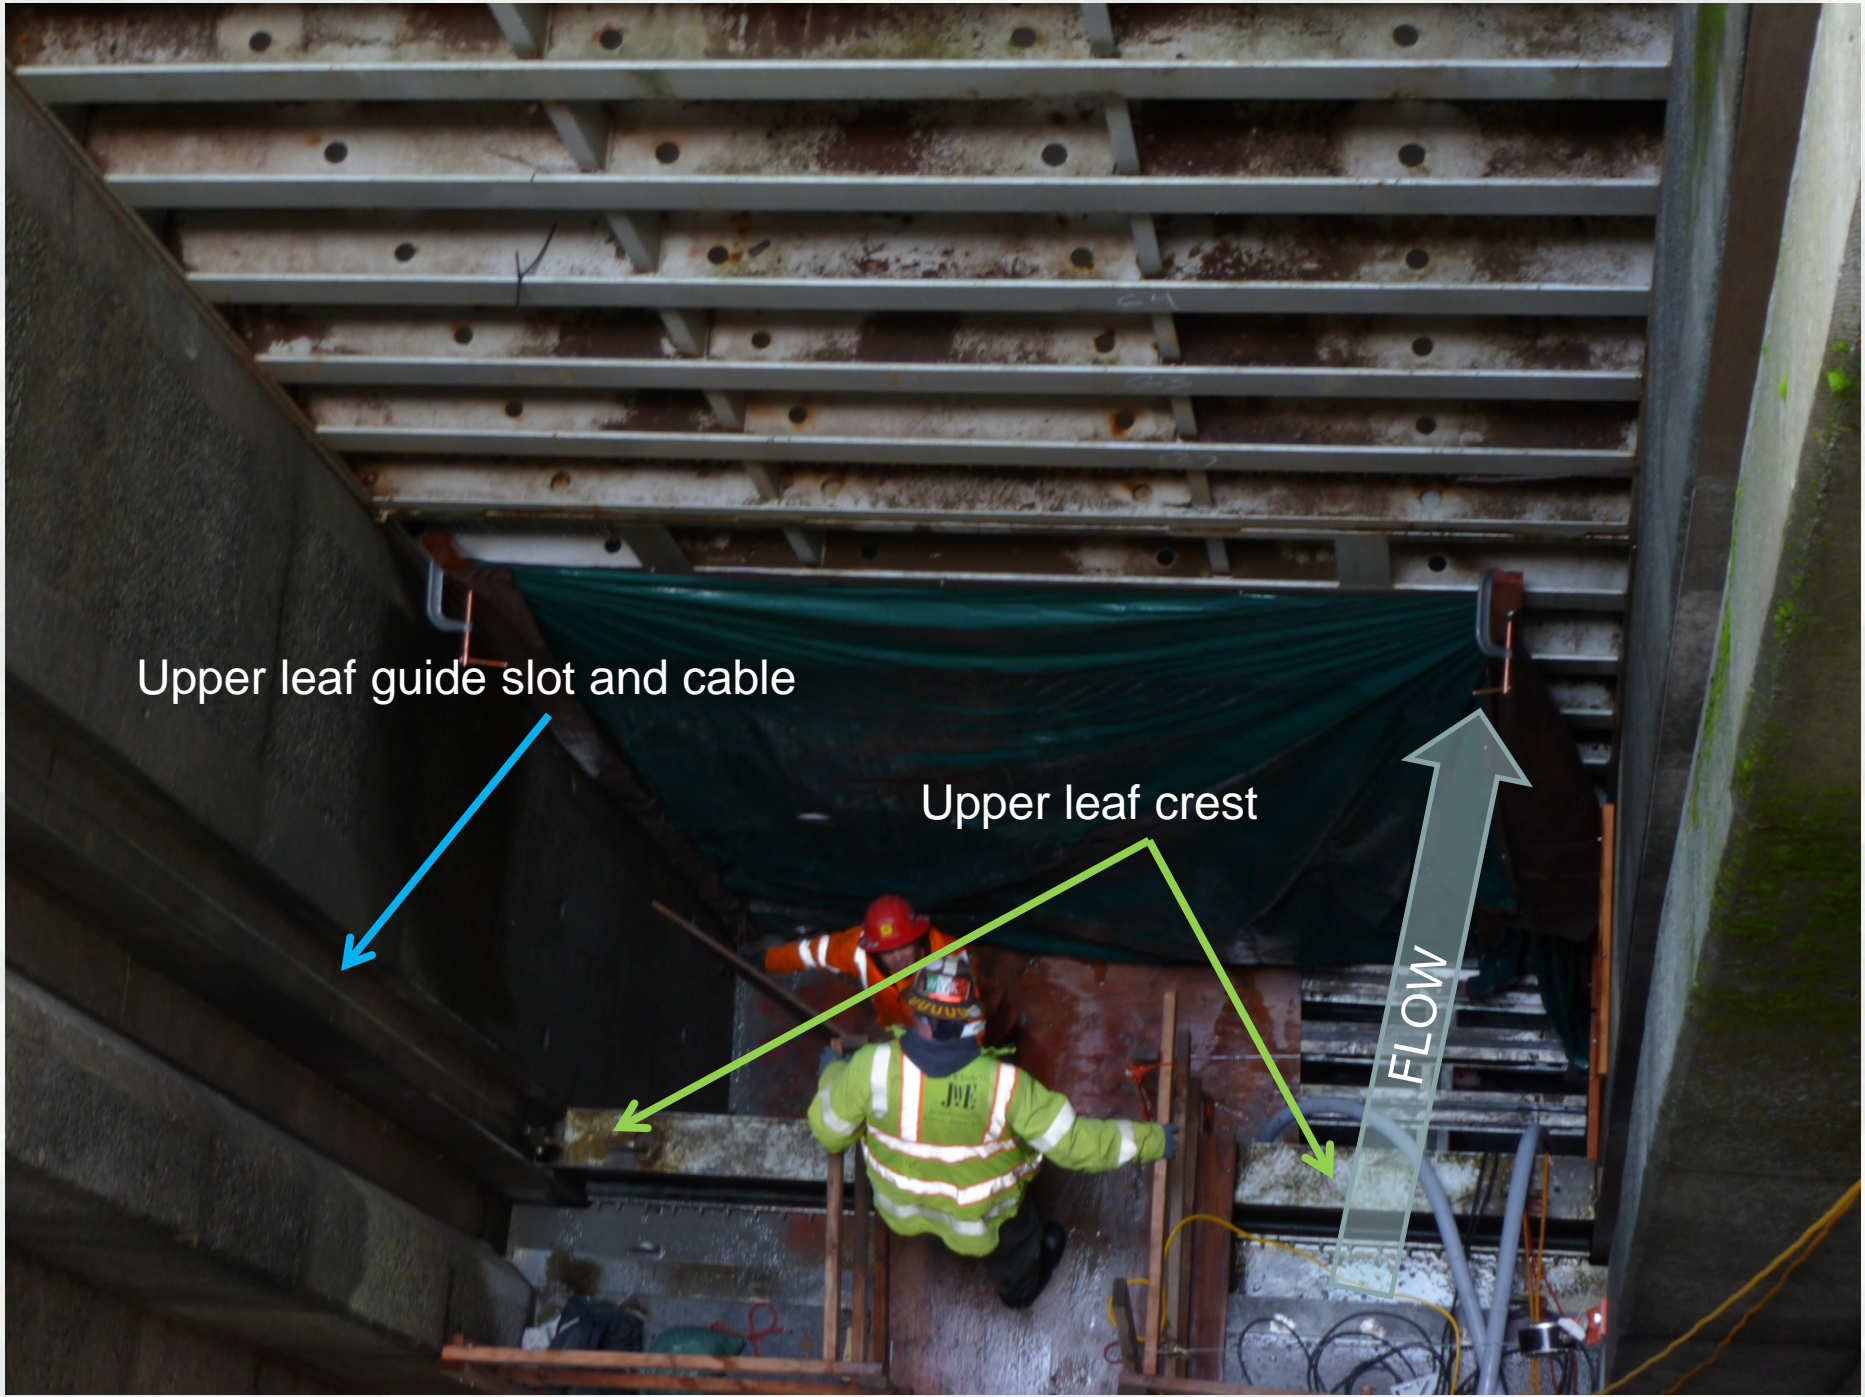
Upper leaf guide slot and cable

Upper leaf crest

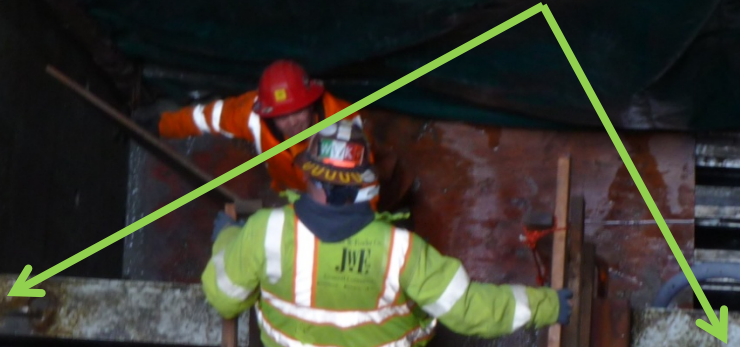
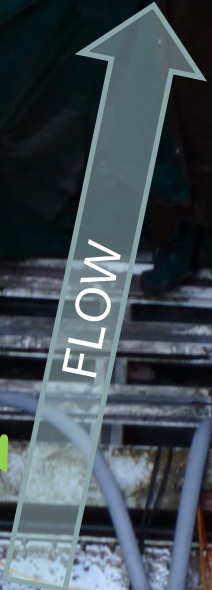
At NDE only, the upper entrance of Lamprey Flume System is positioned between bulkhead slot and entrance weir. Aqua colored thimble is part of this structure.

Upper leaf crest w/
rough sketch of rounded
crest (note lifting eye)

Bulkhead

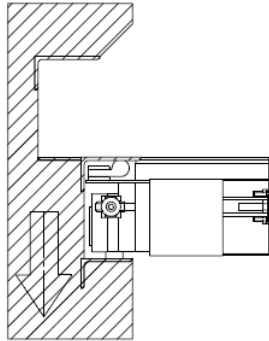
SECTION H-H
SCALE 1 : 10

BON WA Shore Ladder Rounded Entrance Weir Caps
