OFFICIAL COORDINATION REQUEST FOR NON-ROUTINE OPERATIONS AND MAINTENANCE

COORDINATION TITLE- 14BON01 BI lamprey wetted wall prototype

PROJECT- Bonneville Lock and Dam

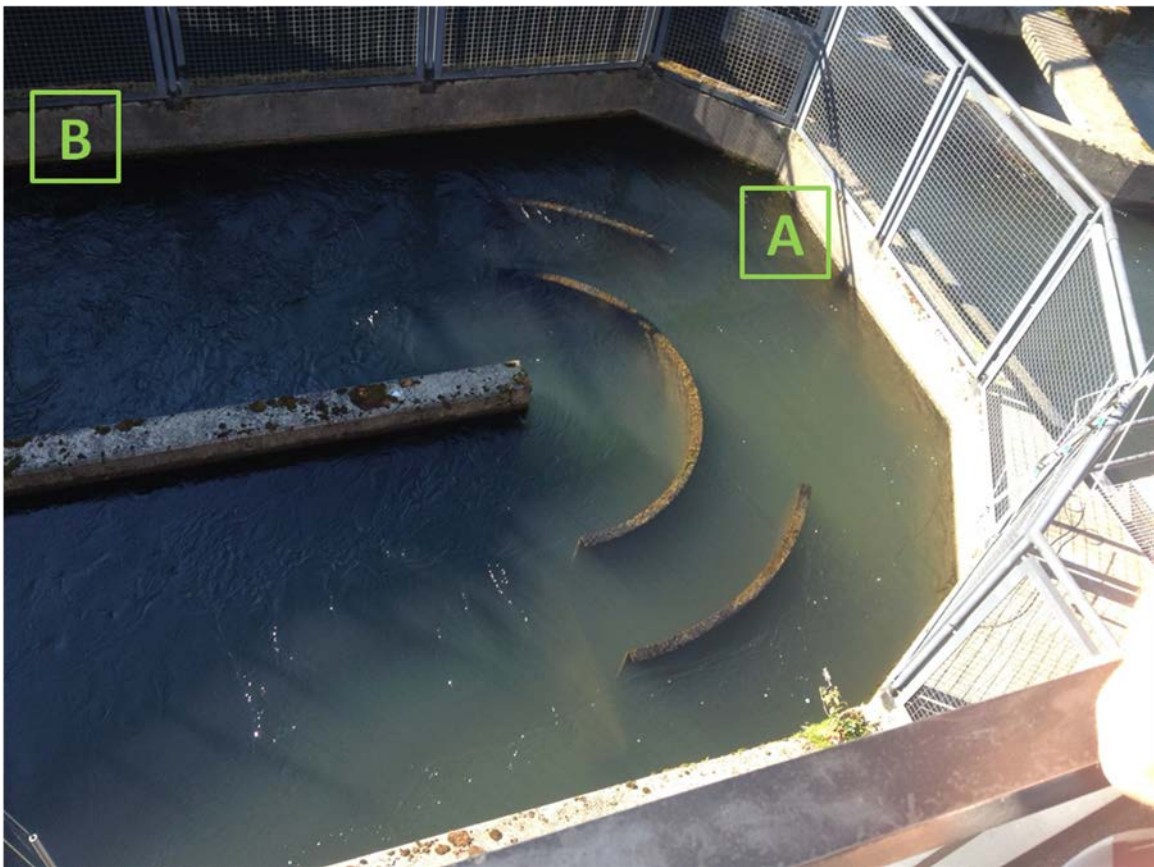
Figure 1. Photo of the Bradford Island Fish Ladder showing proposed installation locations A (preferred) and B (if “A” is not acceptable). Lamprey would be guided to the adjacent AWS channel, where two LPS entrance ramps are located.

Impact on facility operation- None. The installation of this structure will require that a hole be cut in the fencing atop the fishway wall (see **Figure 1** photo); to accommodate the rounded flume and hood. This hole would need to be approximately 24 inches wide by 14 inches tall and would be cut through the fence grid without impacting the support structure or overall integrity of the fence itself. The hole will be patched and repaired if or when the structure is removed.

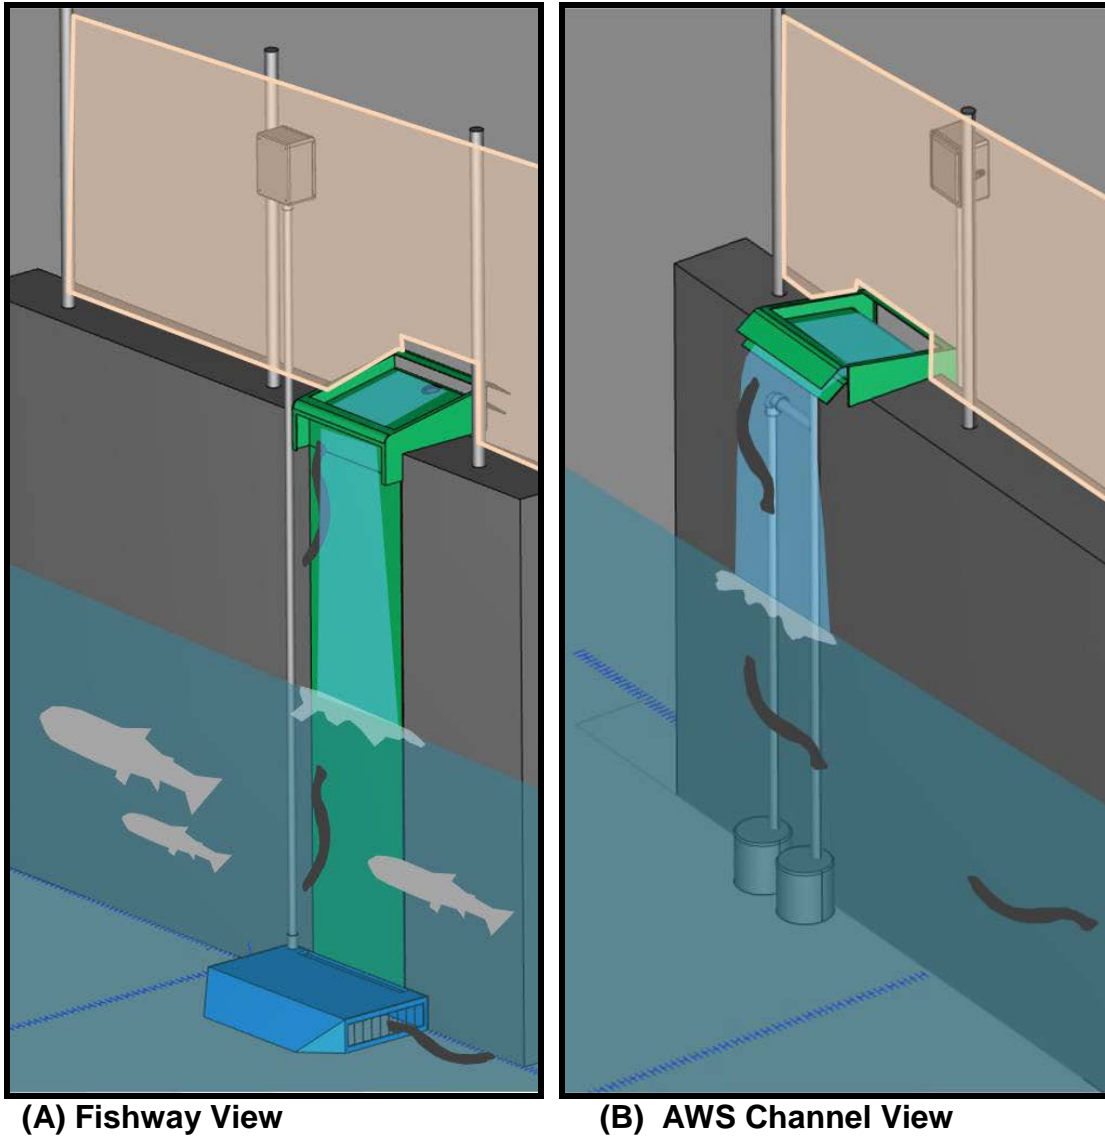
Figure 2. Isometric illustrations of the proposed wetted wall lamprey passage structure (lid on hood box at top of structure omitted in illustration). View (A) depicts the fishway side of the structure, including refuge box, climbing plate, and upstream 1.5" conduit. View (B) depicts the AWS channel side of the structure, including exit crest and two 115V submerged pumps. Water may be supplied via a nearby spigot instead (pending verification from Bonneville Project staff).

Key features of the prototype “wetted wall” structure (**Figure 2**):

1. The refuge box situated at the base of the waterfall will have access across the downstream face, fitted with vertical slats allowing no more than a 1.5” wide opening.

2. The upstream edge of the entrance box will be constructed of perforated plating to provide water flow through the box but will have no opening for passage. The box edges are 5” high and approximately 15” × 30” at their widest points with external 45° beveling on the solid edge.

4. The box will be anchored to the fishway floor and the fishway wall with 3/16” thick aluminum straps and 3/8” × 4” stainless concrete anchors spaced approximately 6” apart.

5. A length of 1.5” conduit attached to the fishway wall with stainless clamps along the upstream edge of the climbing plate will present a roadblock to lamprey moving along the wall to encourage them to find and use the climbing surface.
