OFFICIAL COORDINATION REQUEST FOR NON-ROUTINE OPERATIONS AND MAINTENANCE

COORDINATION TITLE: 14BON20 WA Shore LFS venting modifications

PROJECT: Bonneville Dam

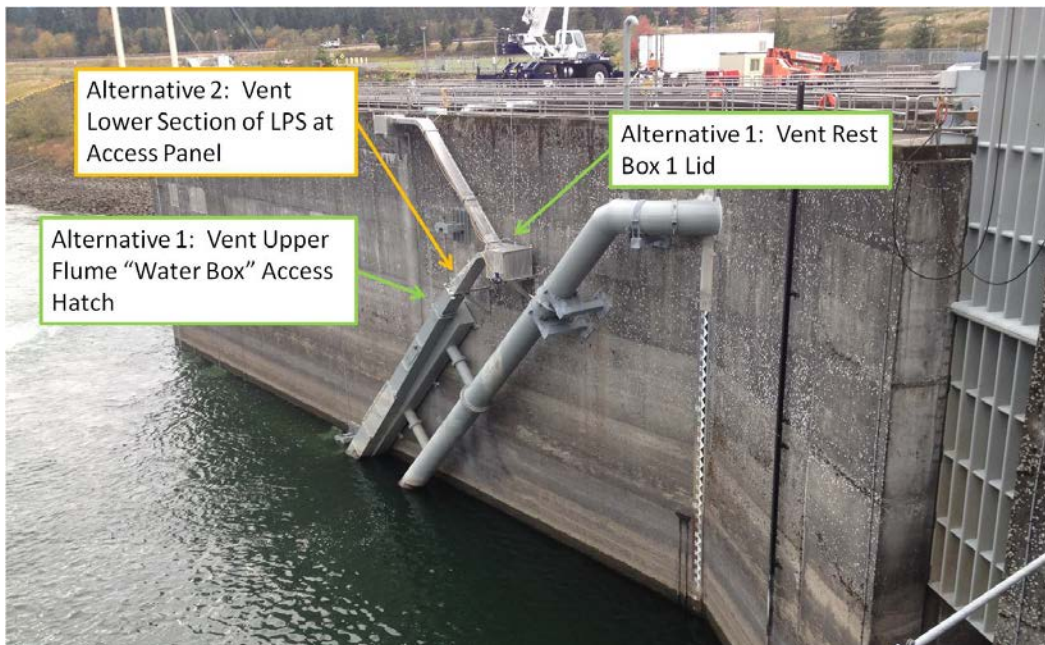
Figure 1. Photograph showing locations of venting alternatives for the Bonneville Washington Shore Lamprey Flume System (LFS). A mobile crane would be staged near the North Upstream Entrance (NUE), in the right of this photo.

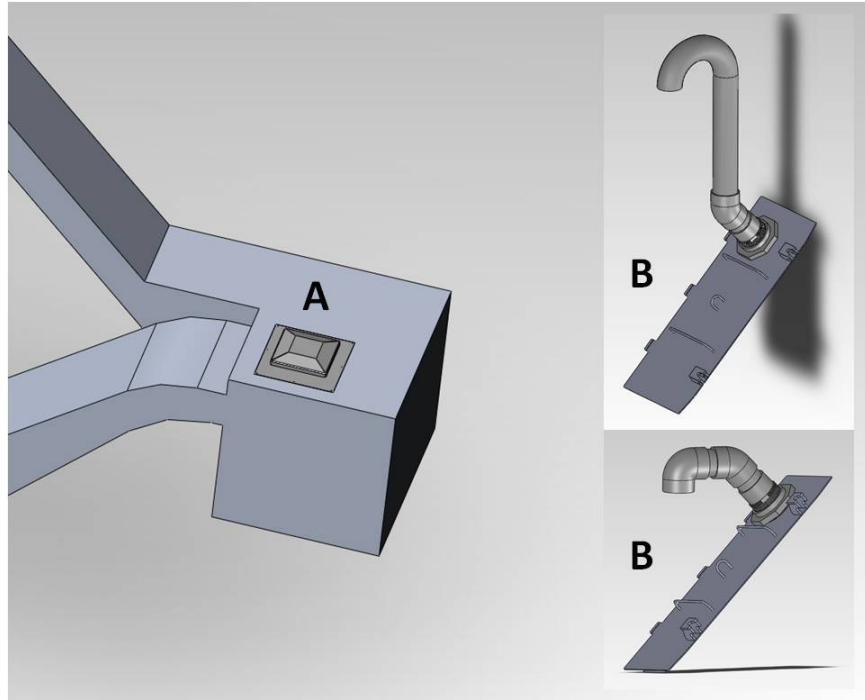
Figure 2. Conceptual drawings of venting structures for Rest Box 1 (A) and the Upper Flume “Water Box” Access Hatch (B). Designs for Alternative 2 are still in development.

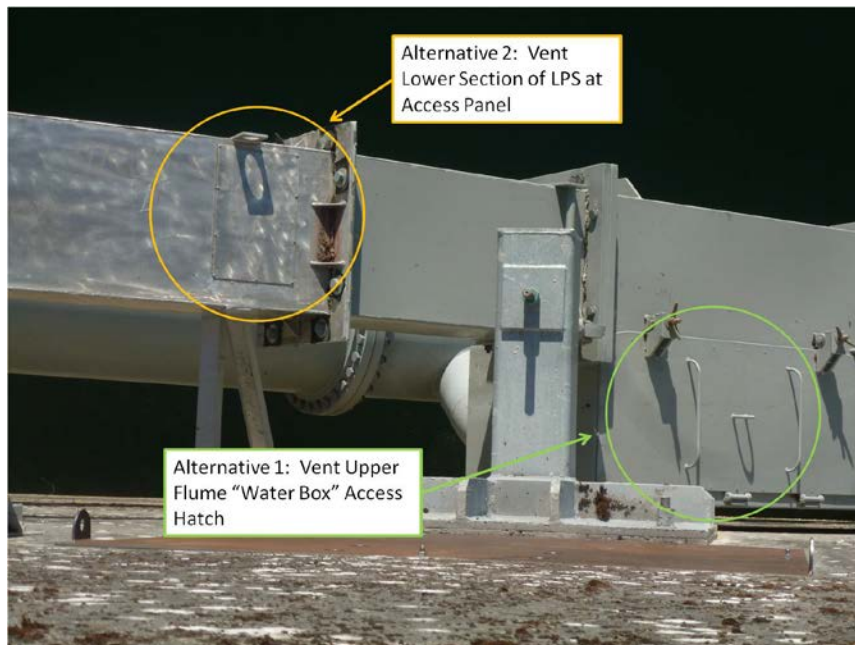
Figure 3. Photograph showing existing access panel on lower portion of LPS (A) and LFS upper flume water box access hatch (B).

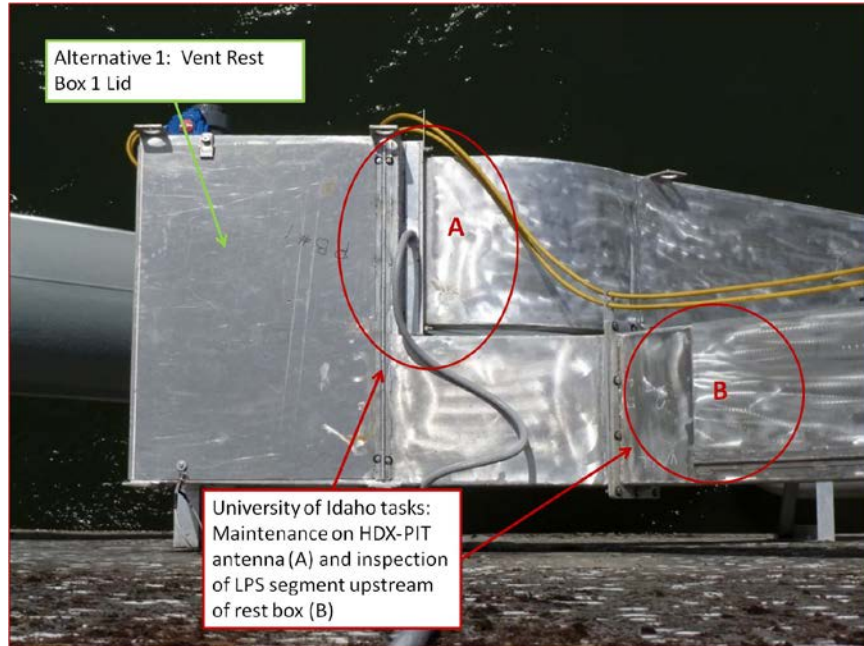
Figure 4. Photograph showing lower sections of LPS, including Rest Box 1, Rest Box 1 half-duplex PIT antenna (A), and LPS segment above Rest Box 1 (B). The PIT antenna at this location is not functional and will be replaced. Water has been observed emanating from the edges of the inspection lid of the LPS segment above Rest Box 1.

In addition to this work, the University of Idaho has two small-scale tasks that require work over the water. The half-duplex PIT antenna located in Rest Box 1 requires maintenance and the Lamprey Passage Structure (LPS) inspection lid located immediately above Rest Box 1 is leaking water, which may indicate some sort of blockage or disturbance of flow within the LPS (Figure 4). A similar issue identified in 2013 led to minor modifications to the fyke leading from the rest box to the ramp.

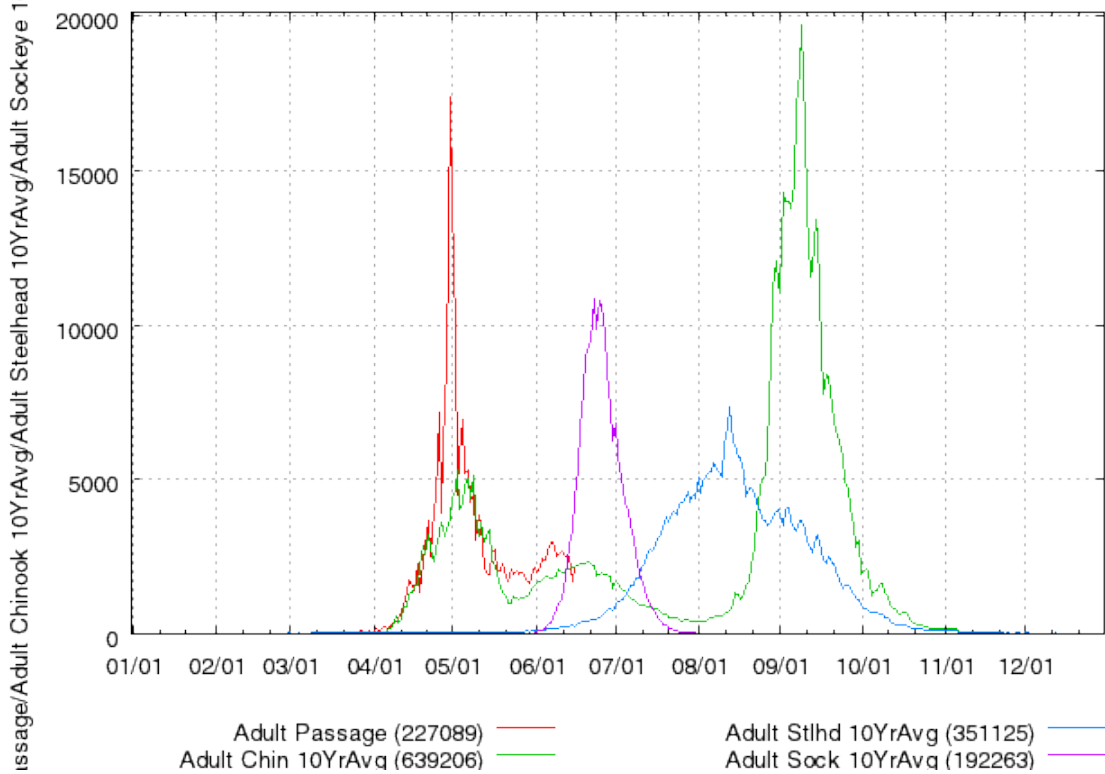
Figure 5. Adult salmonid passage at Bonneville Dam, 2004-2013. The proposed July 7-10 period for completing this work is intended to minimize any impacts on passage by timing the operation between summer and fall Chinook runs, after the sockeye run, and on the ascending portion of the summer steelhead run.

Expected impacts on fish passage: Minimal. Operation of the crane, hand tools, and boat in the vicinity of the fishway may cause minor disturbance. The proposed dates were selected based on the typical lull in passage between summer and fall runs, but will coincide with the first portion of the summer steelhead run.
