**MEMORANDUM FOR THE RECORD**

**SUBJECT: 21BON014 FV 3-7 and FG 3-4,5,6 OOC**

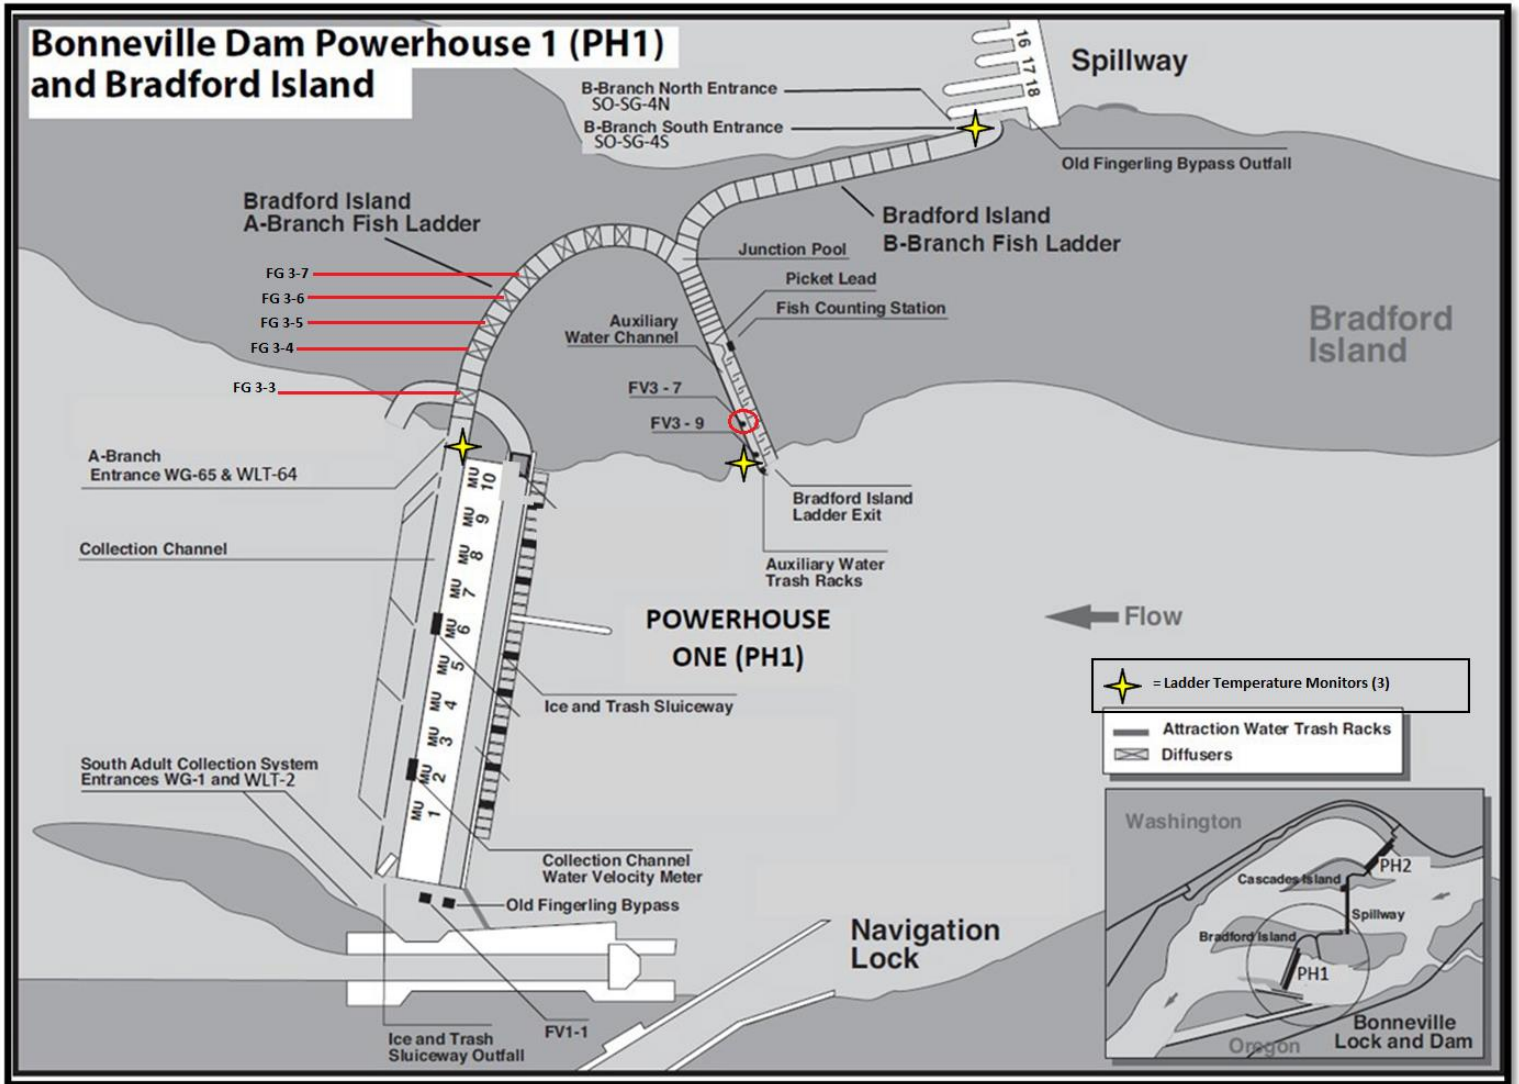
**Figure BON 2 (FPP). Bonneville Dam Powerhouse 1 (PH1 and Bradford Island Adult Fish Ladder A-Branch and B-Branch.**

Please see **Figure BON 2** from the Fish Passage Plan (FPP) at the end of this document for location descriptions.
