**OFFICIAL COORDINATION REQUEST FOR
NON-ROUTINE OPERATIONS AND MAINTENANCE**

COORDINATION TITLE- 23JDA05 Floating Orifice Gate Removal

PROJECT- John Day Dam

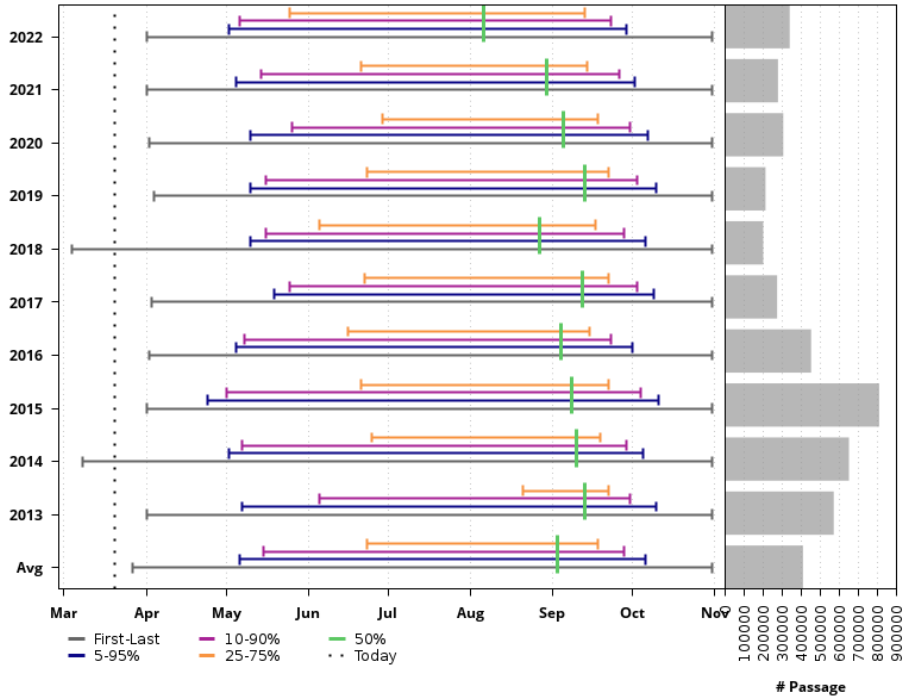
**Historical Run Timing, 2013 - 2022
Adult Visual Counts Chinook
John Day Dam, 3/1 - 10/31**

Pulling the floating orifice gates from units 1 & 2 could possibly cause slight upstream migration delays for some adult salmon populations due to fewer entrance options.

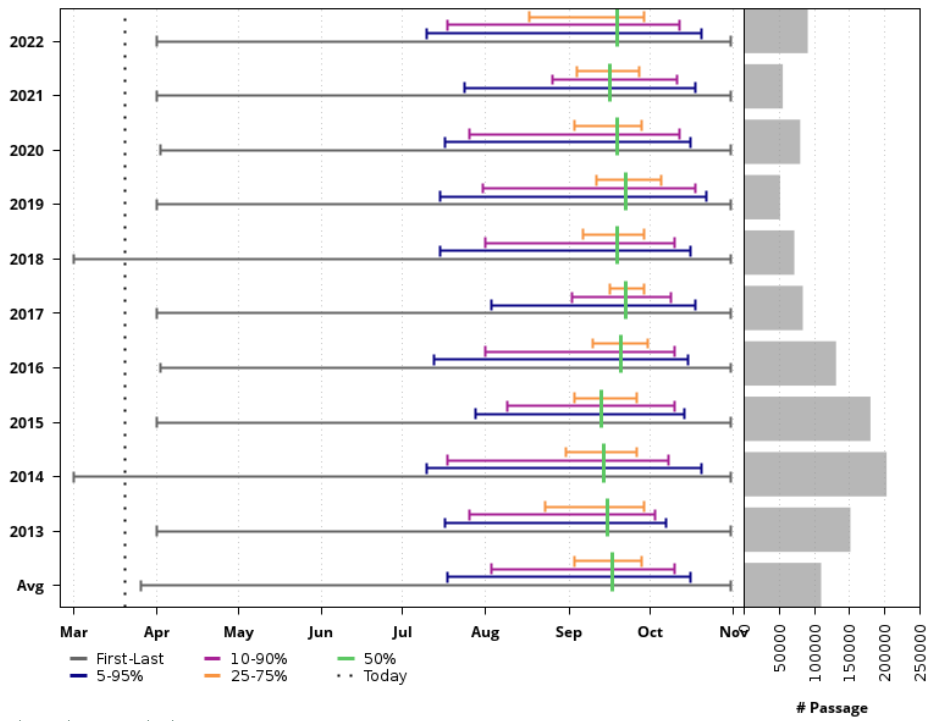
**Historical Run Timing, 2013 - 2022
Adult Visual Counts Steelhead
John Day Dam, 3/1 - 10/31**

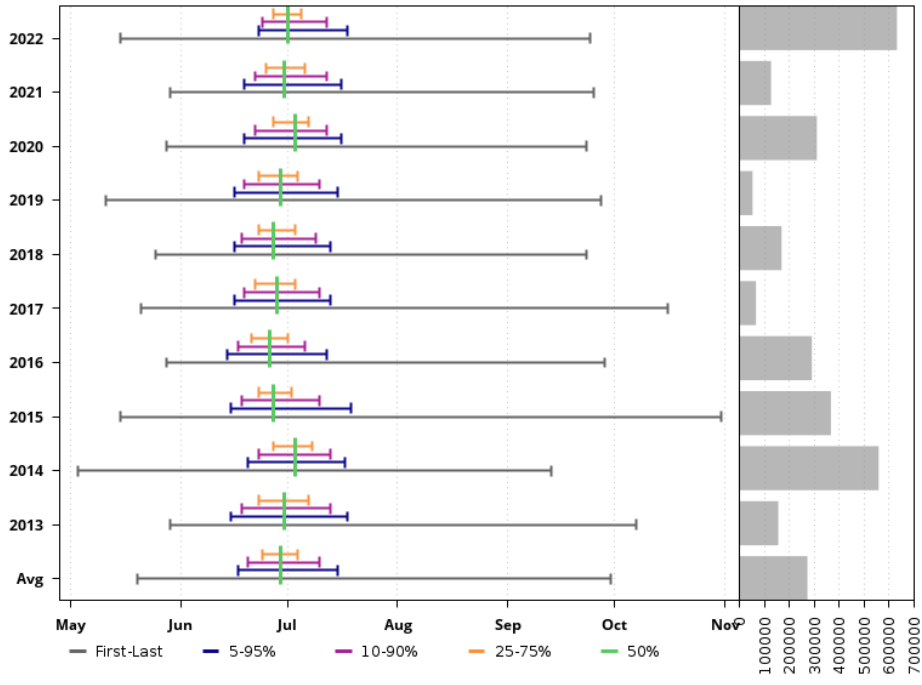
Historical Run Timing, 2013 - 2022
 Adult Visual Counts Sockeye
 John Day Dam, 3/1 - 10/31

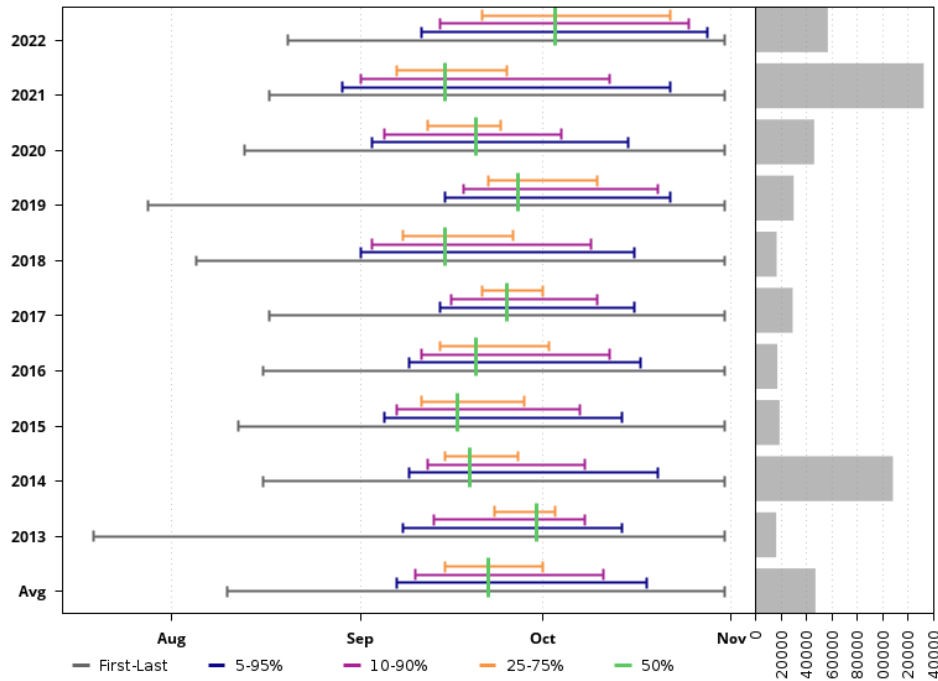
Historical Run Timing, 2013 - 2022
 Adult Visual Counts Coho
 John Day Dam, 3/1 - 10/31

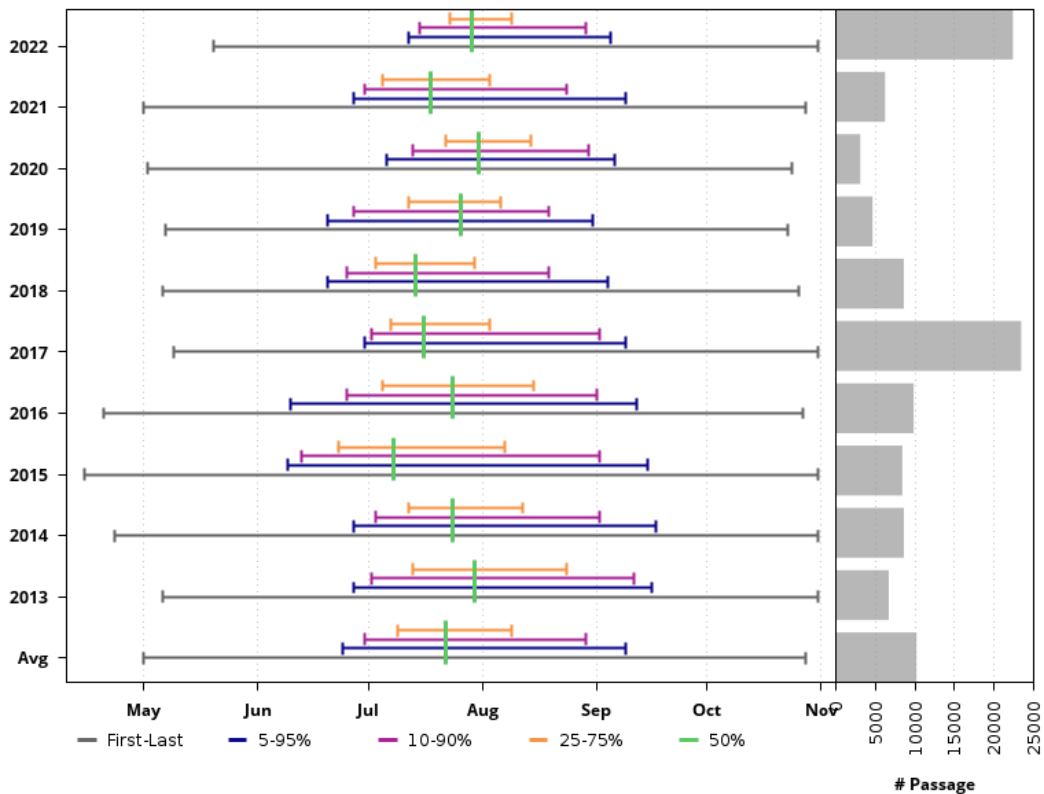
**Historical Run Timing, 2013 - 2022
Adult Visual Counts Lamprey
John Day Dam, 3/1 - 10/31**
