**OFFICIAL COORDINATION REQUEST FOR
NON-ROUTINE OPERATIONS AND MAINTENANCE**

COORDINATION TITLE- 18 MCN 02 Spill pattern deviation

PROJECT- McNary

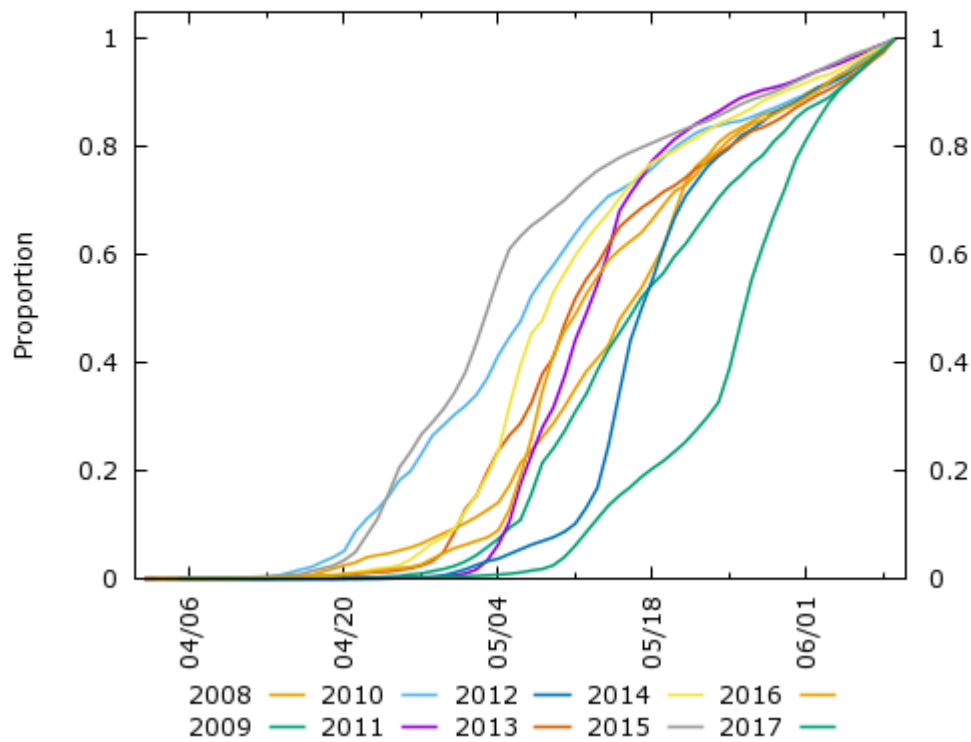
Chinook Adult Passage Counts
McNary Dam Cumulative Passage
Years 2008 - 2017

- a. **Downstream migrants:** Smolts moving downstream should experience no impact or delay in finding downstream passage route with gas cap spill operation.
- b. **Upstream migrants (including Bull Trout):** Low to no impact expected since spillbay 2 is closest to north ladder, and first 1% of spring Chinook run did not pass McNary in 2017 until May 6. Steelhead passage is largely complete for 2017-18 with currently counts in single digits daily. All species will notice little change from FPP Table 7 with the proposed modification.
- c. **Lamprey:** Juvenile lamprey moving downstream should experience no impact or delay in finding downstream passage route with gas cap spill operation.

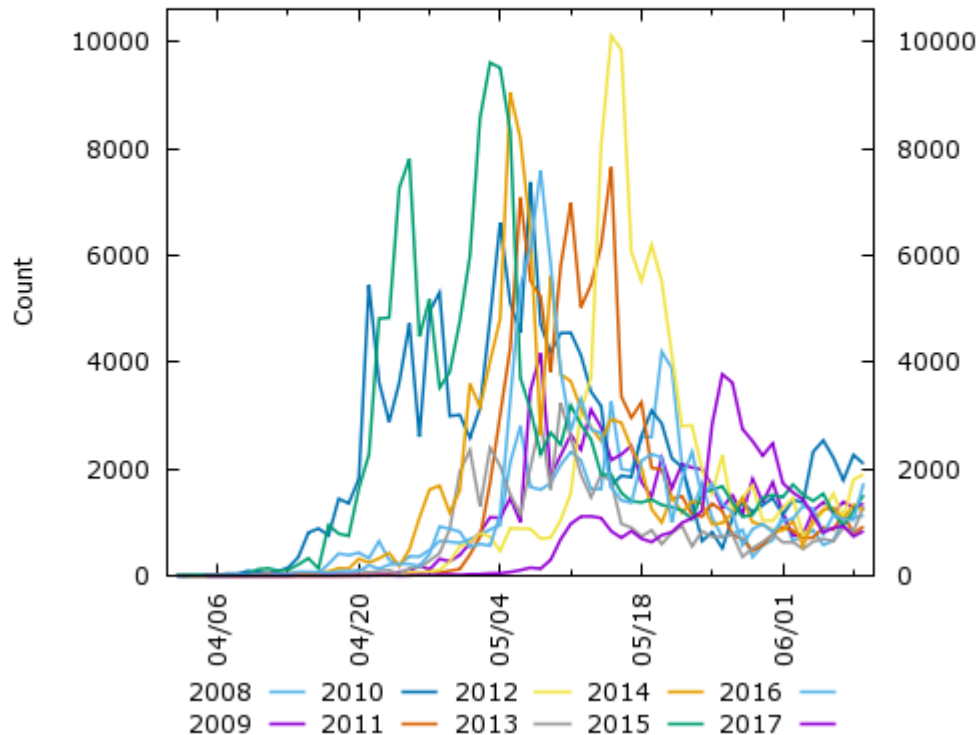
Chinook Adult Passage Counts

McNary Dam Passage
Years 2008 - 2017
