BONNEVILLE DAM

FISHWAY STATUS ANNUAL REPORT

2013

U. S. Army Corps of Engineers
CENWP-OD-B
Bonneville Lock & Dam
Cascade Locks, OR 97014
(541) 374-4598

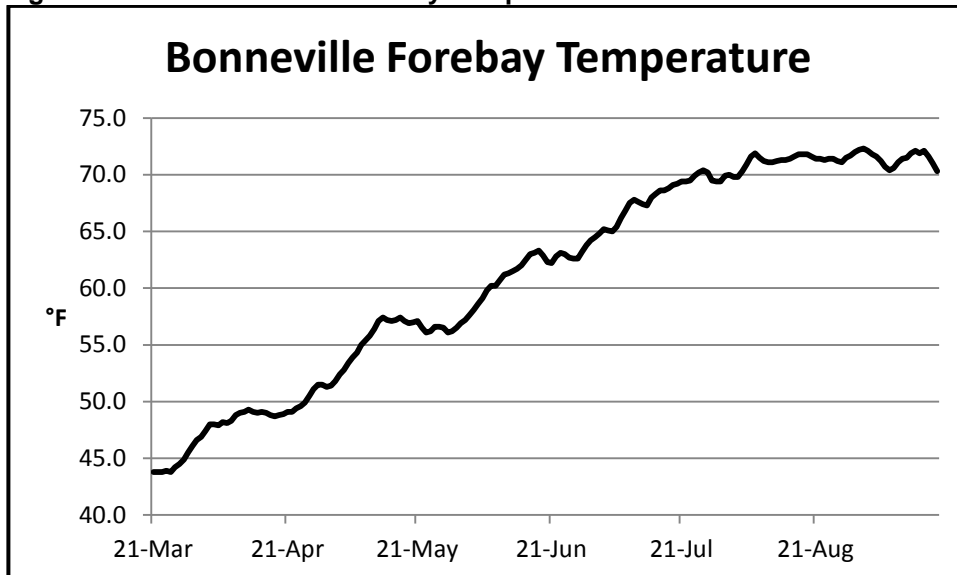
Figure 2. 2013 Bonneville Forebay Temperatures.

Project biologists monitor fishway temperatures throughout the fish passage season, from March through November. Temperature probes are installed in the upper Bradford Island and WA shore fishways, the Adult Fish Facility (AFF), and the Juvenile Monitoring Facility (JMF). These fishway probes were not operational until 21 July 2013. Additionally, the Technical Management Team (TMT) tracks BON forebay temperature on their [website](#). The TMT temperature is publically accessible real-time, and is the standard utilized per the [FPP](#) to determine when high-temperature fish sampling restrictions are operative in BON facilities. In 2013, these temperatures were available from 21 March - 18 September 2013. Detailed daily temperatures can be found in the weekly reports.
