BONNEVILLE DAM

FISHWAY STATUS ANNUAL REPORT

2015

U. S. Army Corps of Engineers
CENWP-OD-B
Bonneville Lock & Dam
Cascade Locks, OR 97014
(541) 374-4598

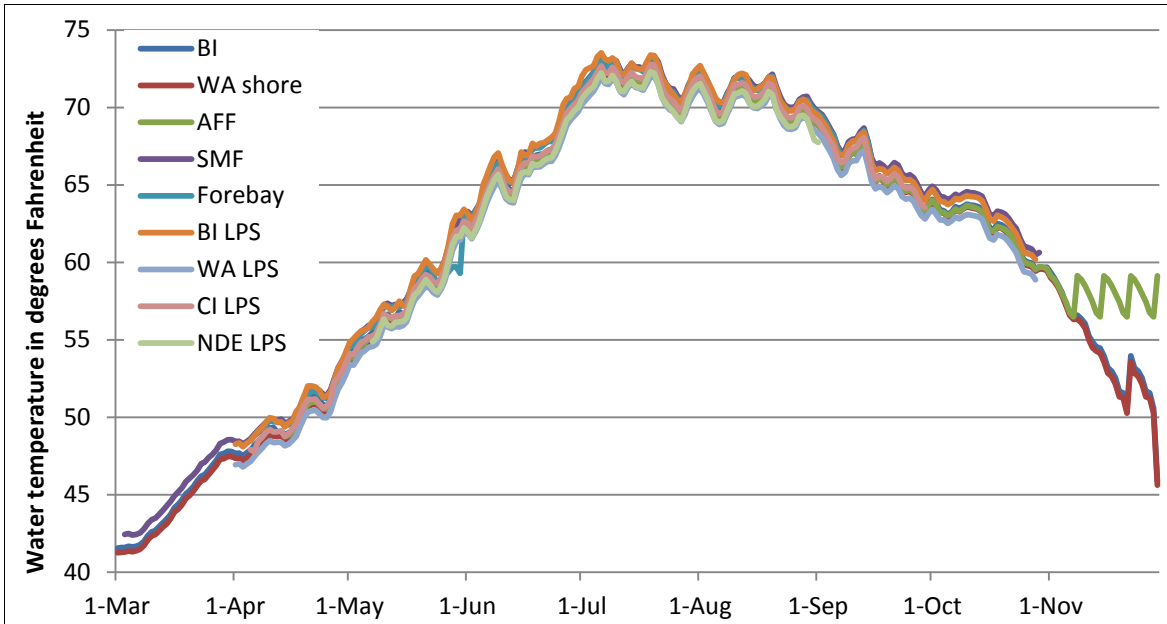
Figure 2. 2015 Bonneville temperatures.

Project biologists monitor fishway temperatures throughout the fish passage season, from March through November. Temperature probes are installed in the upper Bradford Island and WA shore fishways, the Adult Fish Facility (AFF), and the Juvenile Monitoring Facility (JMF). Probes are also installed in rest boxes of all four lamprey passage structures (LPS), which are located at Bradford Island, Cascades Island, the Washington shore auxiliary water supply channel, and at the PH2 north downstream entrance (NDE). Additionally, the Technical Management Team (TMT) tracks BON forebay temperature on their [website](#). The TMT temperature is publicly accessible real-time, and is the standard utilized per the [FPP](#) to determine when high-temperature fish sampling restrictions are operative in BON facilities. In 2015, these temperatures were available from 18 March - 16 September. Detailed daily temperatures can be found in the weekly reports.
