2020 Annual Fishway Status Report for Bonneville Project

U. S. Army Corps of Engineers
Bonneville Lock & Dam
Cascade Locks, OR 97014
(541) 374-4598

This **2020** Project Fisheries Annual Report for Bonneville Project summarizes activities occurring from **01 December 2019 through 30 November 2020** and is required by the Fish Passage Plan (FPP), per section 2.5.2.3.

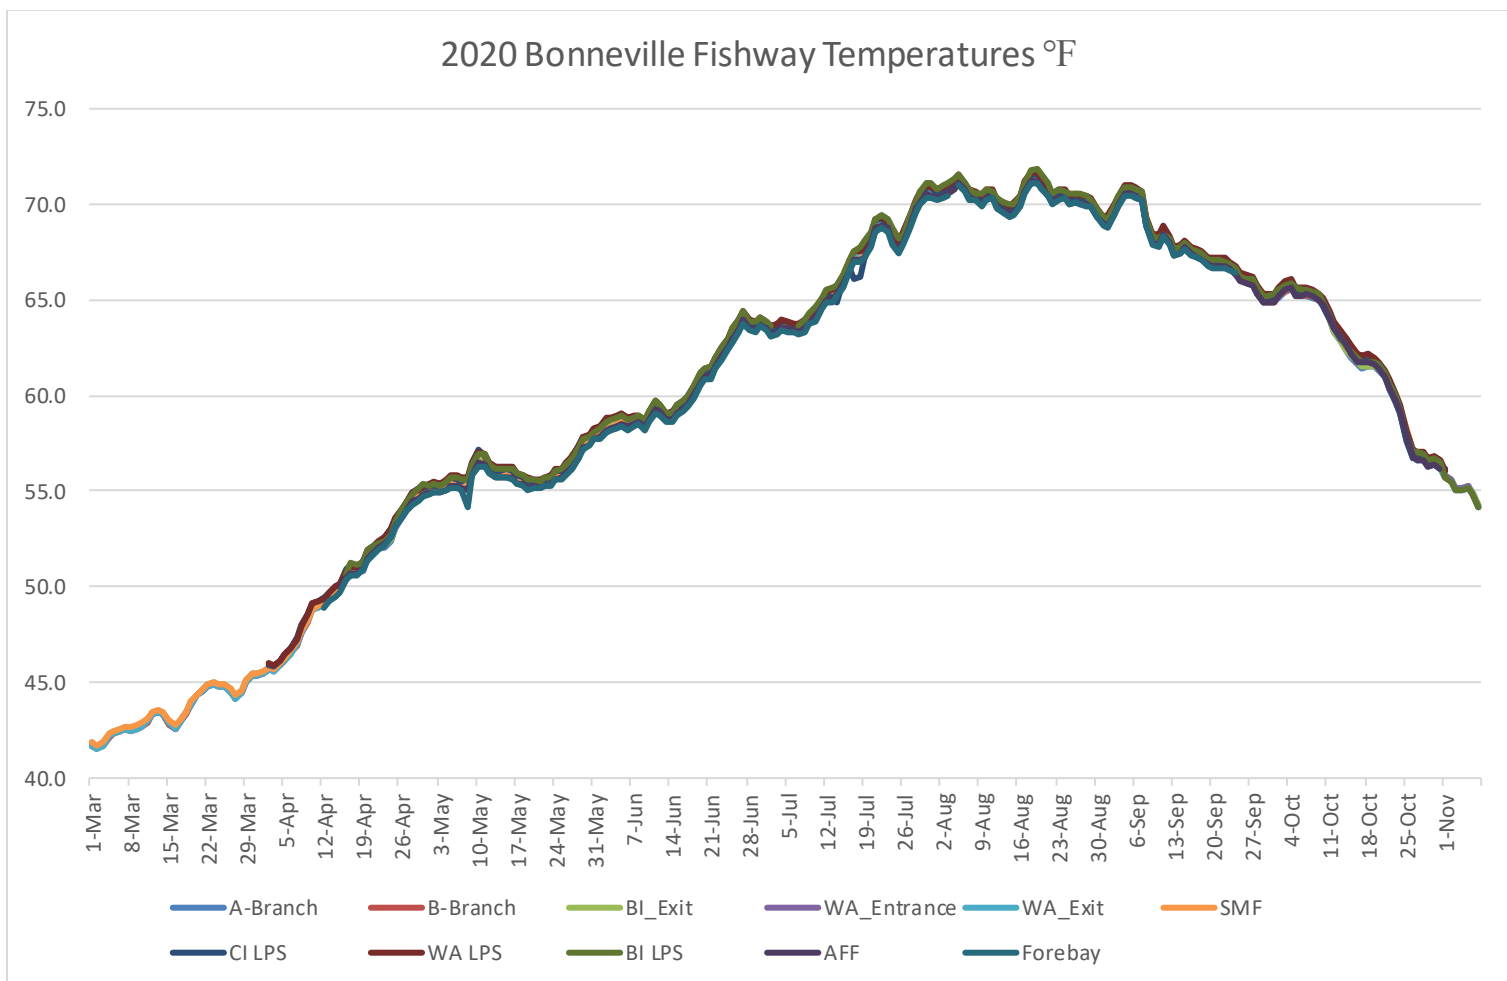
Project biologists monitor fishway temperatures throughout the fish passage season, from 01 March through 07 November (**Figure 2**). Temperature probes are installed at the following locations: A-Branch entrance, B-Branch entrance, Bradford Island exit, Washington Shore Entrance (NDE), Washington Shore Exit (near FV6-9), AFF, SMF, BI LPS, CI LPS, WA LPS, and the LFS. Additionally, the Technical Management Team (TMT) tracks BON forebay temperature on their [website](#). The TMT temperature is publicly accessible in real-time, and is the standard utilized per the FPP to determine when high-temperature fish sampling restrictions are operative in BON facilities. In 2020, these temperatures were available from 12 March - 24 September. Detailed daily temperatures can be found in the weekly reports and are available upon request.

Figure 2. 2020 Temperatures at Bonneville.
